ZAHL-FORD, inc.

September 26, 2011

Re: State Capitol Building
Structural Inspection of South Portico Façade
DCS# ID12115 – DCSOFM

Zahl-Ford Project #11179

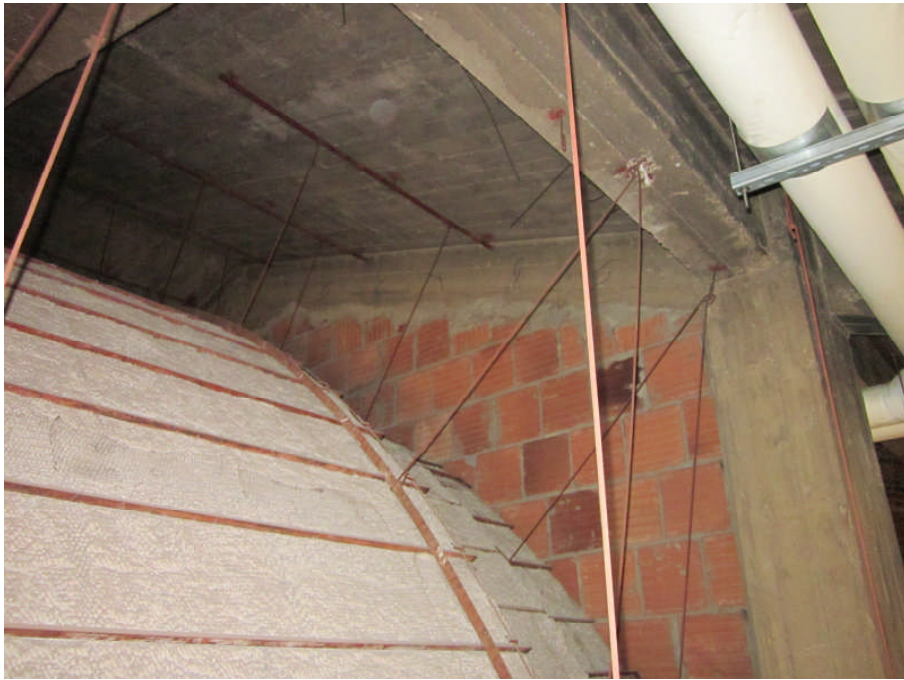
Structurally, the south portico portion of the Capitol is a concrete-frame building with in-fill clay masonry (brick and tile) walls. Refer to Photos 1 through 3. Architecturally, the building is designed in the classic Greco-Roman style with white limestone cladding above a base of pink granite and entrance colonnades at the north and south porticos with closely spaced white limestone columns.

Photo 1 Concrete Frame with Clay Tile Infill

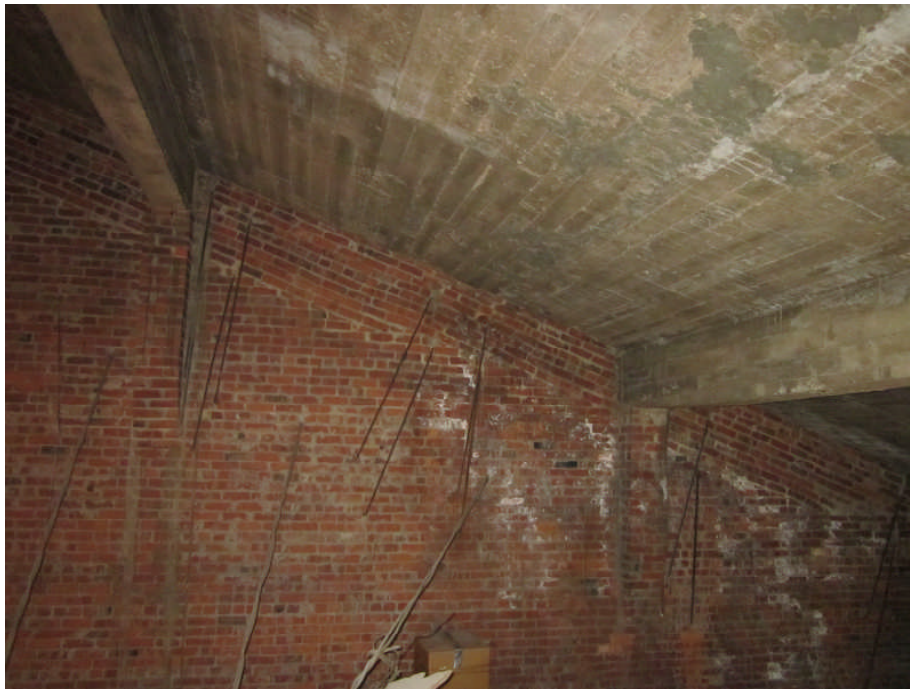
4. Evidence of water infiltration that has occurred as the result of the opened mortar joints is visible in the attic space at the end wall of the south portico. The brick wall that provides the back-up wall support for the exterior cladding has a significant amount of efflorescence, which has occurred as the result of water passing through the deteriorated joints of the exterior limestone cladding and through the brick wall, leaching out the lime in the mortar. The observed efflorescence is not directly attributable to water infiltration through joints in the limestone veneer at the southeast and southwest corners but is attributable to failed mortar joints in the limestone veneer located in the triangular area of the gabled end wall of the south portico. This condition supports our observation that the problems with deteriorating joints extend beyond the two corners of the south portico. Refer to Photos 2 and 3.

Photo 2 Concrete Roof and Beams with Clay Brick Infill

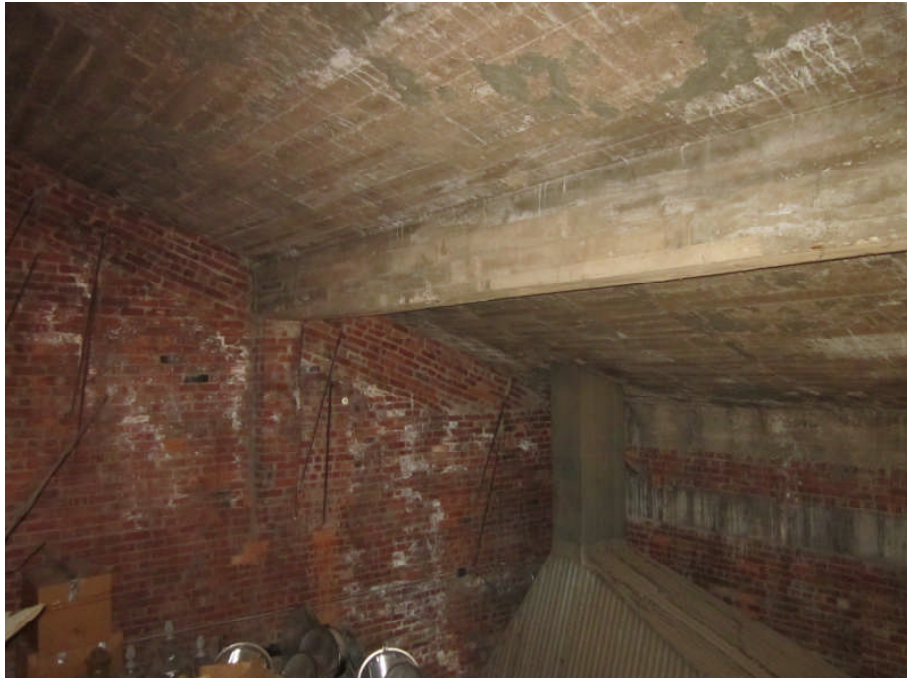
Photo 3 Concrete Roof and Beams with Clay Brick Infill

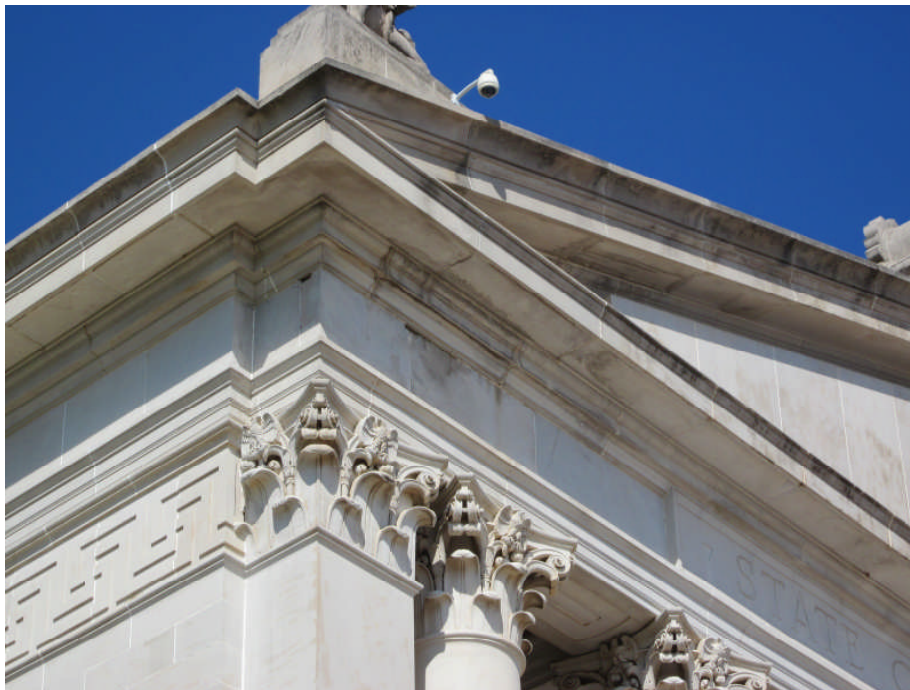
The source of the falling debris was reportedly from the east and west corners of the band of limestone cladding just above the south portico colonnade columns. Refer to Photos 4 and 5.

Photo 4 West Corner of South Portico

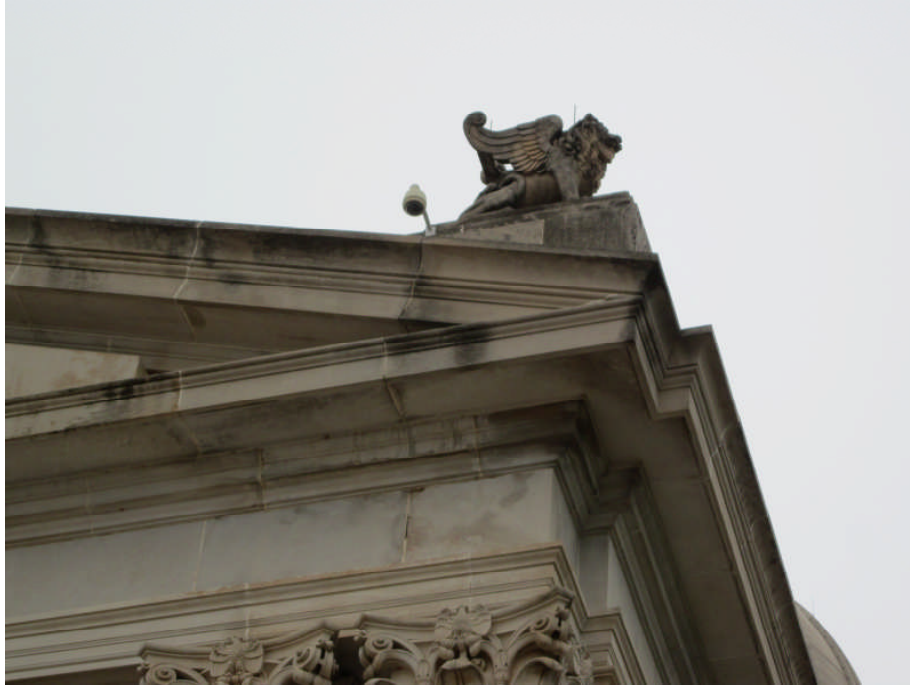
Photo 5 East Corner of South Portico

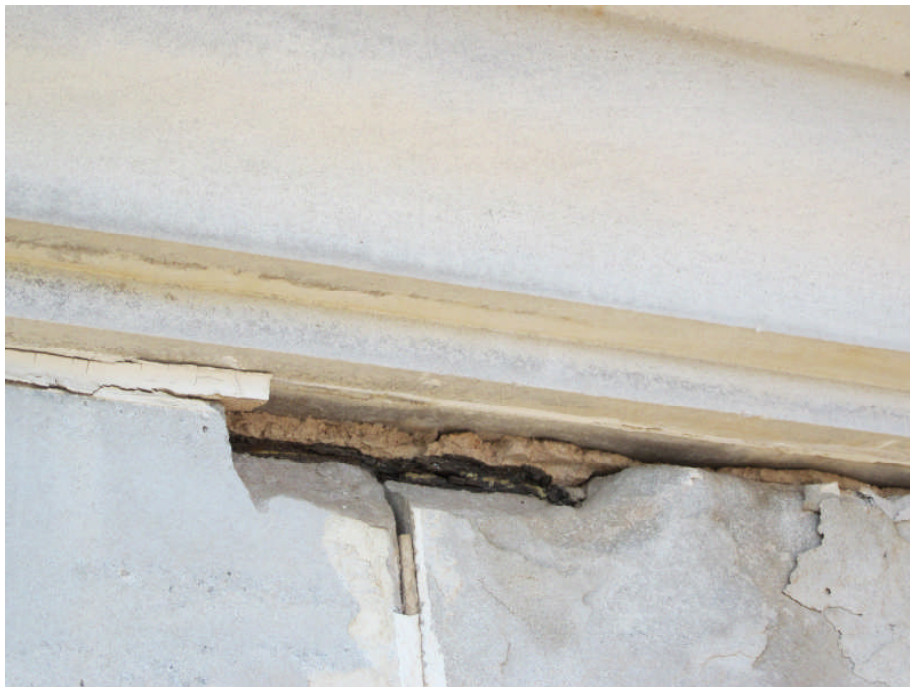
1. All mortar joints between limestone panels are severely deteriorated. The cementitious mortar that remains in the joints is severely cracked and eroded from weathering. Mortar is missing entirely along significant portions of joints. A surface sealer that was applied to the joints in the past has failed and is in a rigid and cracked state with open edges indicating that it has deteriorated due to sun and weather exposure. Refer to Photos 6 through 15.

2. The upper corners of several limestone panels at the southwest corner and one panel at the southeast corner have broken off. In most cases the broken corners have exposed steel block-to-block ties. The exposed steel ties have corroded severely to the point that the exposed steel flakes off when disturbed. The broken limestone panel corner at the southeast portico corner has been filled with caulking or putty, which covers the steel tie. Consequently the condition of the block-to-block tie at that location is not known. Refer to Photos 6 through 9, and 13.

Photo 6 Southwest Corner: Corroded Steel Tie at Upper Corners of Limestone Blocks

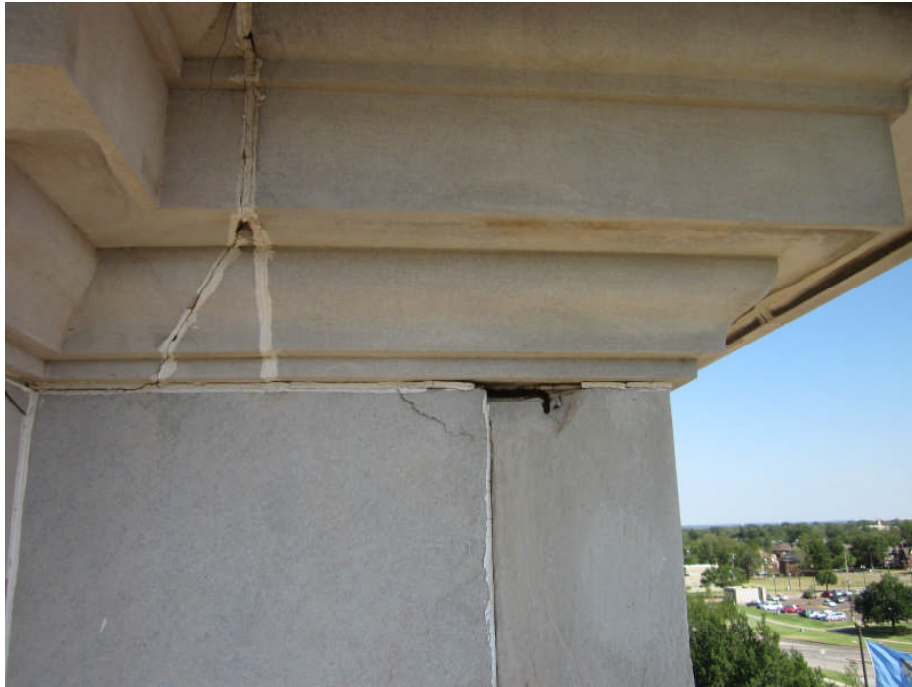
Photo 7 Southwest Corner: Broken Limestone Corner and Exposed and Corroded Steel Tie

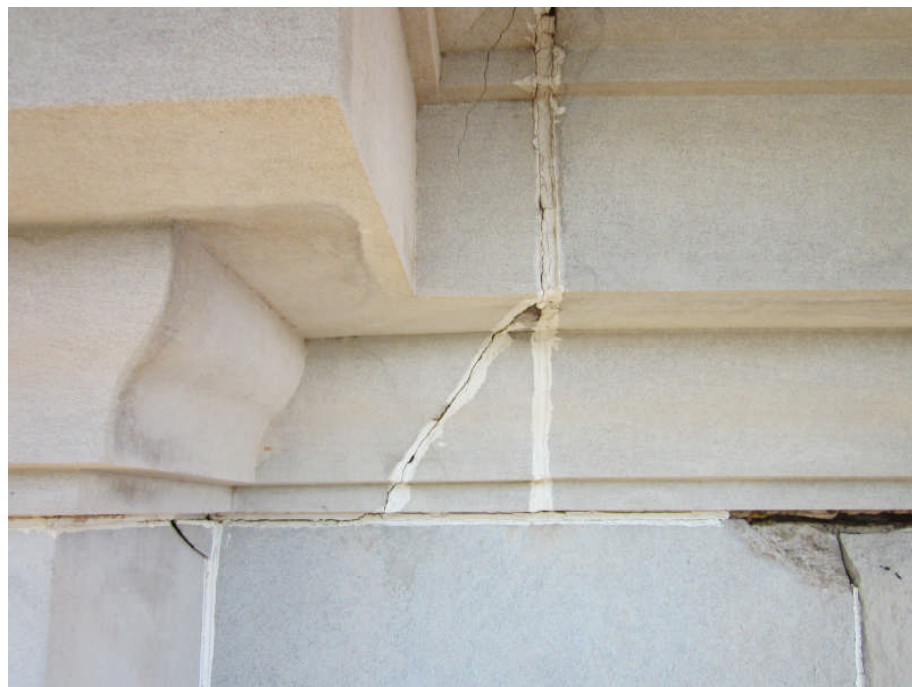
Photos 8 Southwest Corner: Deteriorated Mortar Joints, Crack Limestone Block Corners, Exposed and Corroded Steel Tie

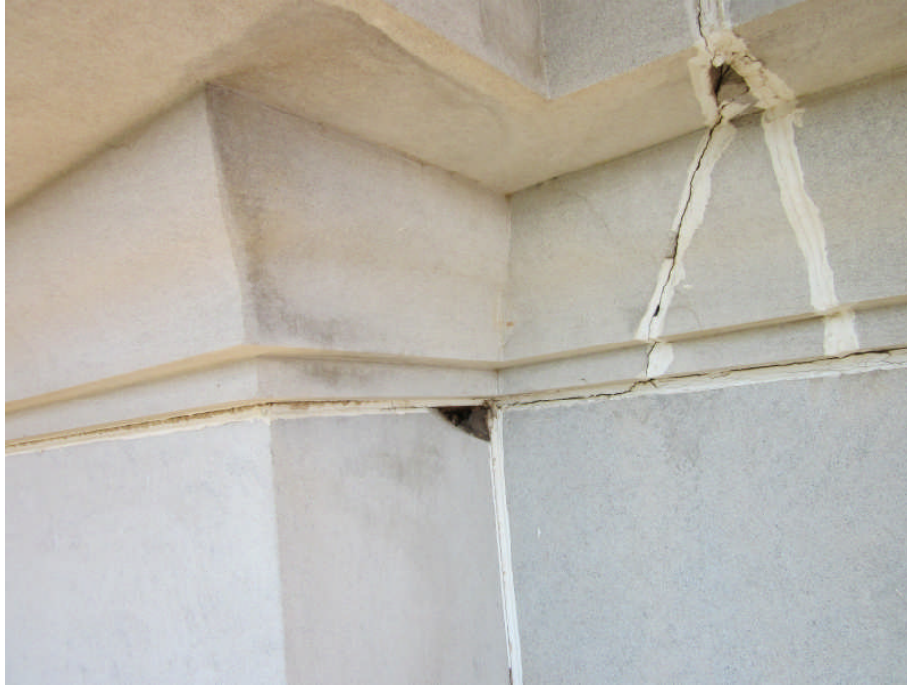
Photo 9 Southwest Corner: Deteriorated Mortar Joints and Crack Limestone Block Corners

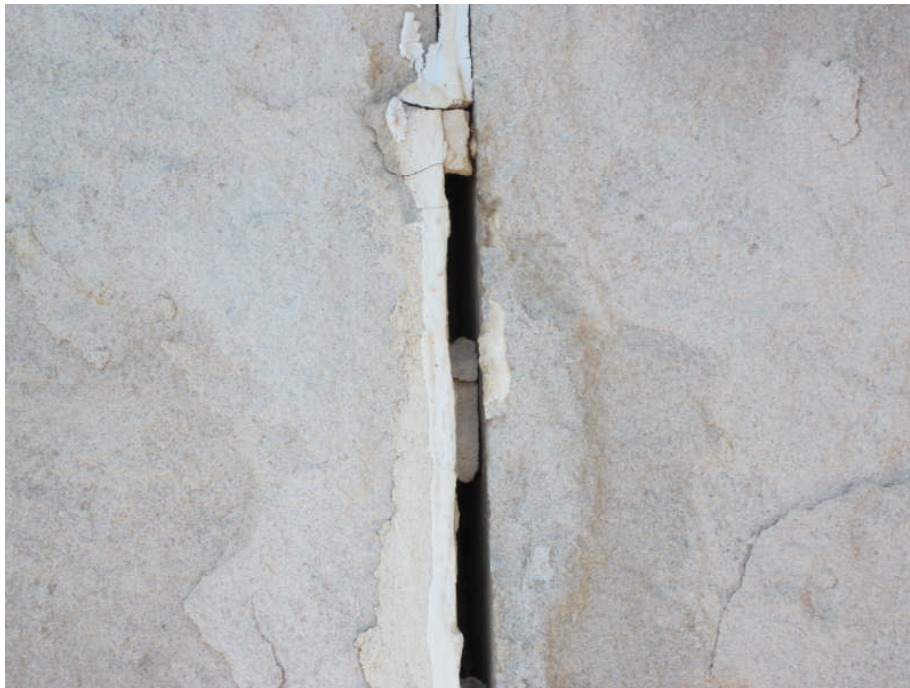
Photo 10 Southwest Corner: Deteriorated Mortar Joint Between Limestone Blocks

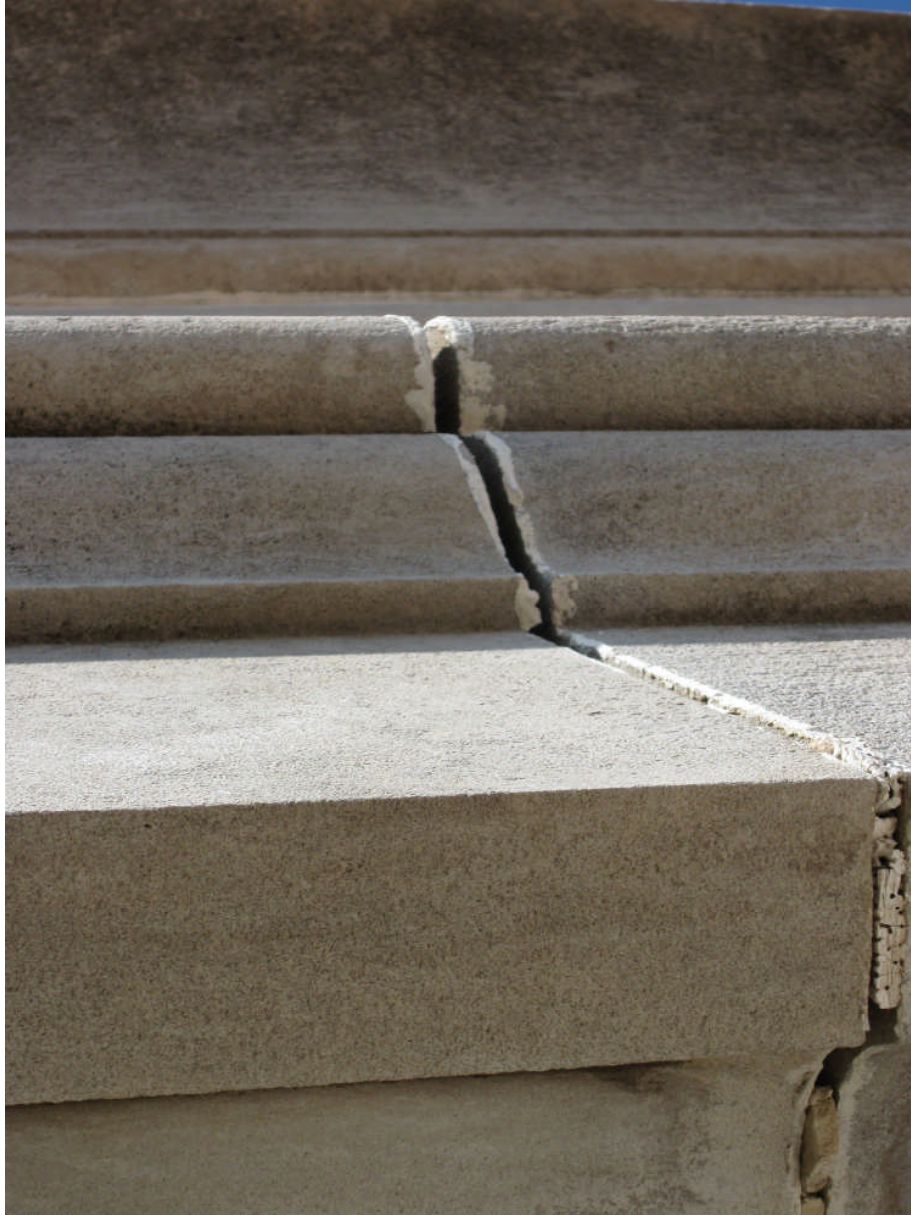
Photo 11 Southwest Corner: Deteriorated Mortar Joint Between Limestone Cornice Pieces

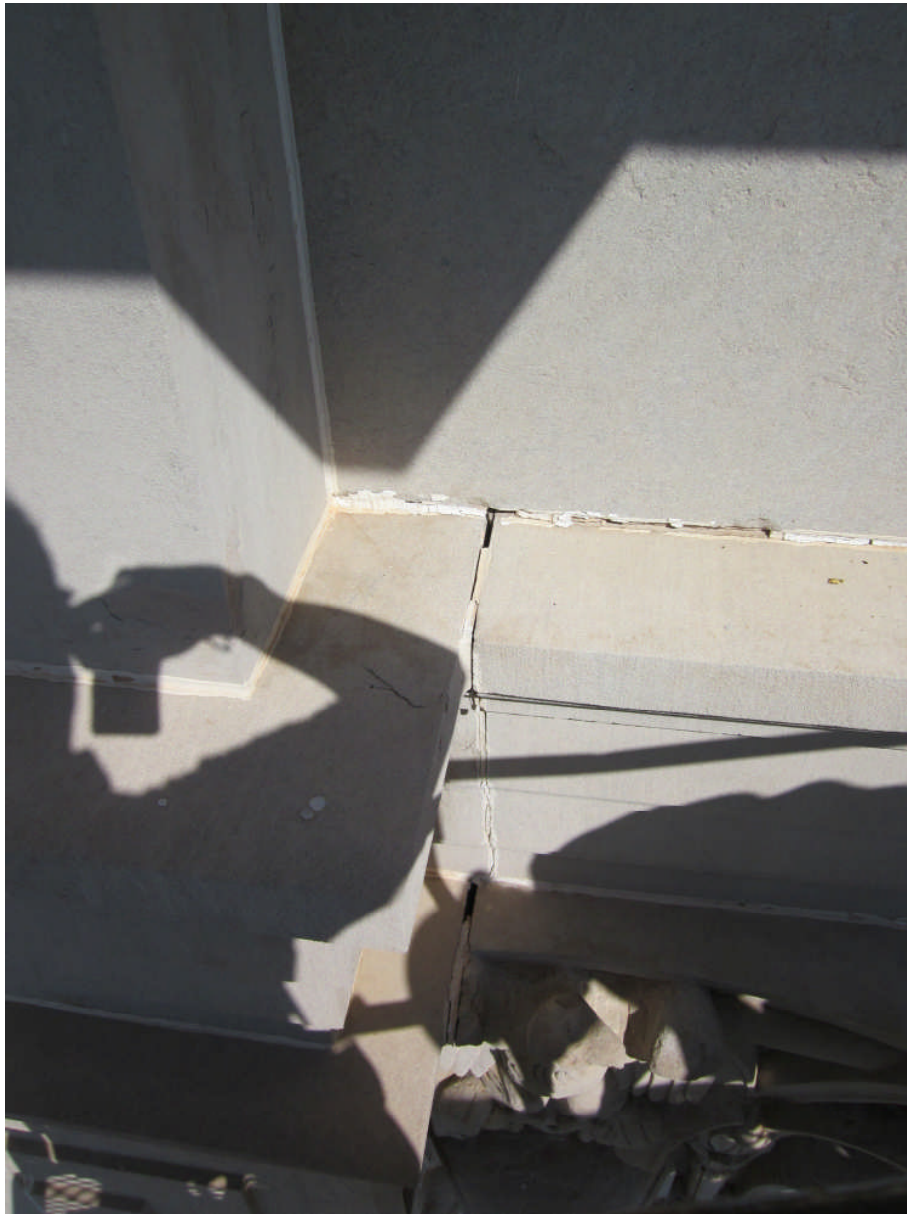
Photo 12 Southwest Corner: Deteriorated Mortar Joints in Limestone Ledge

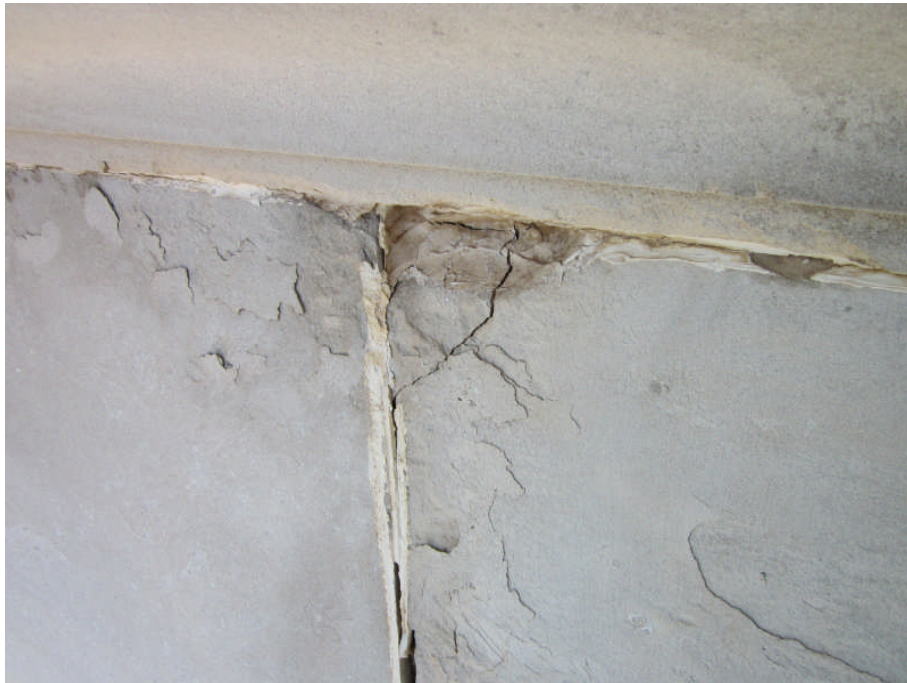
5. The surfaces of the southeast corner limestone panel and the southeast limestone ledge are spalling due to the effects of freeze-thaw cycles. Refer to Photos 13 through 15.

Photo 13 Southeast Corner: Patched Broken Limestone Block Corner

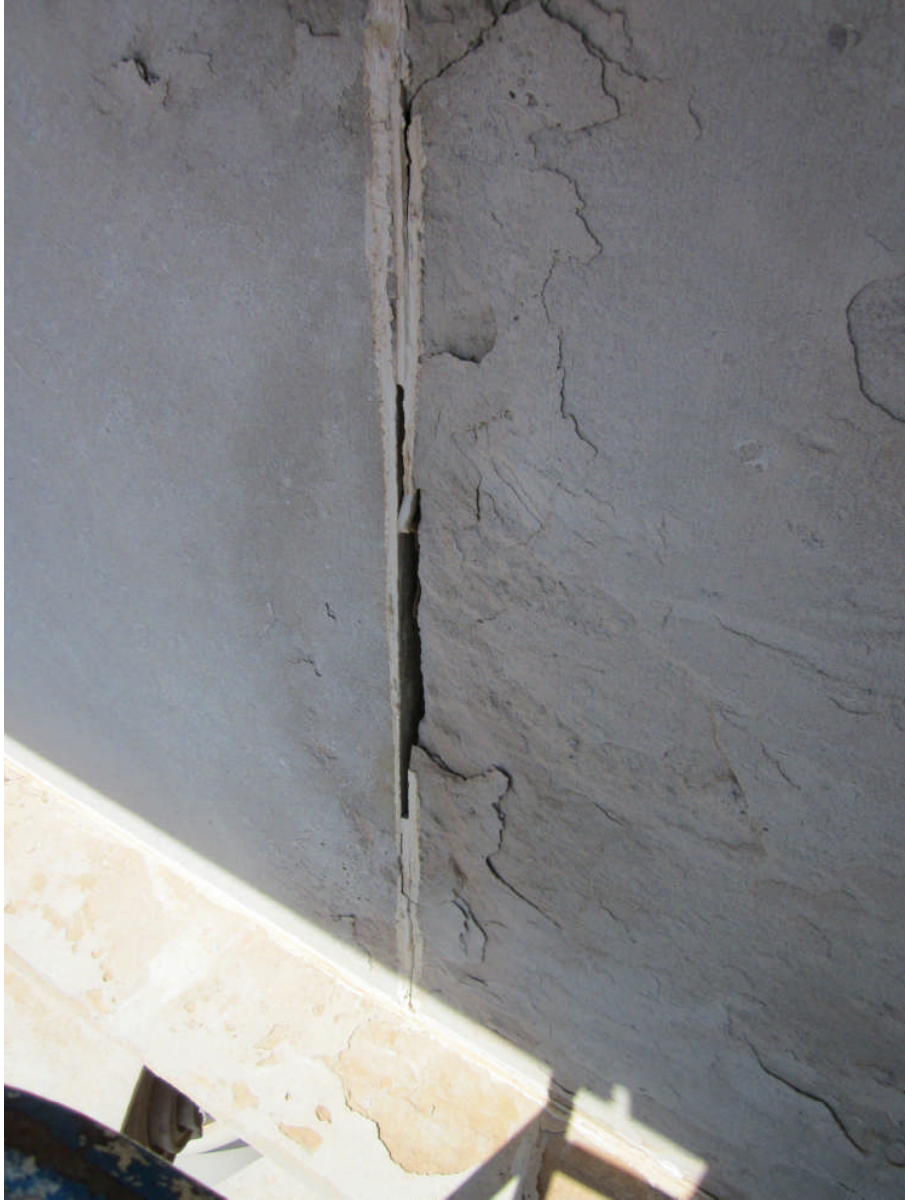
Photo 14 Southeast Corner: Deteriorated Mortar Joint Between Limestone Blocks, Spalling of Limestone Block Face, Spalling at Limestone Ledge

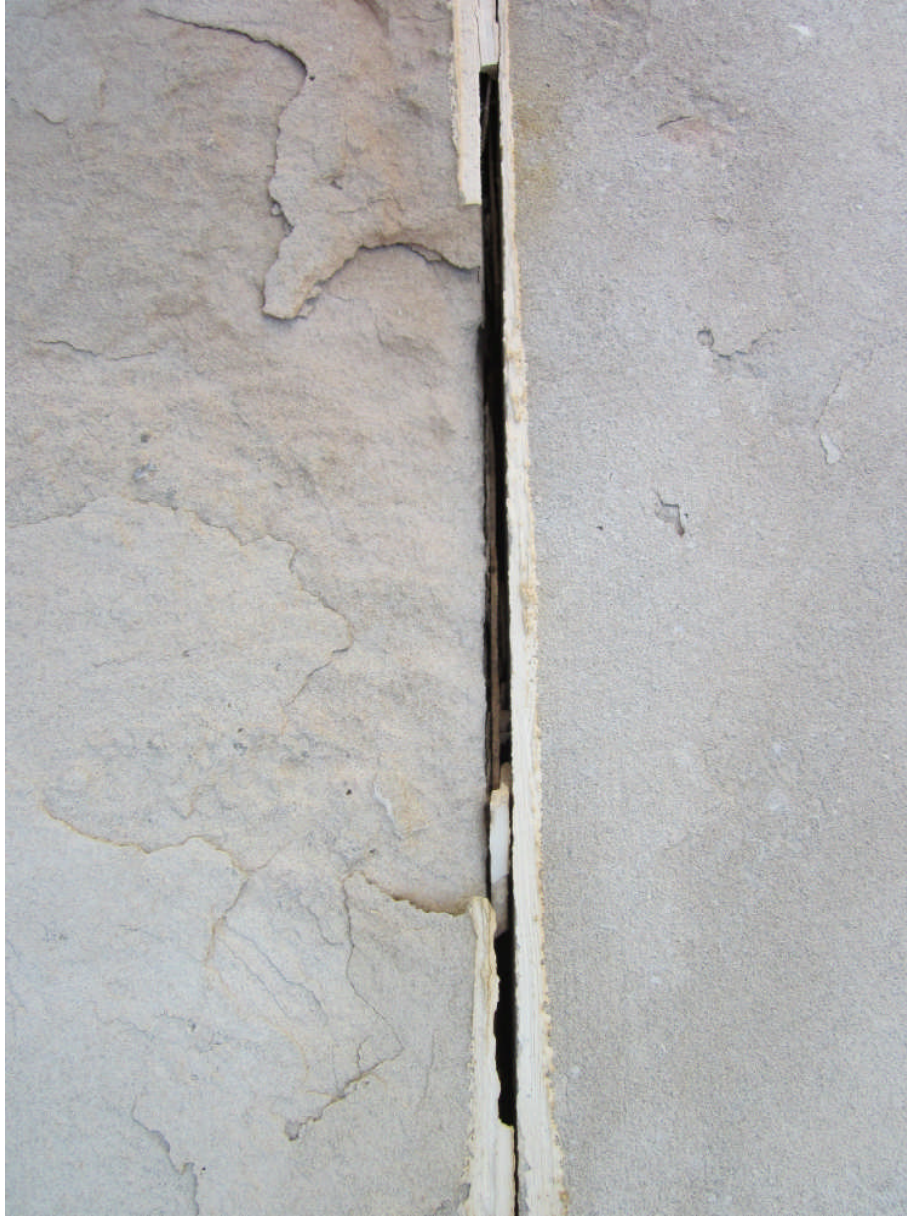
Photo 15 Southeast Corner: Deteriorated Mortar Joint and Spalling Face of Limestone Block

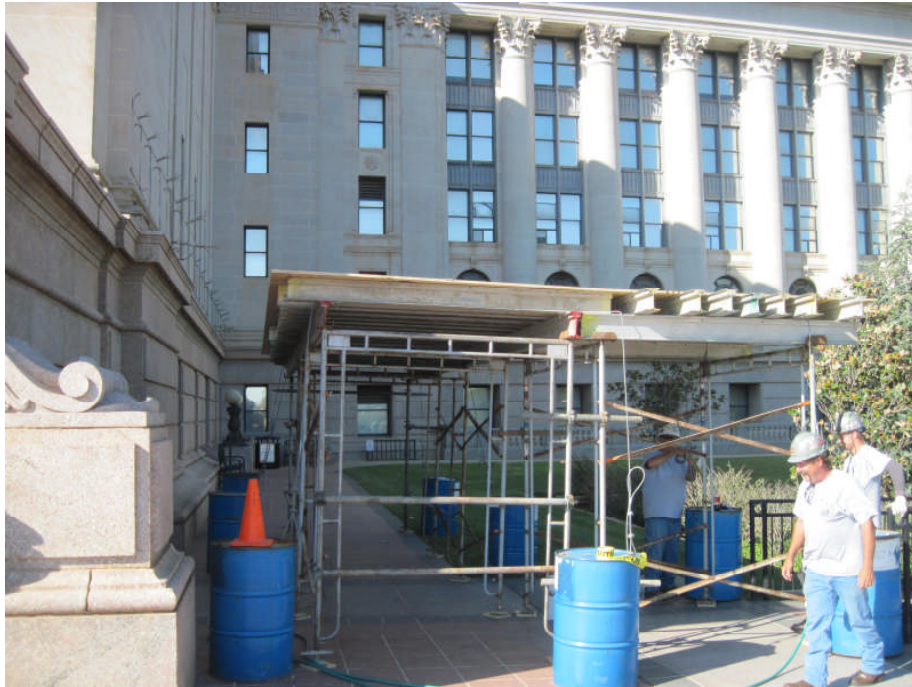
7. Scaffolding has been erected at the sidewalk level of the southeast corner of the portico to protect the handicap access from falling debris. Refer to Photos 16 and 17. The scaffolding appears sufficient to protect the public from the small pieces of debris that have been falling from the limestone veneer above and the scaffolding appears to have been erected in accordance with industry standards.

Photo 16 Debris Protection Scaffolding

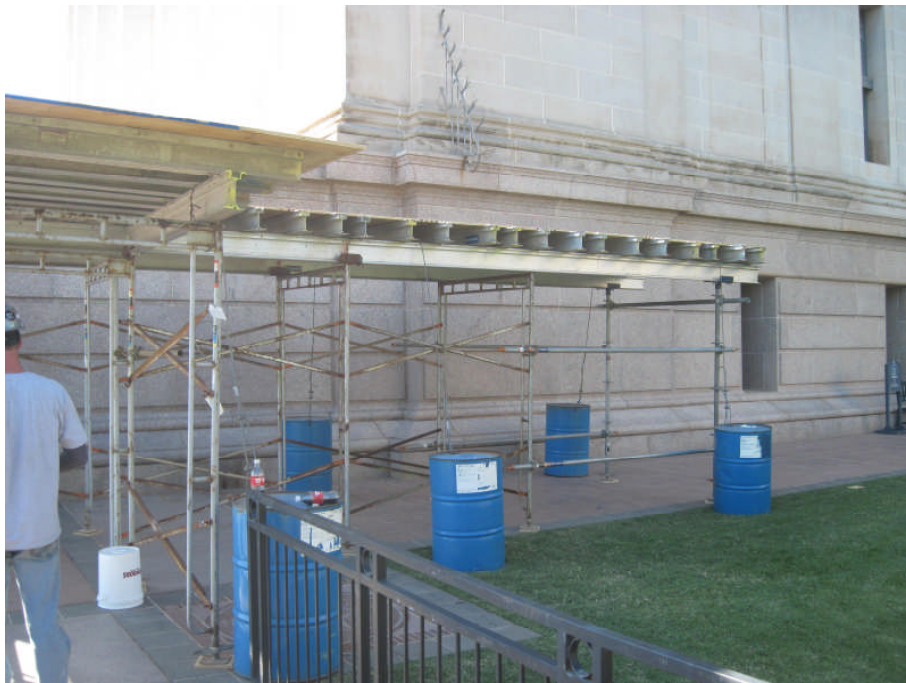
Photo 17 Debris Protection Scaffolding
