Assessment of Watershed Dams

Larry Caldwell, PE
Watershed Specialist
Oklahoma Conservation Commission
Stillwater, OK

OACD Annual Meeting
Midwest City, OK
February 28, 2011

Sallisaw Creek Watershed Dam No. 19

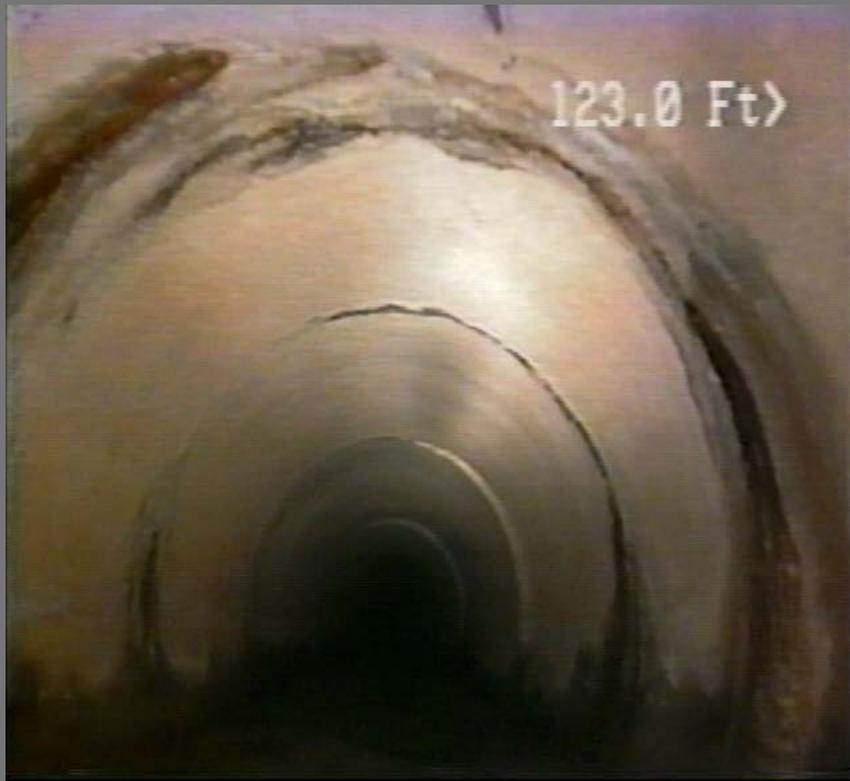
Cracked Pipe

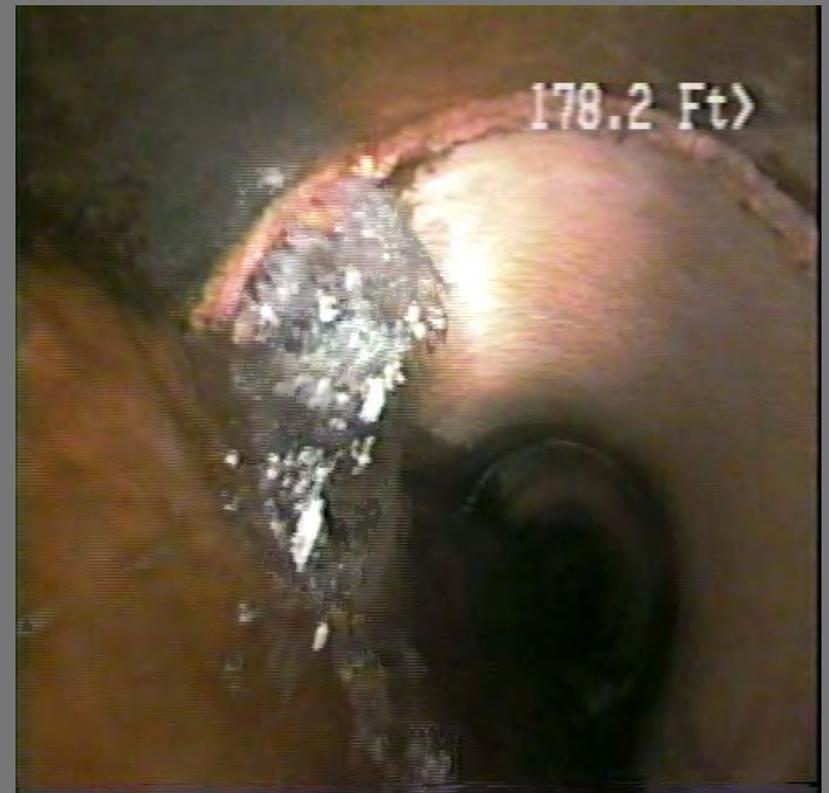
Water Leaking into Pipe

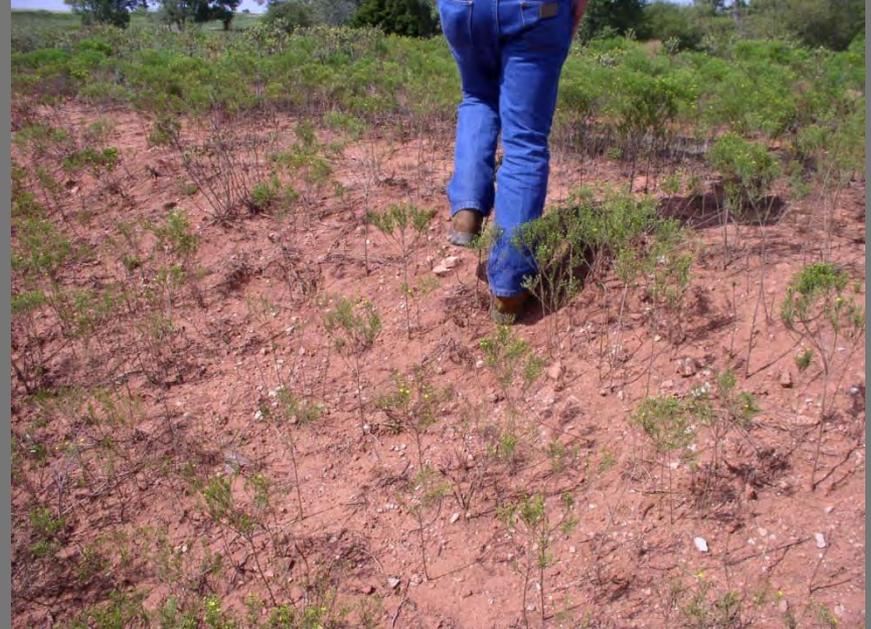
Vegetation

Embankment Condition: There is a good Bermuda grass cover on the dam. There are trees and brush growing on slopes and at the waterline. There are large trees on the right end of the embankment. The top of the dam has some vehicle tracks that should be monitored.

Non-Urgent Actions That Should be Addressed Through Normal Maintenance Activities: The slide gate needs to be replaced, the perimeter fence should be repaired, debris removed from inlet tower, trees and brush removed or chemically controlled. The vehicle and cattle trails in the auxiliary spillway and the trail on the top of the dam should be monitored for erosion problems. The estimated cost of completing this maintenance work is approximately \$6,000.

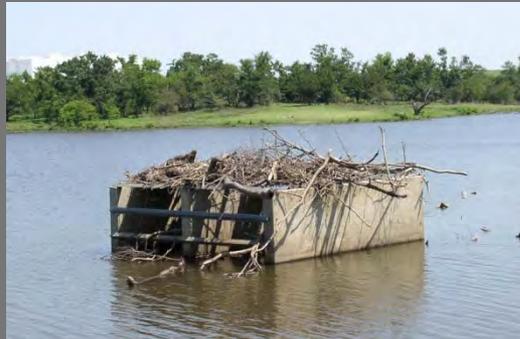
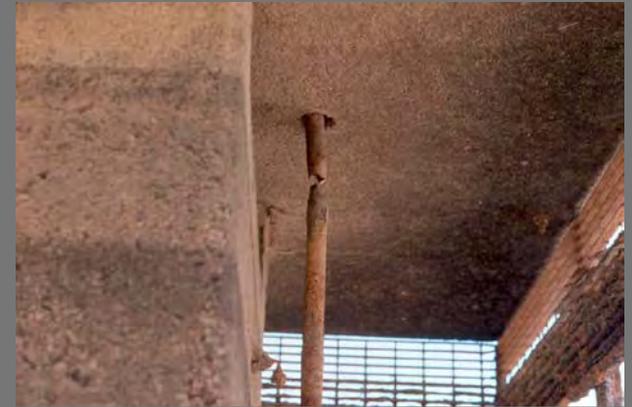
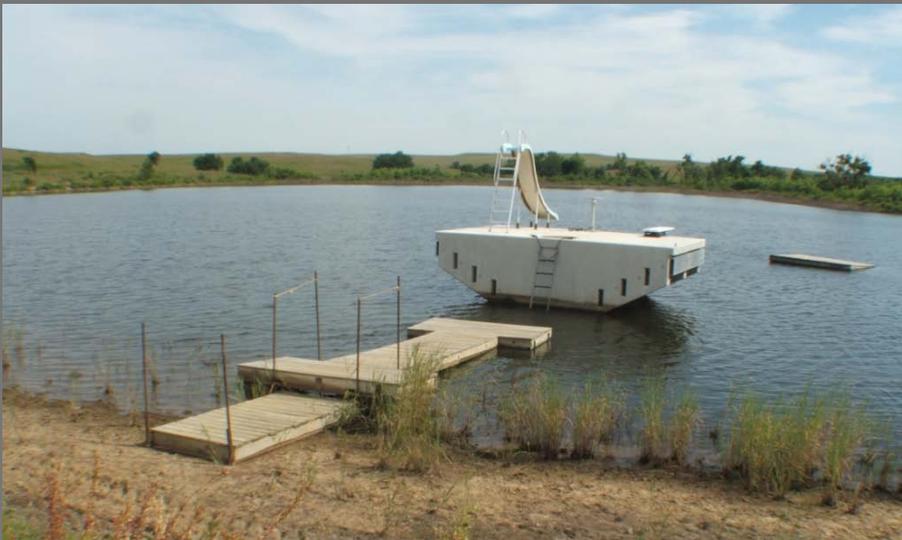
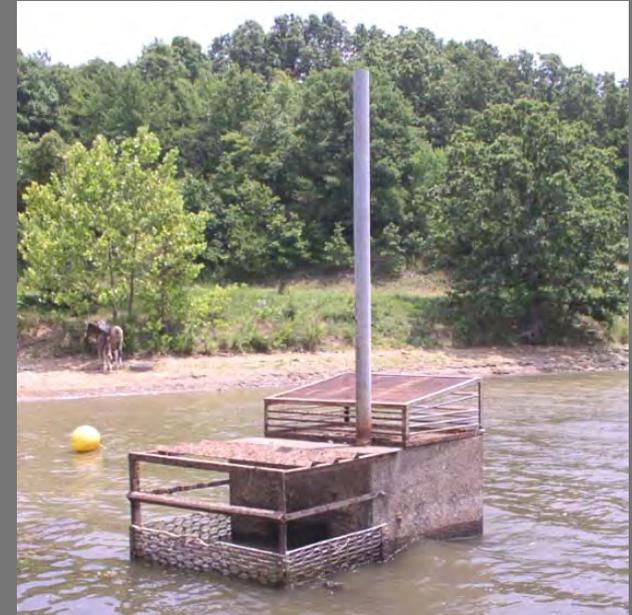
Inlet Structure & Gate Valves

Principal Spillway Inlet: Principal spillway inlet consists of a 30" X 100" concrete open topped inlet 16 feet deep, with a 15" slide gate. The top of the inlet is covered with debris. The Adair County Conservation District equipment manager, Eugene Kester, reported that the slide gate is not operational.

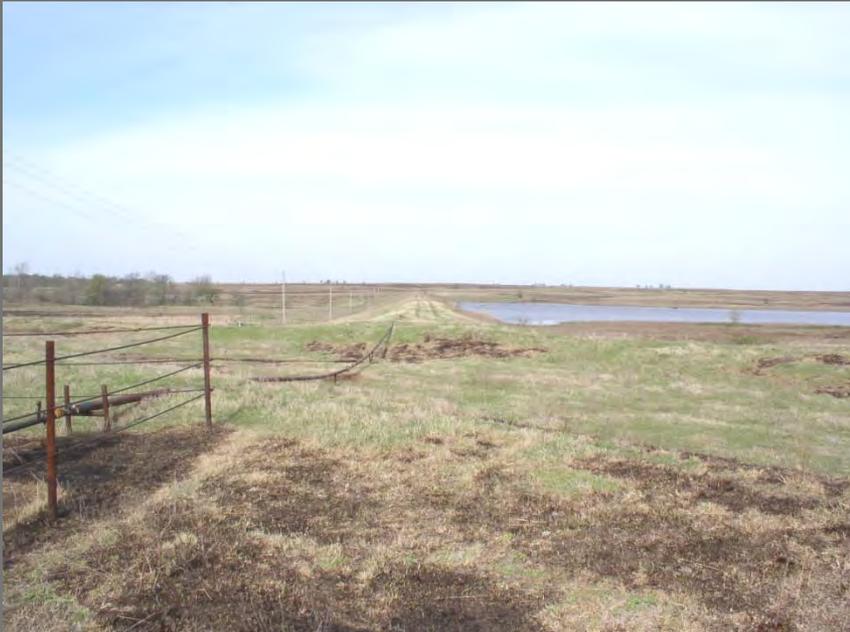
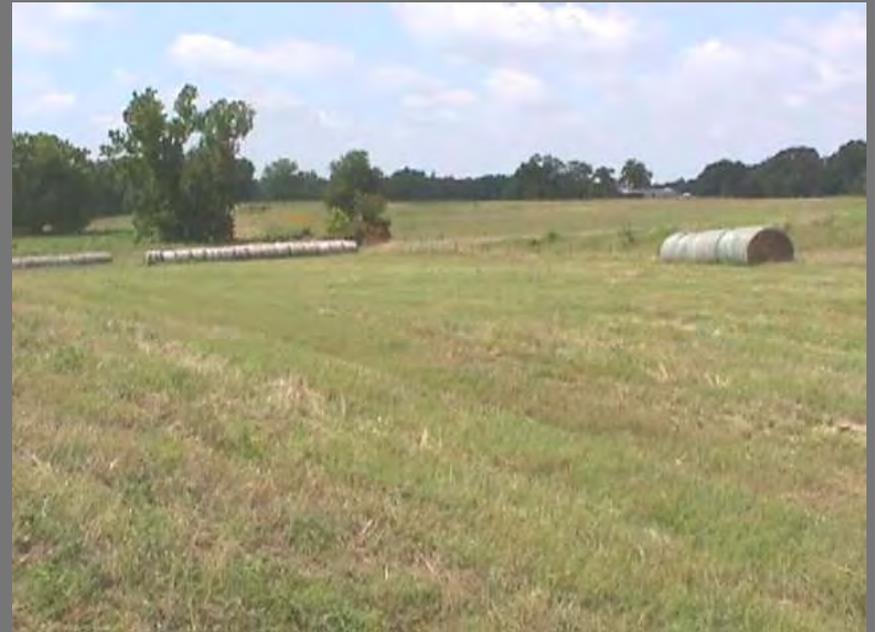
Auxiliary Spillway

Auxiliary Spillway: There is a good vegetative cover of Bermuda grass, but flow could be restricted by trees immediately downstream from the exit channel. Several cattle and vehicle trails were found in the spillway that should be monitored for erosion problems.

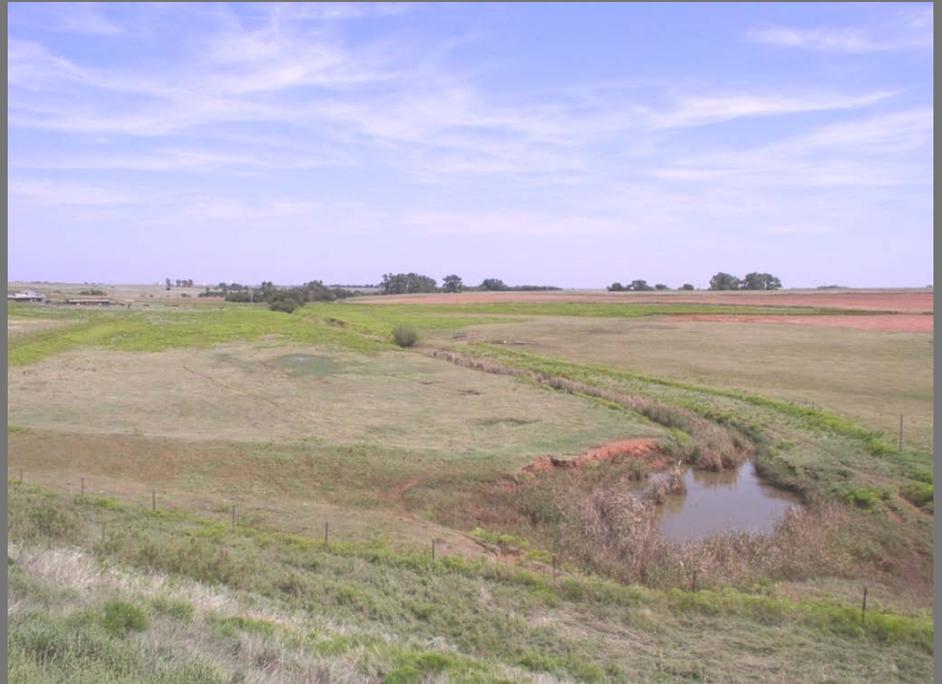
Principal Spillway Release Channel

Principal Spillway Outlet and Release Channel: An earthen plunge basin is provided for energy dissipation at the conduit outlet. There is minor erosion in the plunge basin. The invert of the principal spillway conduit outlet is approximately one foot above the elevation of the water in the release channel.

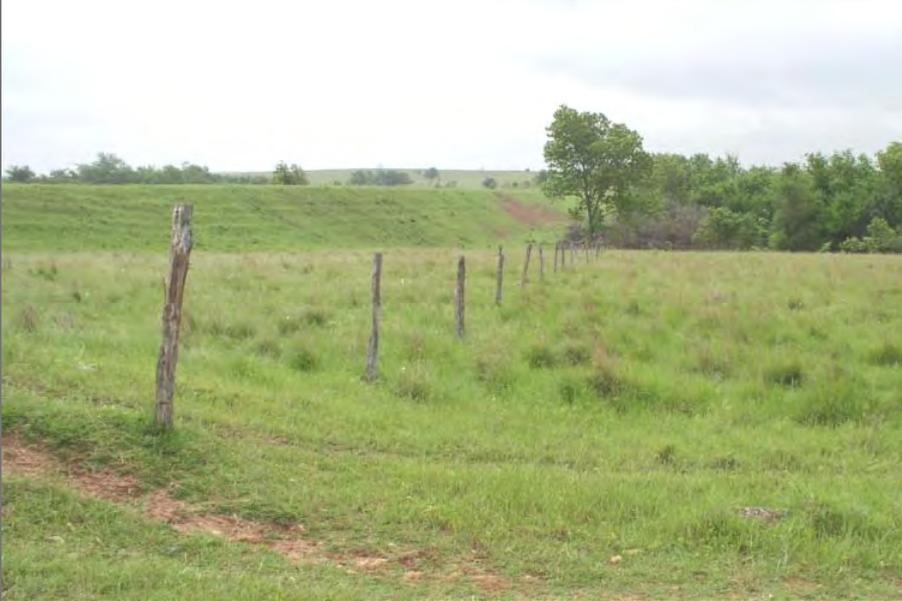
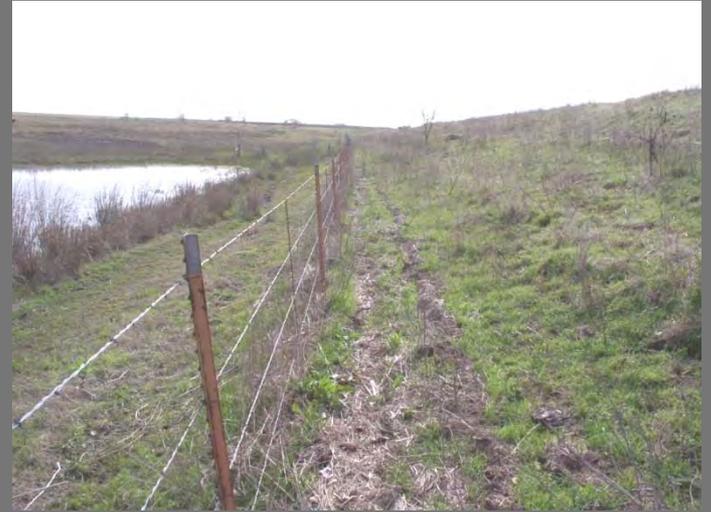
Fencing

Fence repair needs

Gates open

Over grazing

Fence: The fence needs repair and is inadequate for controlling grazing.
