## OKLAHOMA STATE CAPITOL Exterior Facade Investigation

### **Final Report**

December 18, 2014  
WJE No. 2014.3319

#### **Wiss, Janney, Elstner Associates, Inc.**

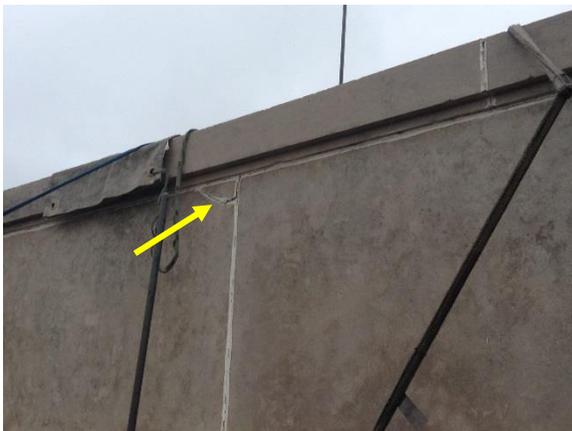
- a. Parapet: Spalls exist at a total of seven parapet wall panels, or 4 percent of all parapet wall panels on the building (Figure 11). The spalls are located on the north, south, and east facades of the building and coincide with concealed mild steel strap anchors (Figure 12). Our visual inspection was supplemented with a survey of all parapet wall panels using a metal detector. Beyond the strap anchors that have spalled, only two or three other strap anchors were identified using a metal detector at parapet wall locations.

*Figure 11. Example of limestone spall observed at parapet wall*

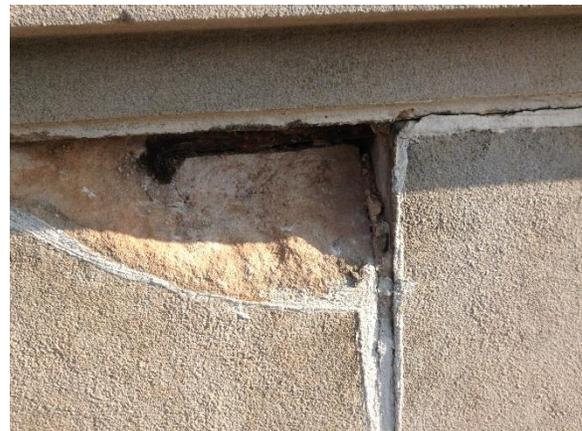
*Figure 12. Close-up view of limestone spall location coincident with original strap anchor*

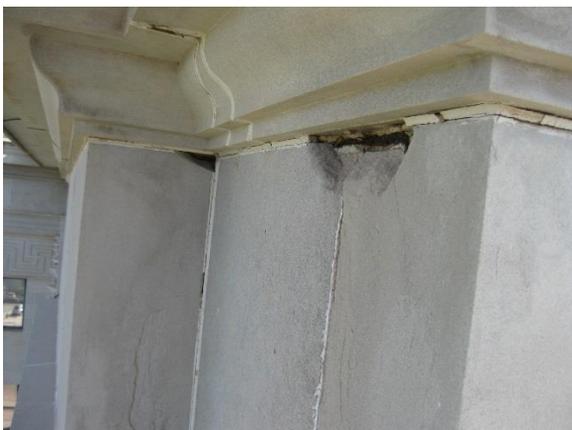
*Figure 13. Example of limestone spall at frieze panel*

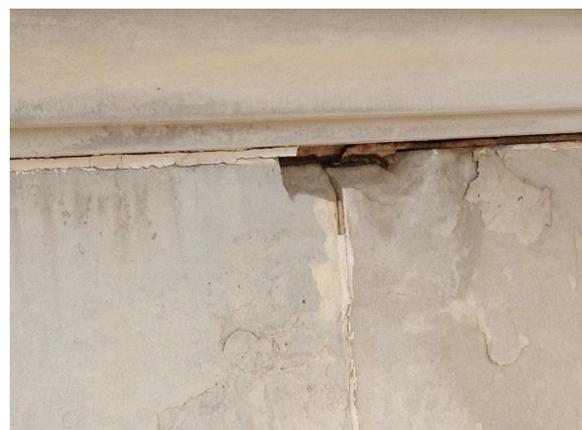
*Figure 14. Close-up view of limestone spall coincident with original strap anchor*

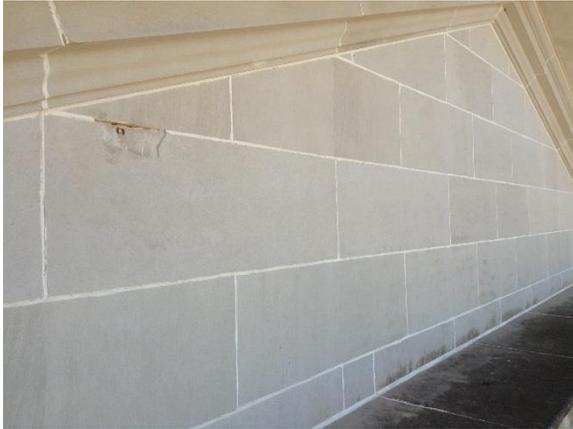
*Figure 15. Example of limestone spall at pediment ashlar units*

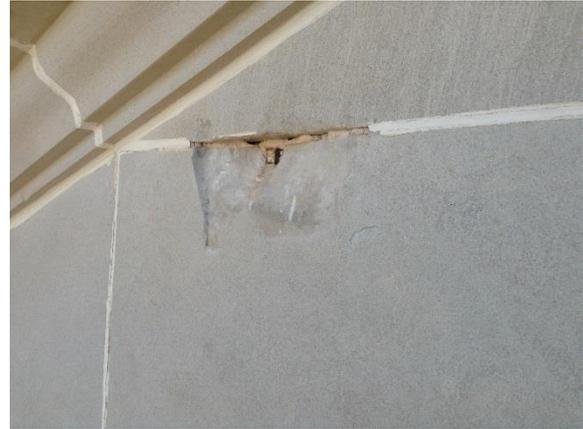
*Figure 16. Close-up view of limestone spall at pediment ashlar unit coincident with original strap anchor*

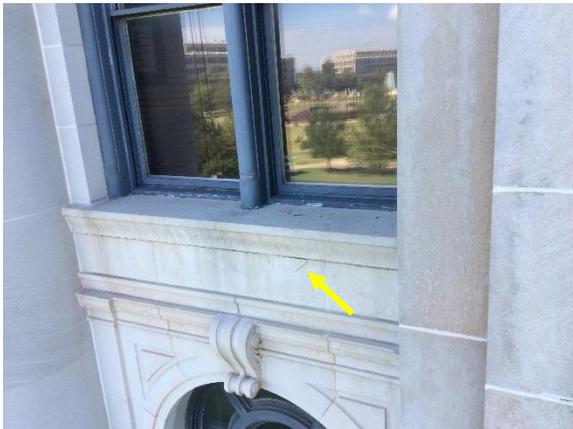
*Figure 17. Example of limestone spall at spandrel panel*

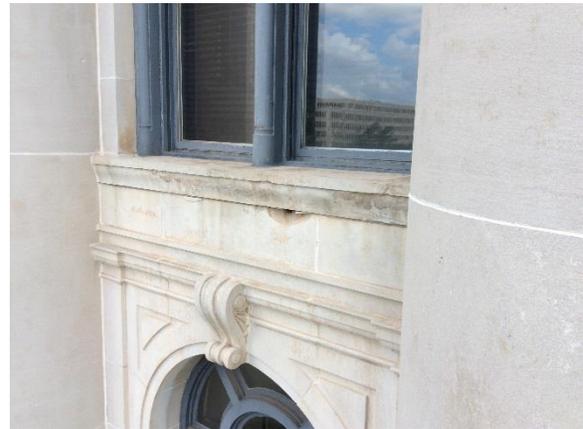
*Figure 18. Example of limestone spall at spandrel panel*

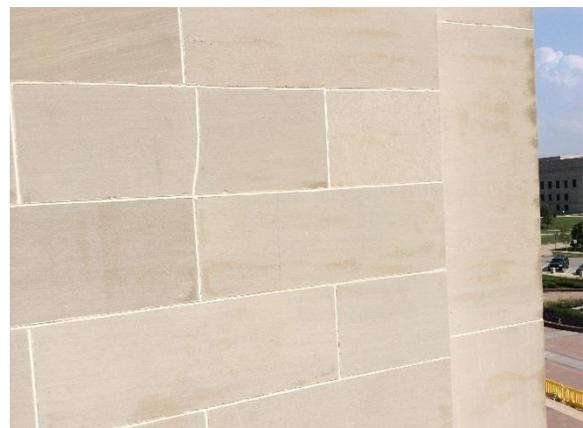
*Figure 20. Example of cracking at ashlar limestone panel on main facade*

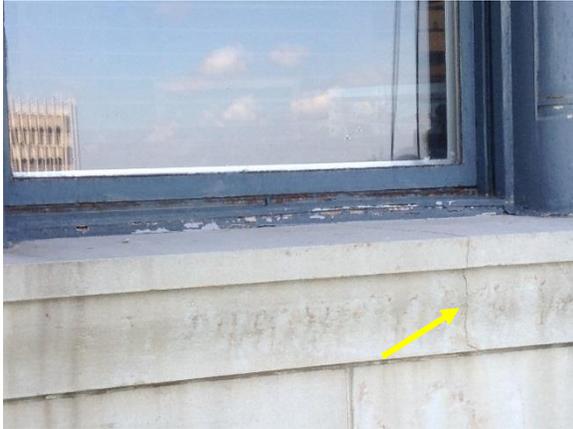
Figure 21. Example of cracked limestone at windowsill

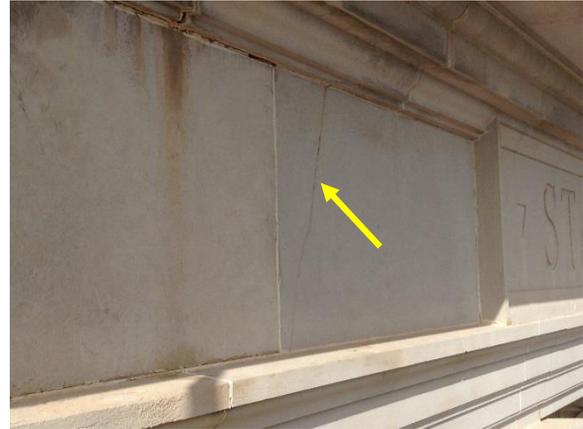
Figure 22. Example of cracked limestone at frieze panel

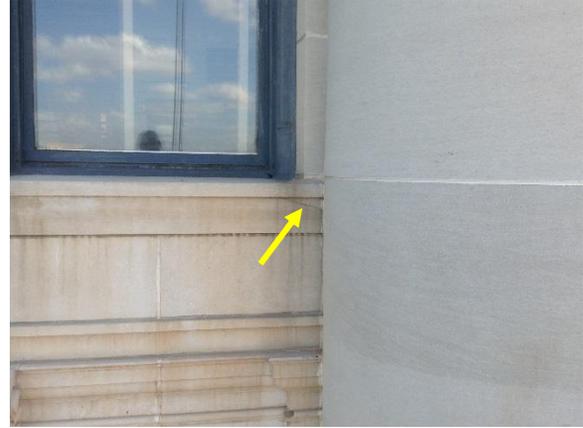
3. Cracks and incipient spalls exist at third floor windowsills (Figure 24 and Figure 25). Spalls exist at nine windowsills, or 22 percent of all windowsills on the north and south facades.

Figure 24. Limestone spall at third floor windowsill

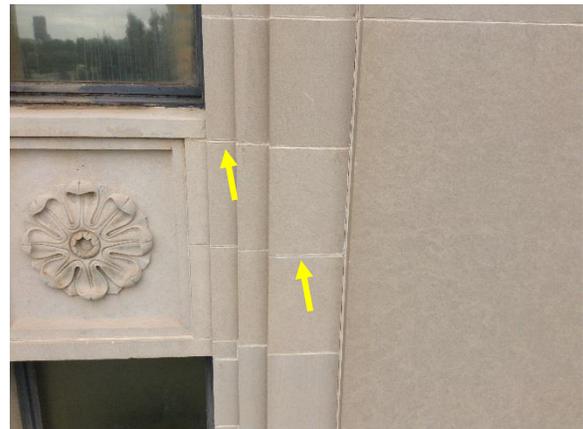
Figure 26. Mortar bond failure between limestone units

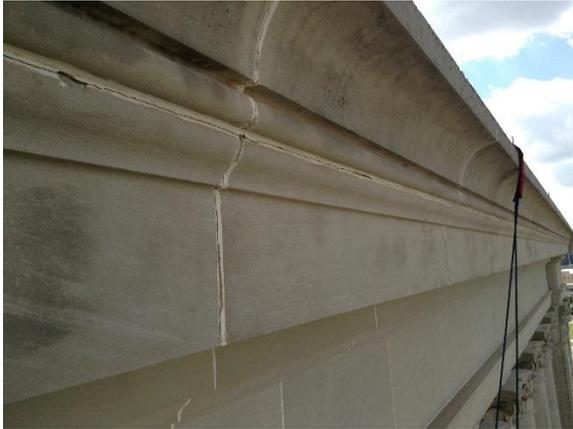
Figure 27. Cementitious coating at mortar joints

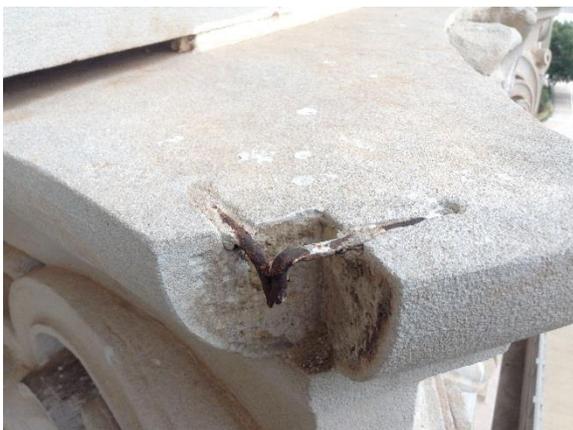
Figure 31. Area of limestone dutchman repair removed during inspection

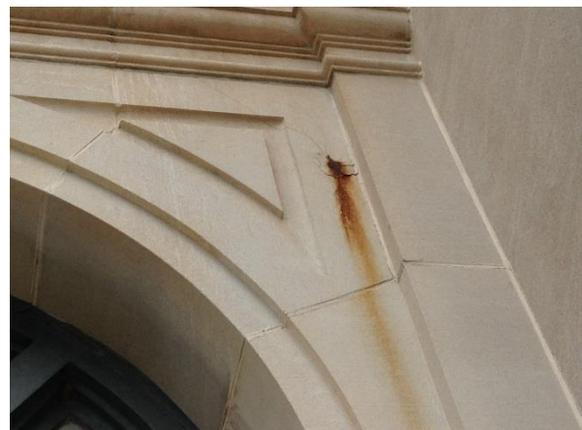
Figure 32. Mineral inclusion in limestone causing iron oxide staining

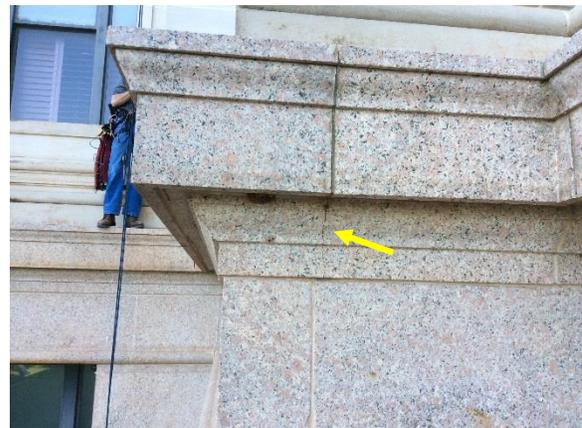
*Figure 35. Crack within granite unit*

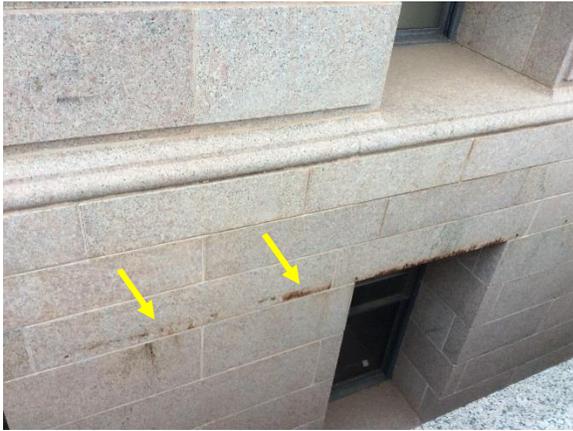
*Figure 36. Corrosion staining at abandoned anchors at light wells*

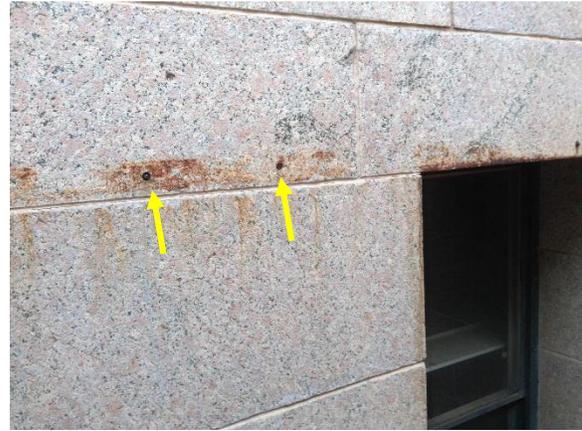
*Figure 37. Close-up view of abandoned anchors*

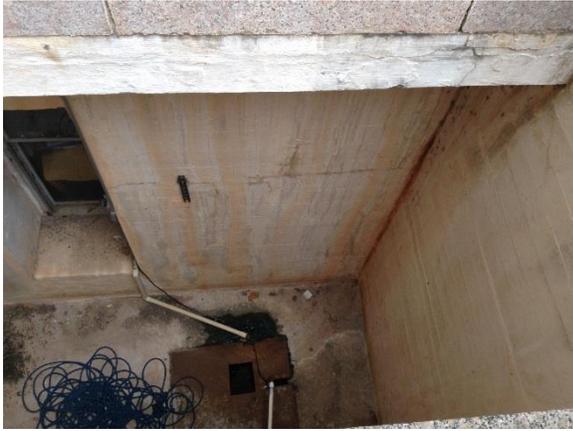
Figure 40. Coating applied to light well walls

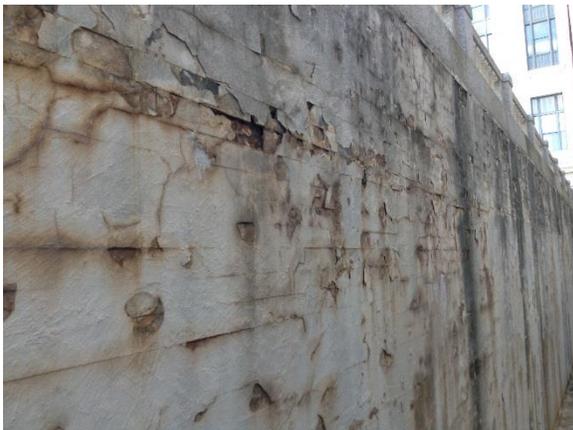
Figure 43. Cracks and spalls at foundation walls

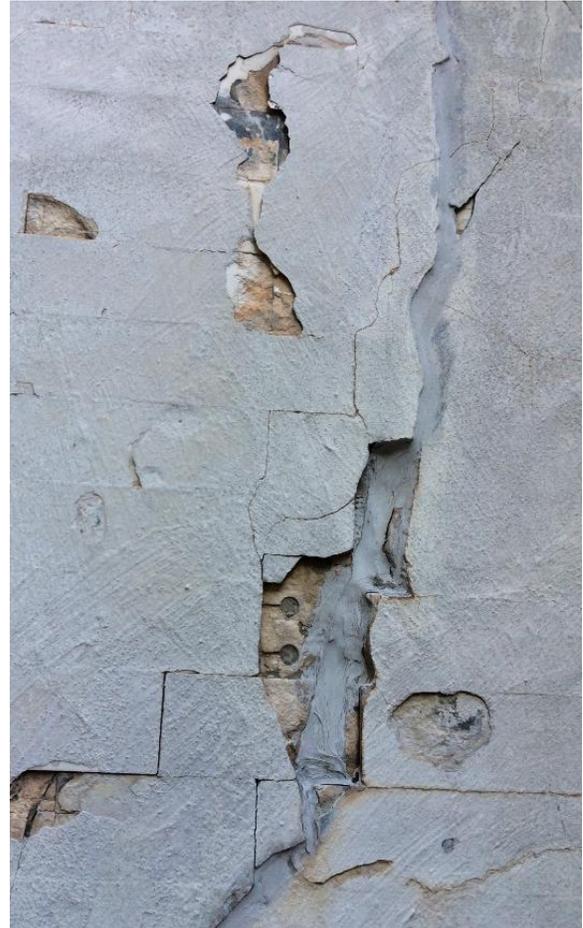
Figure 44. Cracks and spalls at foundation walls

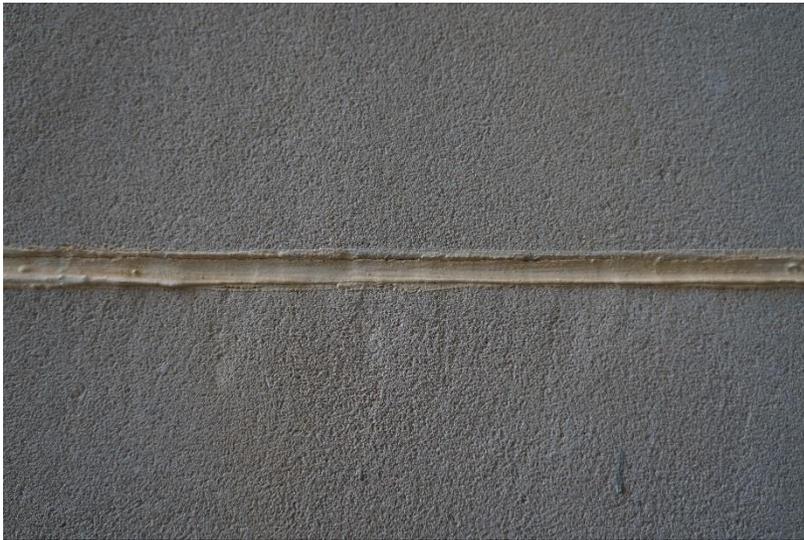
A white coating had been applied to the mortar joints in the limestone masonry (Figure 52). The coating was likely applied by brush and frequently extends on to the adjacent limestone. A sample of the white coating applied to the mortar joints was analyzed to identify any polymeric binder that may have been present in the coating. The samples were extracted with a solvent suitable for the isolation of the coatings' polymeric binder components. The collected residues were subjected to Fourier transform infrared (FTIR) spectroscopic analysis. The analysis identified only trace hydrocarbon and ester functionality, indicating that the coating was primarily inorganic.

*Figure 52. White coating applied to mortar joint and adjacent limestone*

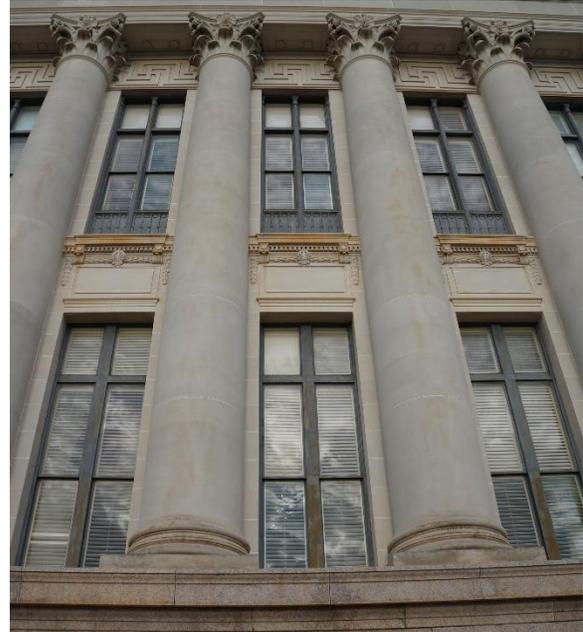
*Figure 54. Light orange streaks at limestone columns (right)*

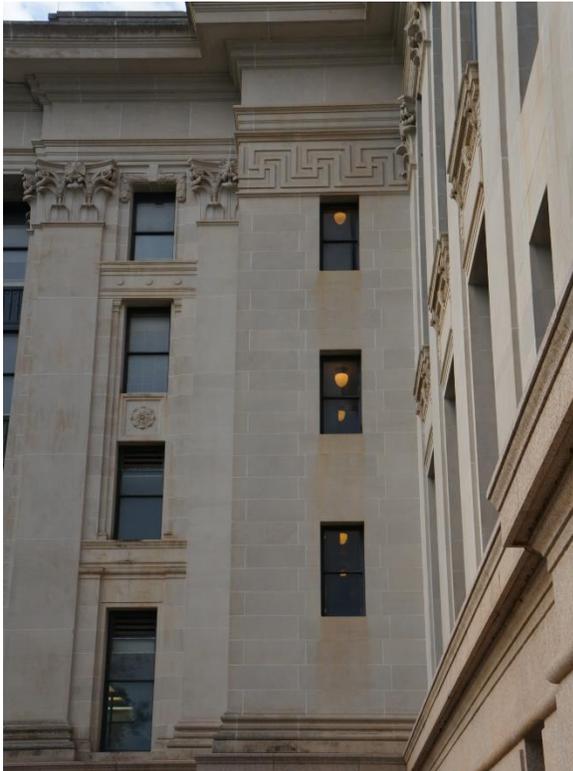
*Figure 55. Orange staining of limestone below punched windows (left)*

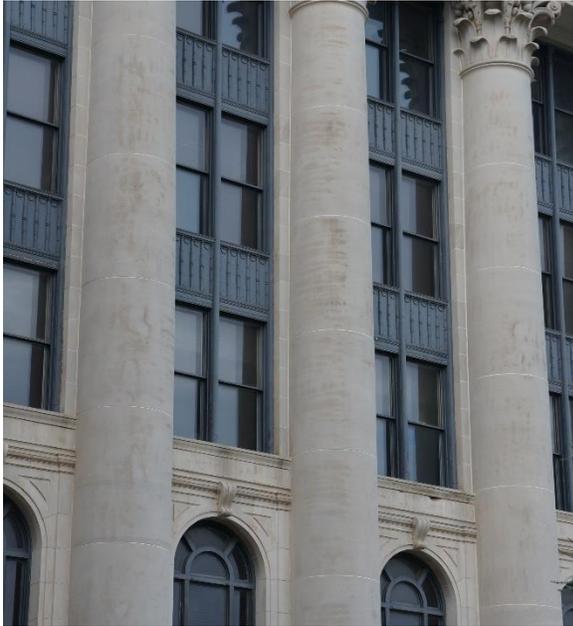
*Figure 57. Dark horizontal streaks on limestone columns (left)*

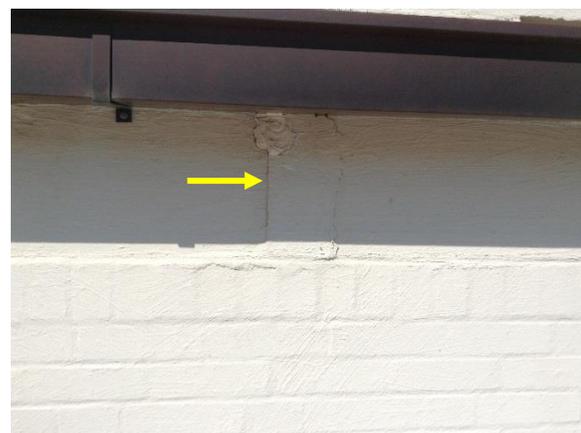
*Figure 83. Close-up view of spalling and cracking at back face of parapet wall*

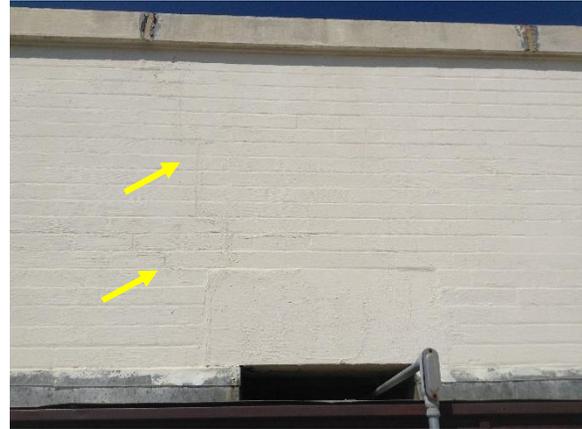
*Figure 85. Cracking at back face of masonry walls*

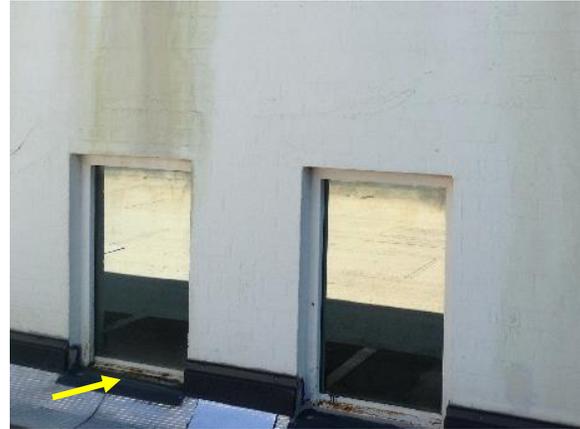
Figure 89. Corrosion staining at clerestory windowsill

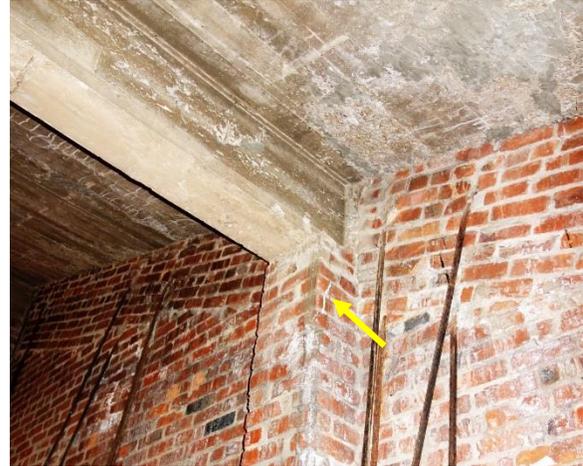
*Figure 98. Crack in the corbel at reinforced concrete beam*

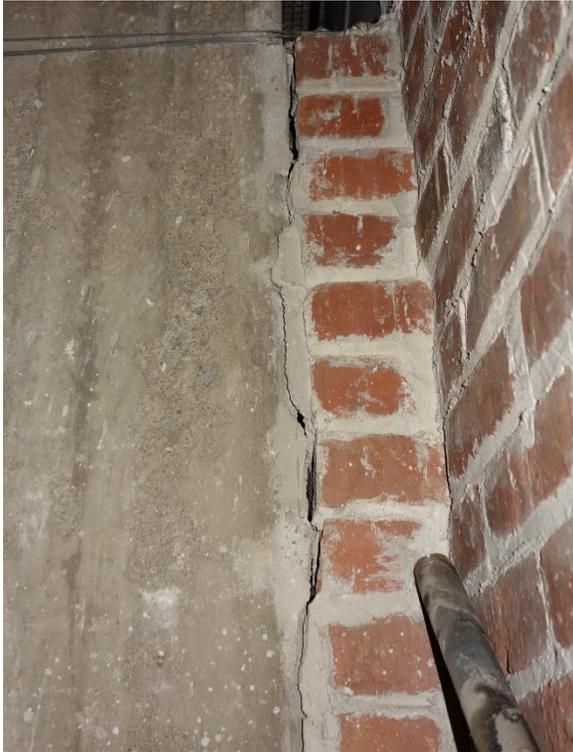
*Figure 105. Crack between the brick wall and concrete frame at west gable*

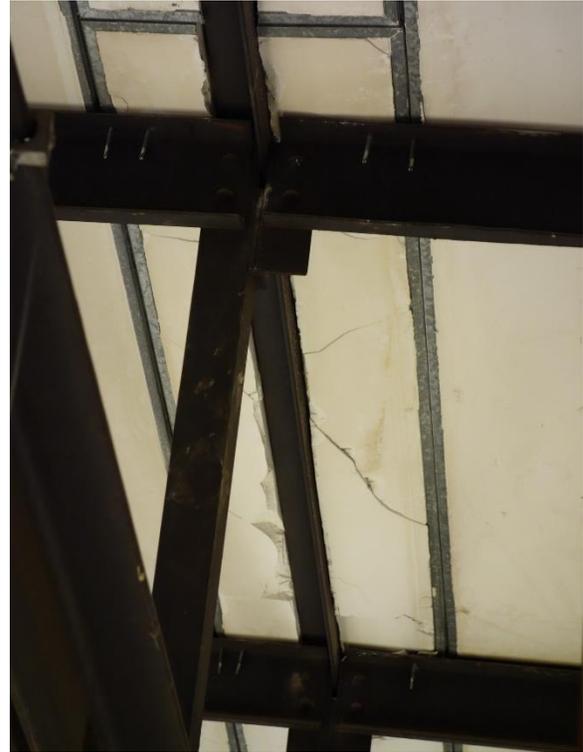
*Figure 106. The gypsum panels above the House chamber are cracked.*

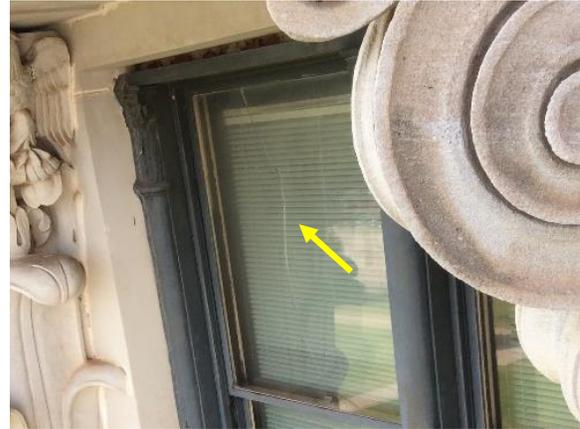
Figure 112. Broken glass

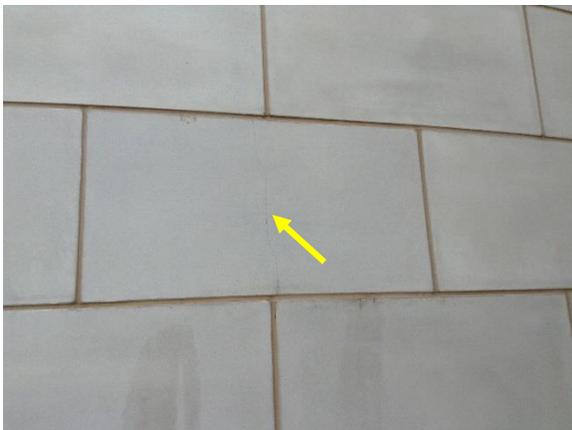
*Figure 131. Crack at cast stone near center of dome base unit*

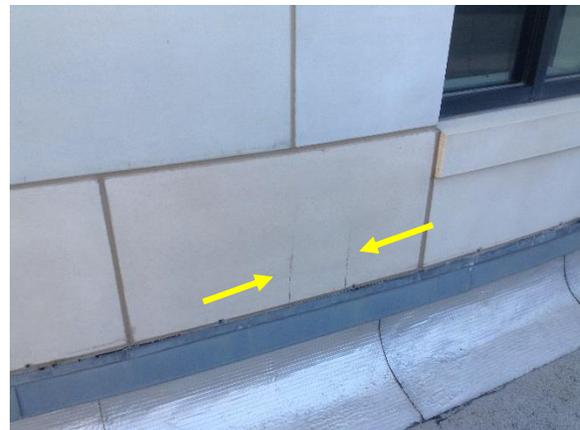
*Figure 132. Parallel cracks within dome base cast stone unit*

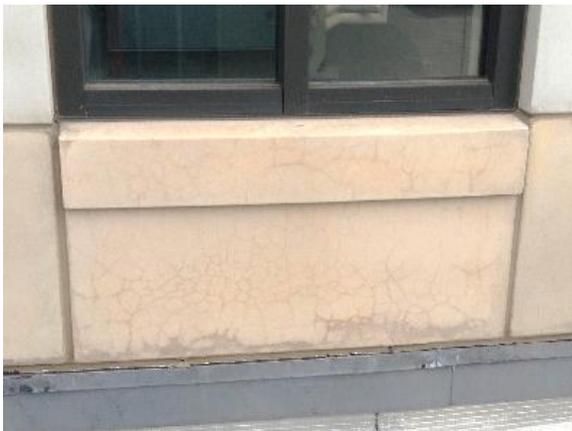
*Figure 135. Craze cracking at face of cast stone unit at base of dome*

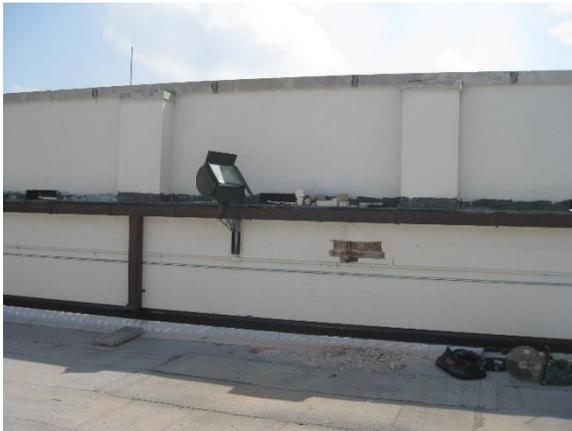
- Located in back face of brick masonry parapet below a spall in the back face of limestone cornice (Figure A1).
- Cornice anchor consists of 1-1/8 inch diameter mild steel rod; the rod aligns with the joint between cornice units. The rod is located approximately 4 inches from the back face of the wall (Figure A2) and falls within the collar joint between the innermost wythes of brick masonry.
- Corrosion scale accumulation estimated to be 1/16 inch thick exists on the surface of the rod directly adjacent to the limestone cornice (Figure A3).

*Figure A1. Overall view of location of Inspection Opening No. 1*

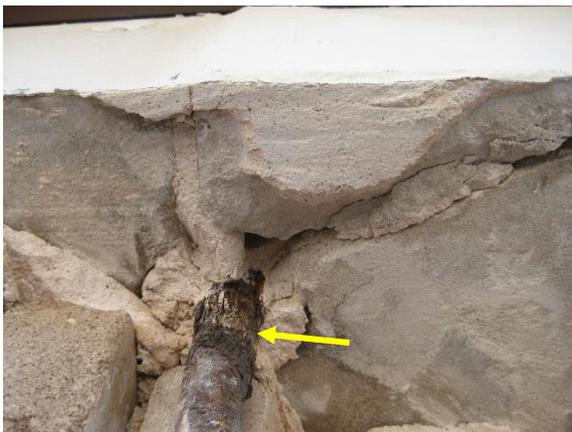
*Figure A3. Corrosion scale on anchor rod*

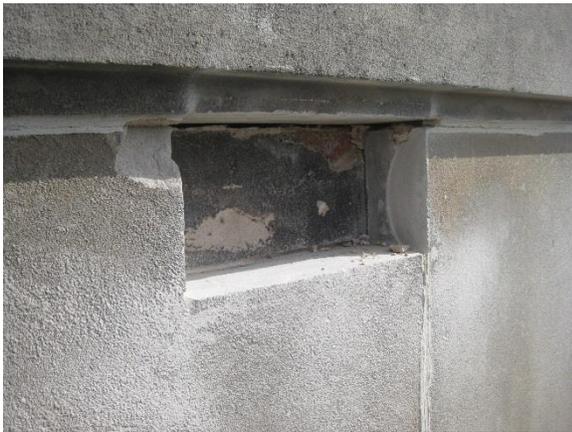
*Figure A10. Lack of strap anchor within opening*

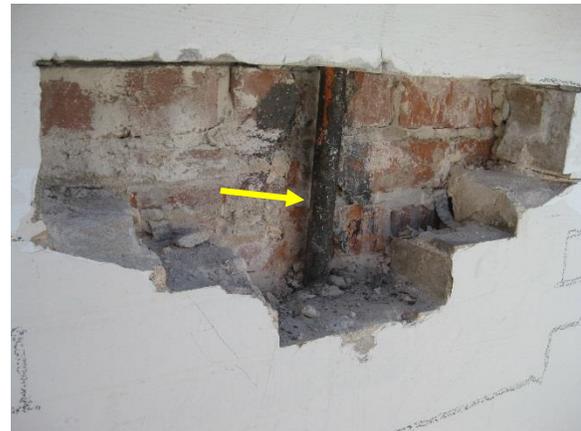
*Figure A13. Minor corrosion on cornice rod*

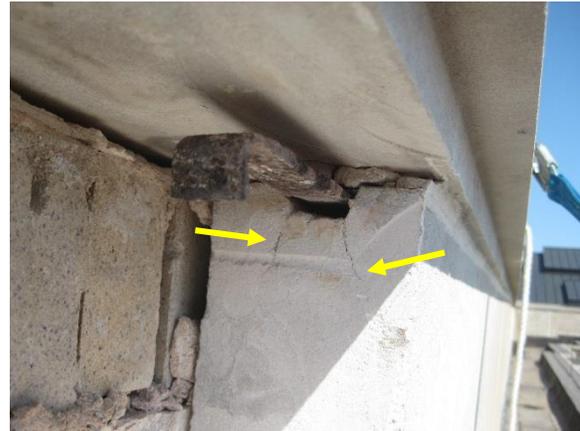
*Figure A18. Cracking at kerf within unit*

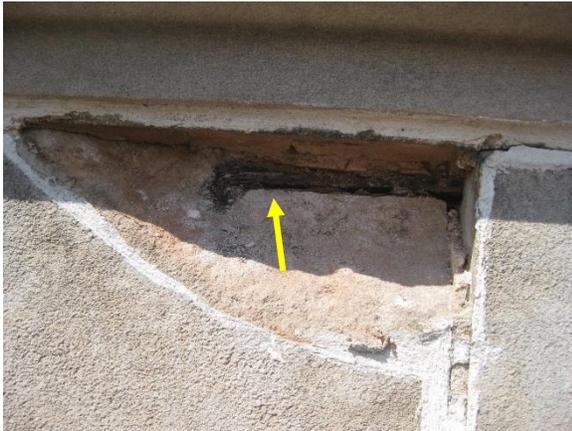
- Located in the top edge of a limestone ashlar near the center of the west wing on the south facade. The location was selected to document the condition of the concealed mild steel anchor at a limestone panel where a sealed crack was observed during our close-up inspection.
- A mild steel cramp anchor exists between adjacent limestone panels (Figure A19). No strap exists between the limestone panel and the brick masonry back-up.
- Corrosion scale on the surfaces of the anchor is estimated to be 1/8 thick.

*Figure A19. Cramp anchor at crack location*

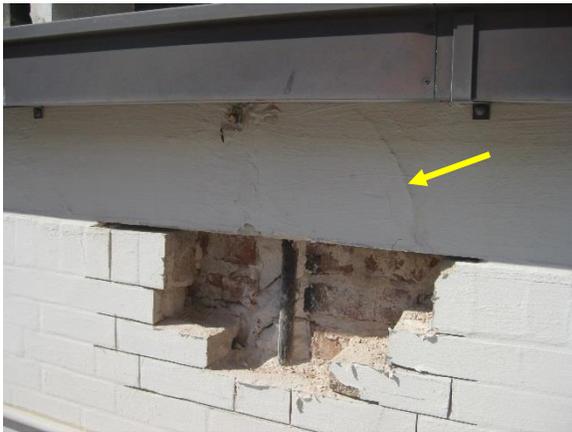
- Located in back face of brick masonry parapet below a spall in the back face of limestone cornice (Figure A20).
- The cornice anchor consists of 1-1/8 inch diameter mild steel rod; rod aligns with joints between cornice units. The rod is located approximately 4 inches from the back face of the wall and falls within the collar joint between the inner-most wythes of brick masonry.
- Corrosion scale accumulation estimated to be 1/16 inch thick exists on the surface of the rod directly adjacent to the limestone cornice (Figure A21).

*Figure A20. Overall view of location of Inspection Opening No. 9*

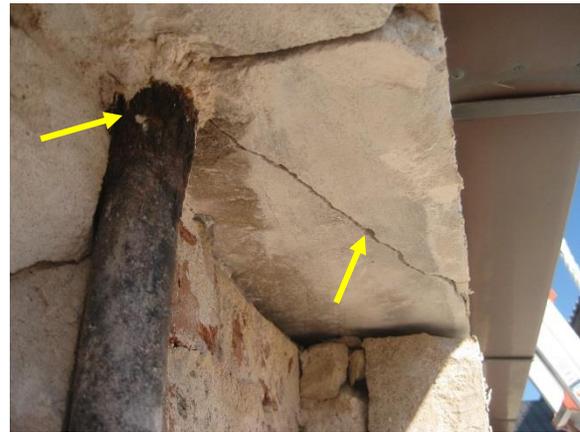
*Figure A21. Corrosion scale on surface of cornice rod*

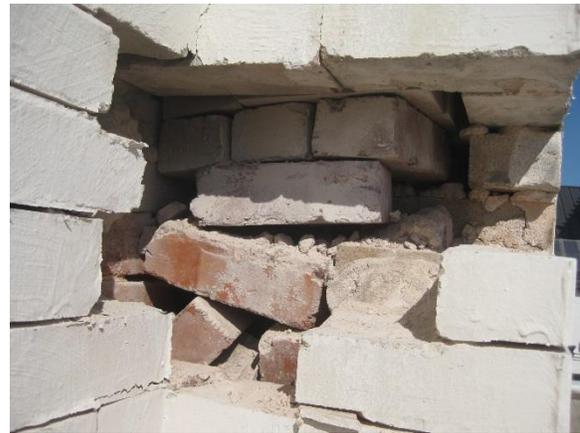
- Located in back face of the parapet adjacent to a brick masonry pilaster near the east end of the roof (Figure A22).
- The outer wythe of the pilaster is tied to the outer wythe of the parapet wall, however, brick masonry within the pilaster was loosely placed at the time of original construction and is not reliably tied to back face of parapet wall (Figure A23).

*Figure A23. Loose masonry within pilaster*

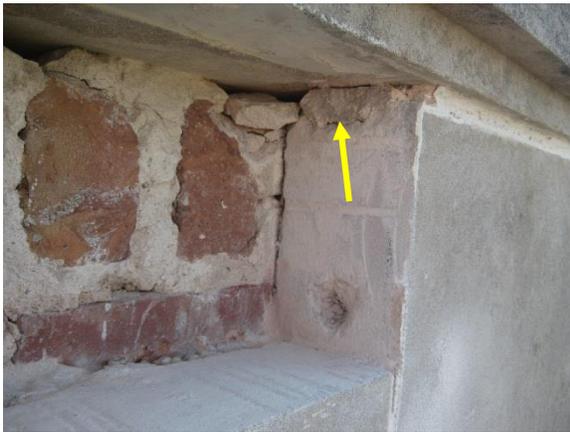
*Figure A28. Lack of anchor within opening*

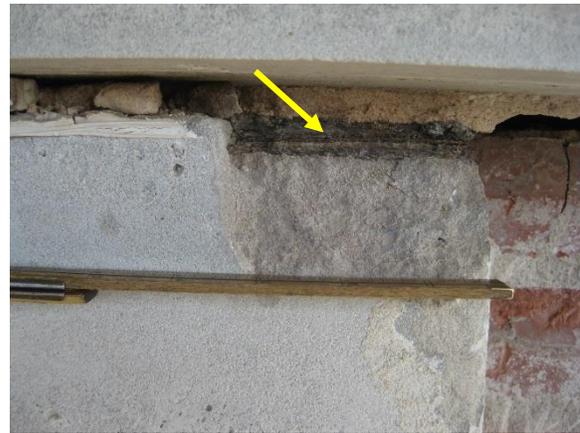
*Figure A30. Corrosion scale on strap anchor*
