# **FATALITY INVESTIGATION**

**MARK EDWARD GORMAN**  
**April 6, 2009**

**Gem Dirt Sales**  
**Section 27/Township 18N/Range 12E/Tulsa County**  
**Permit No. L.E.-1554**

**Investigation By**  
**OKLAHOMA DEPARTMENT OF MINES**

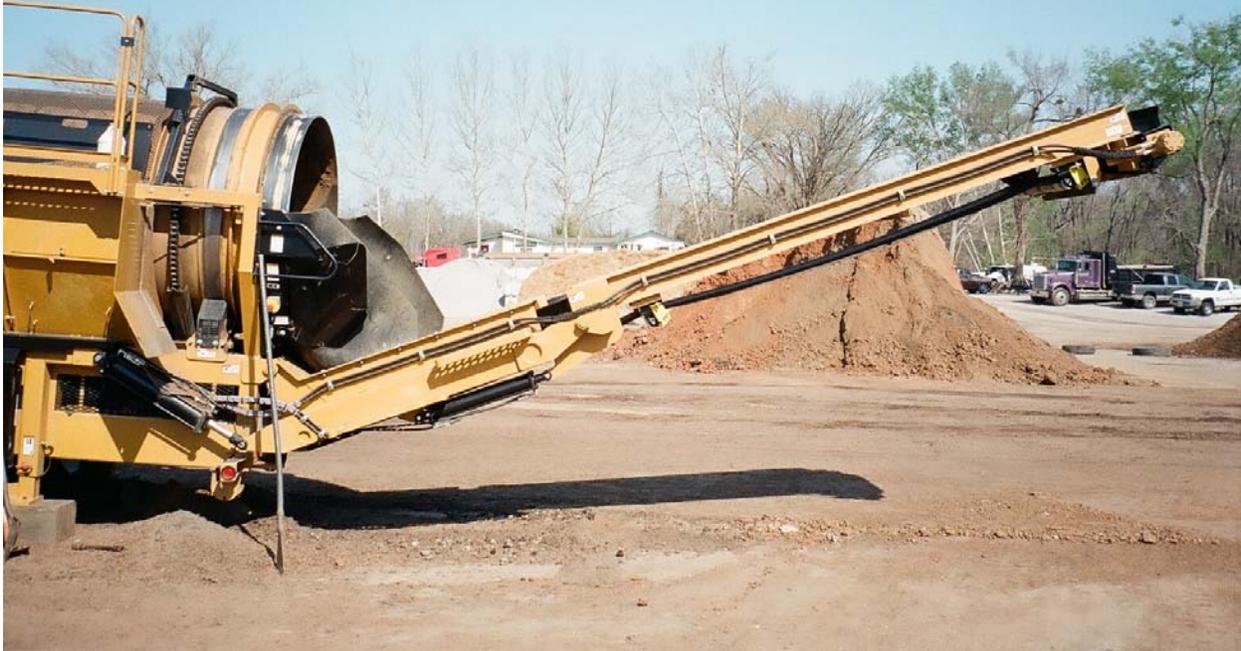
**Discharge end of machine showing waste stacker.  
Taken 4/7/09**

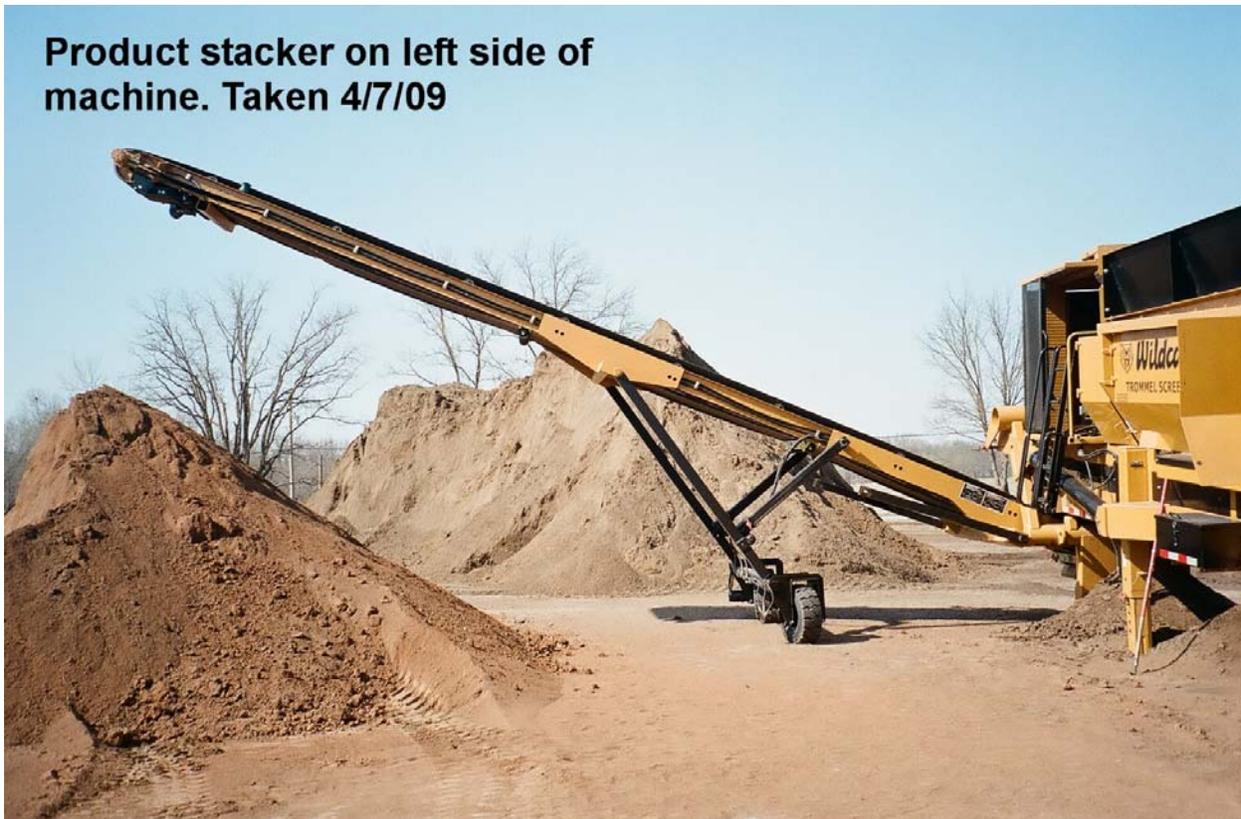
**Product stacker on left side of  
machine. Taken 4/7/09**

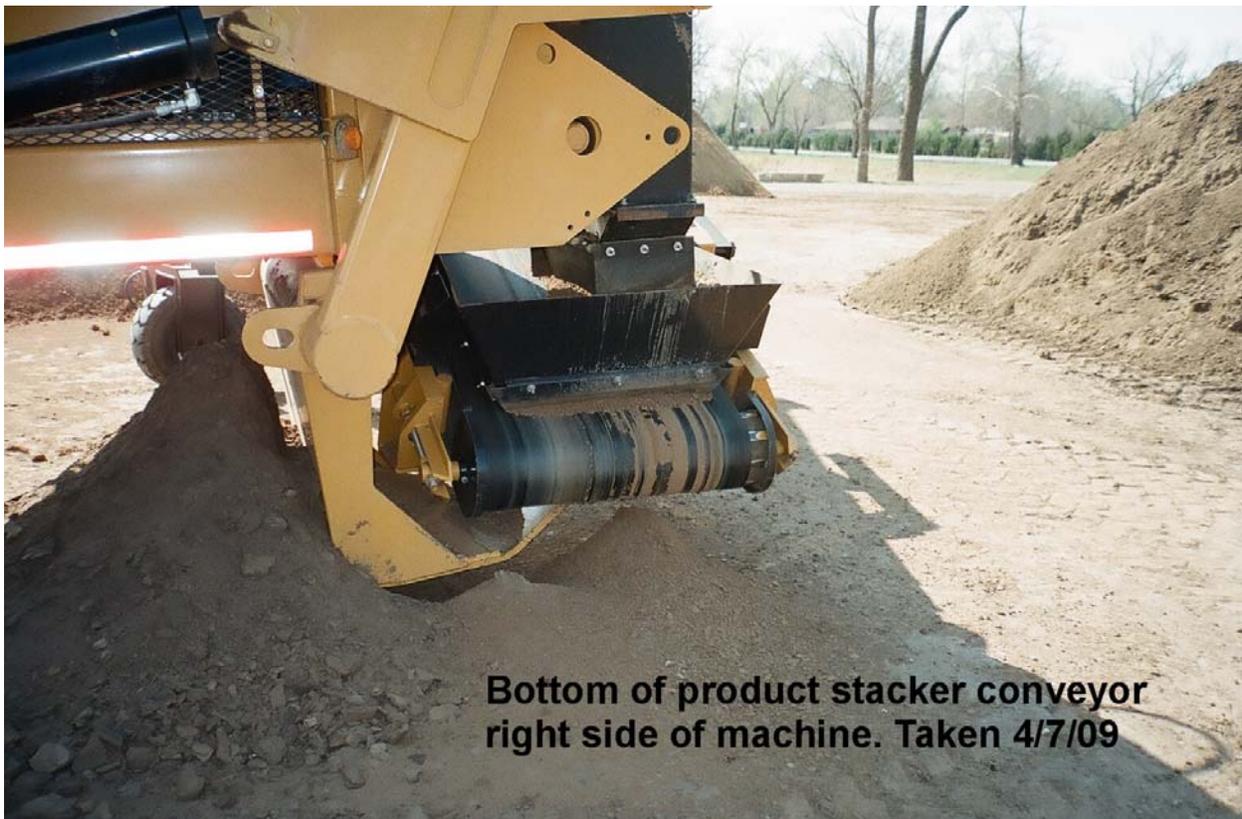
Bottom of product stacker conveyor right side of machine. Taken 4/7/09

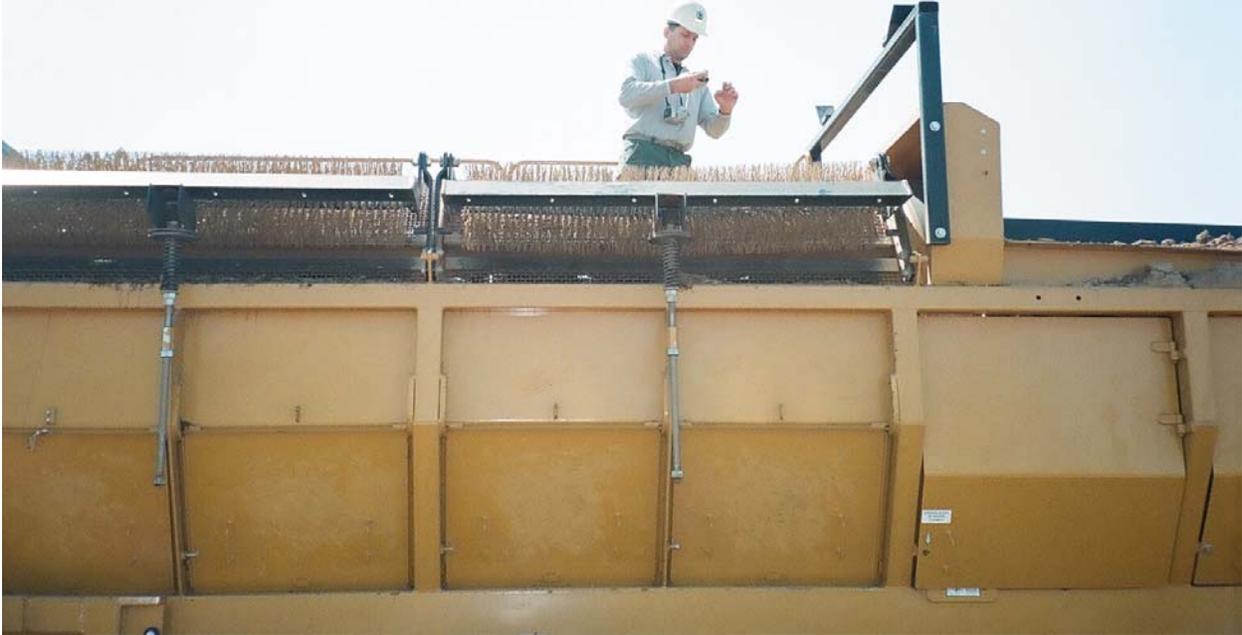
**Right side of machine  
showing cleaning brushes.  
Taken 4/7/09**

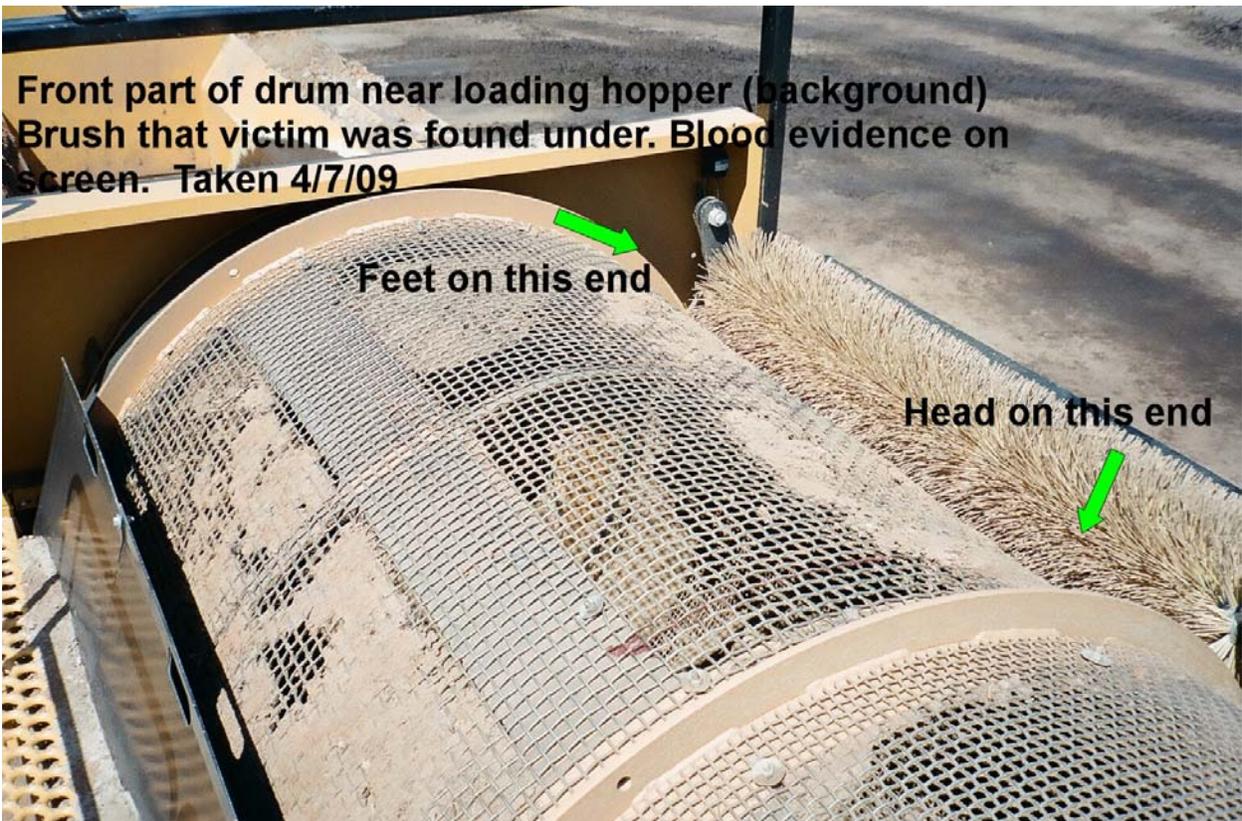
**Front part of drum near loading hopper (background)  
Brush that victim was found under. Blood evidence on  
screen. Taken 4/7/09**

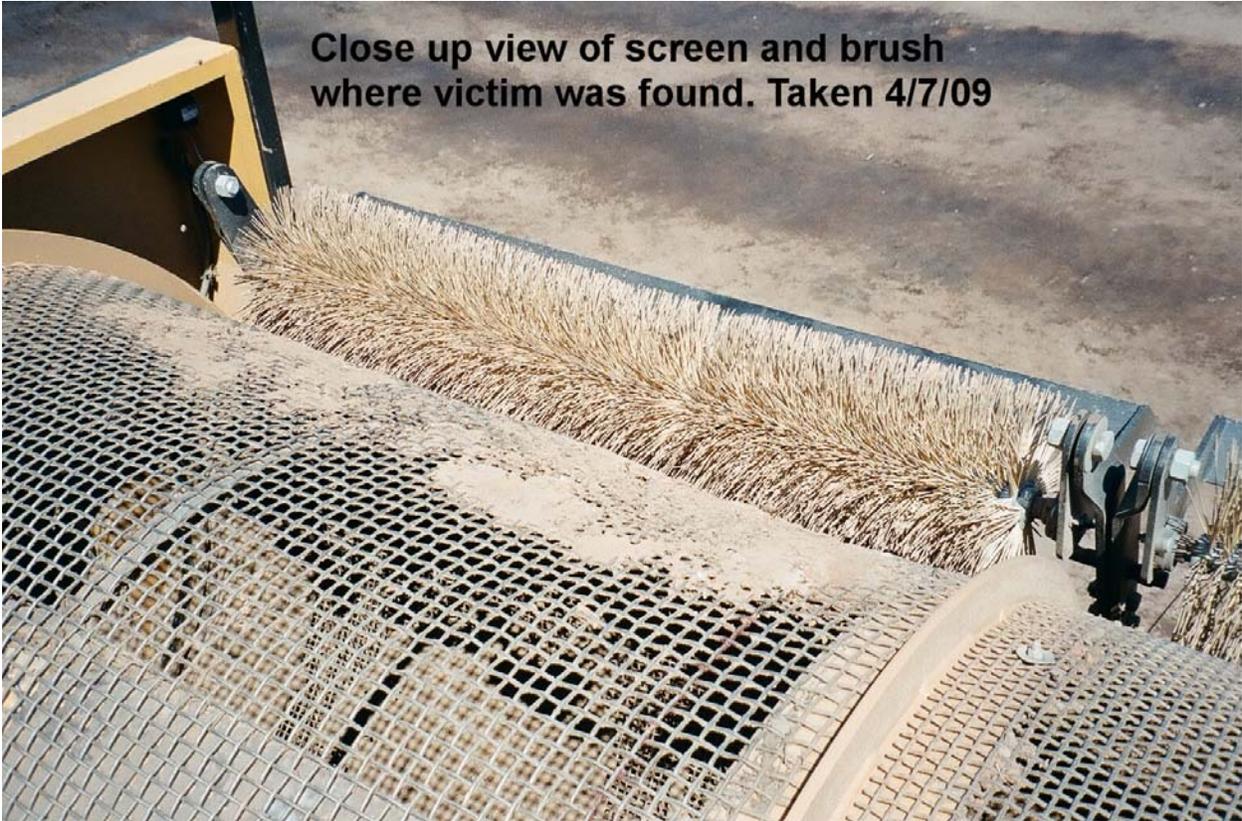
Close up view of screen and brush where victim was found. Taken 4/7/09

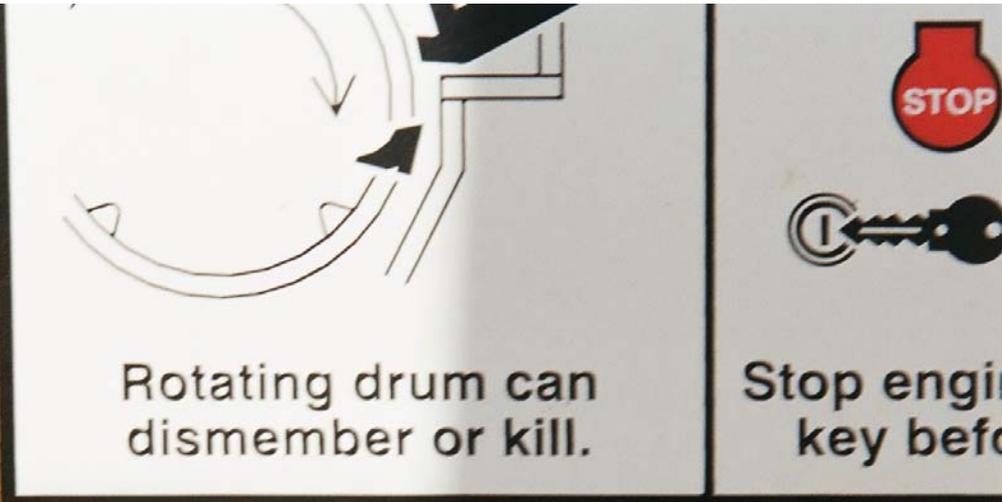
There are at least 12 warning labels located on the control panel side of the machine. Most relevant are two specific warnings in English and International symbols that state "Stop engine and remove key before climbing", which indicates the ladder and, "Rotating drum can dismember or kill."

Warning label on left side of machine near control panel. Taken 4/7/09

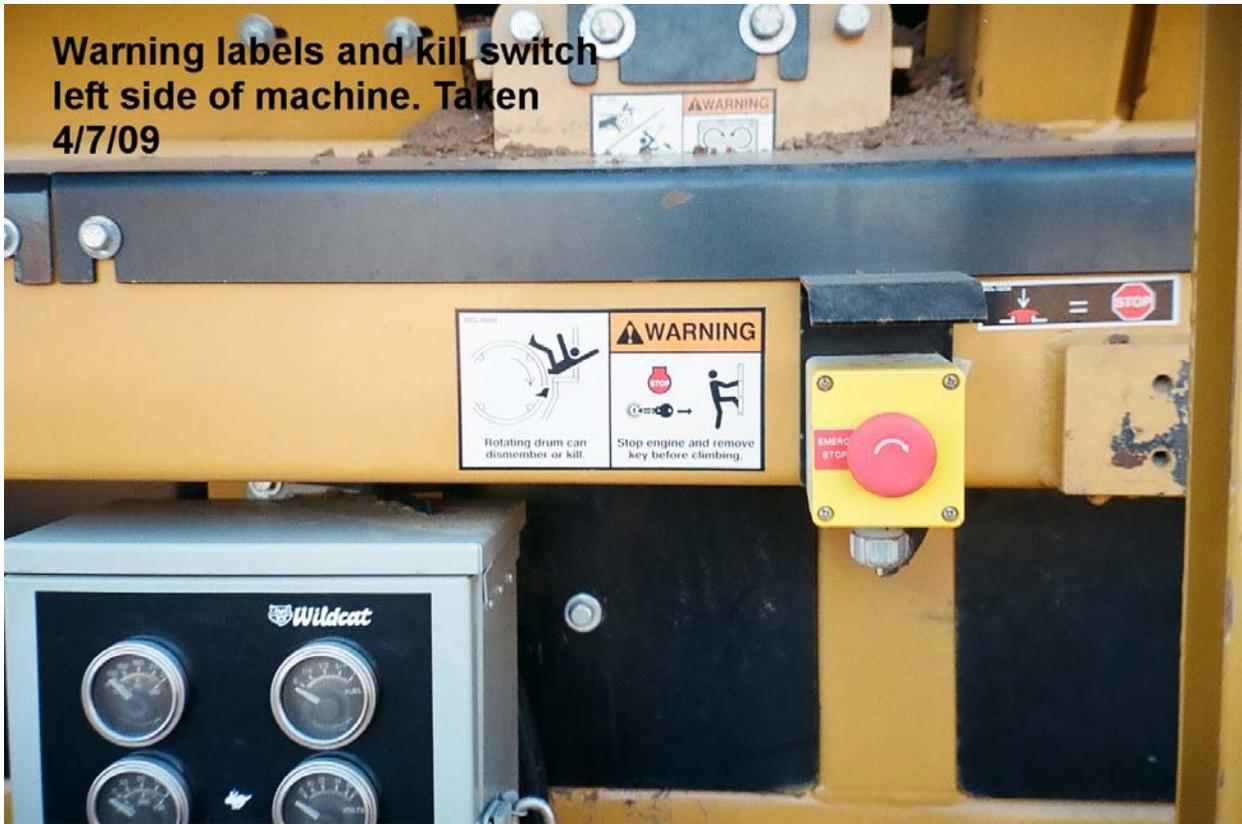
Warning labels and kill switch  
left side of machine. Taken  
4/7/09

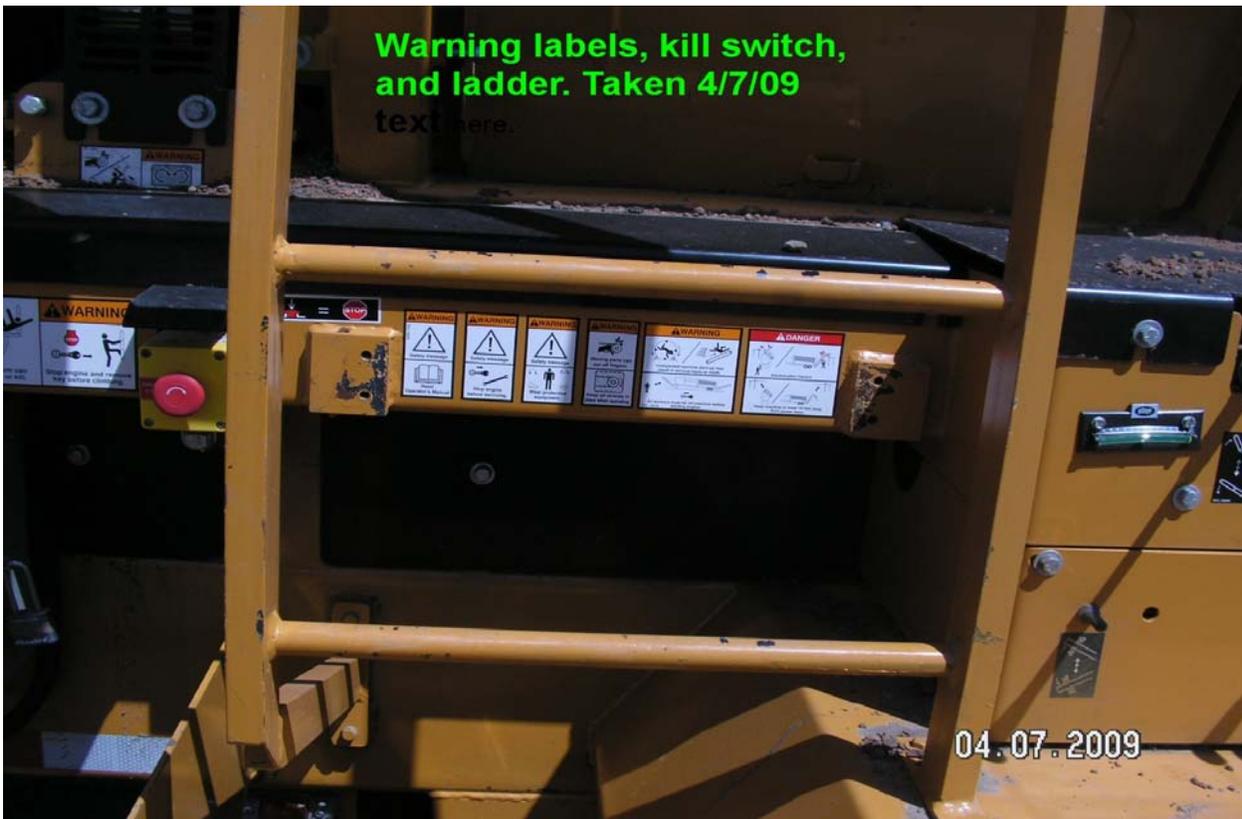
Warning labels, kill switch,  
and ladder. Taken 4/7/09  
text here.

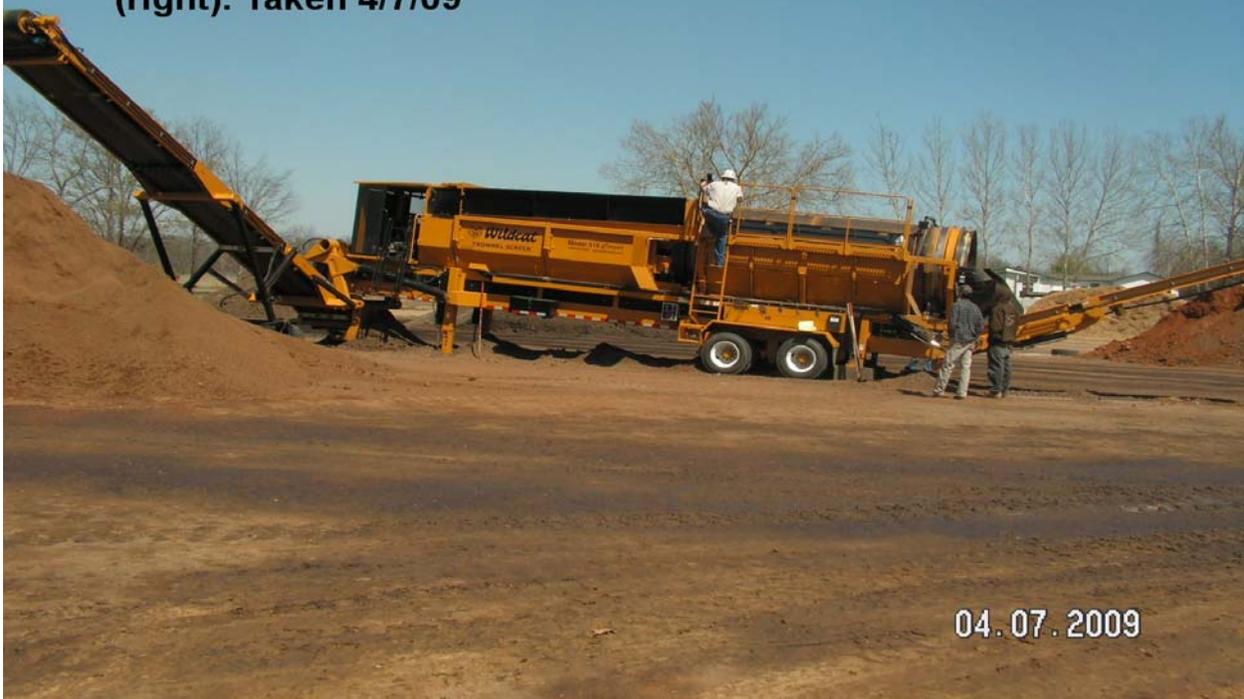
Left side of machine looking east,  
product stacker (left), waste stacker  
(right). Taken 4/7/09

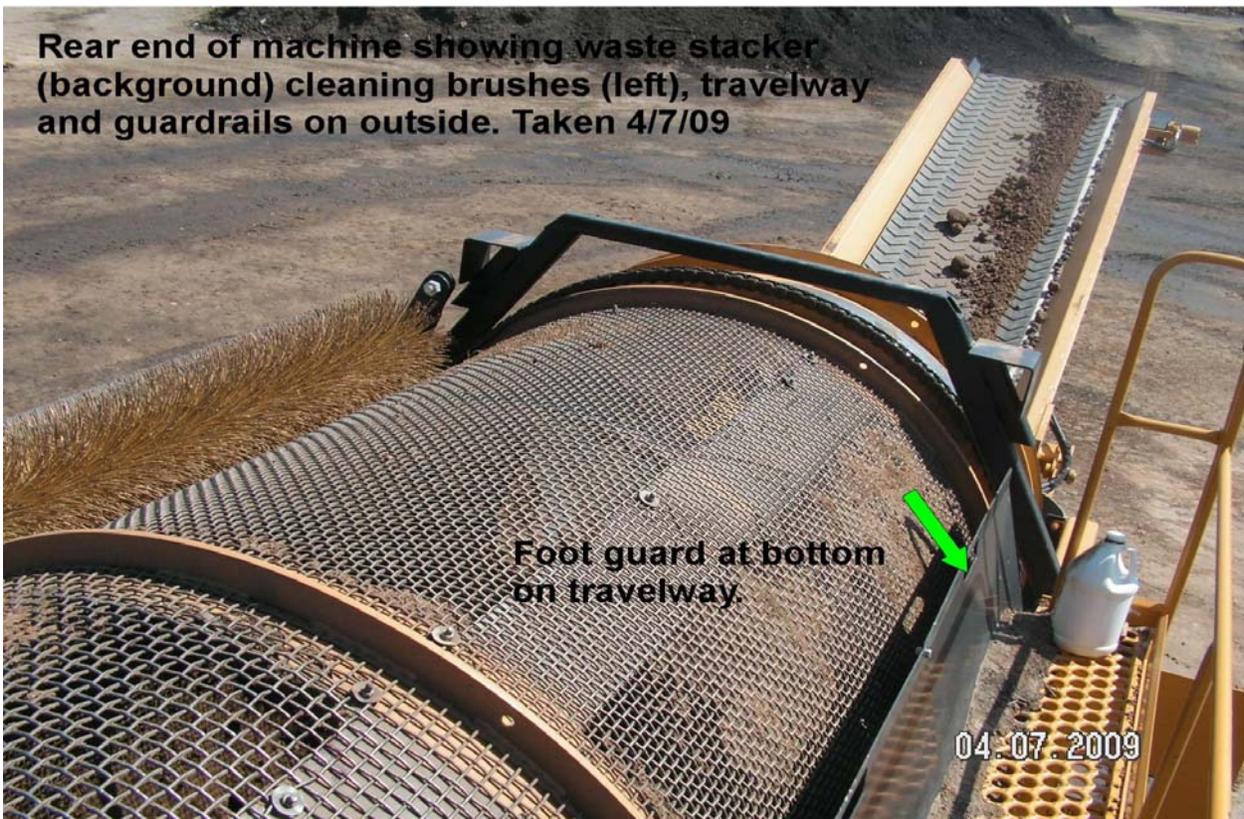
Rear end of machine showing waste stacker  
(background) cleaning brushes (left), travelway  
and guardrails on outside. Taken 4/7/09

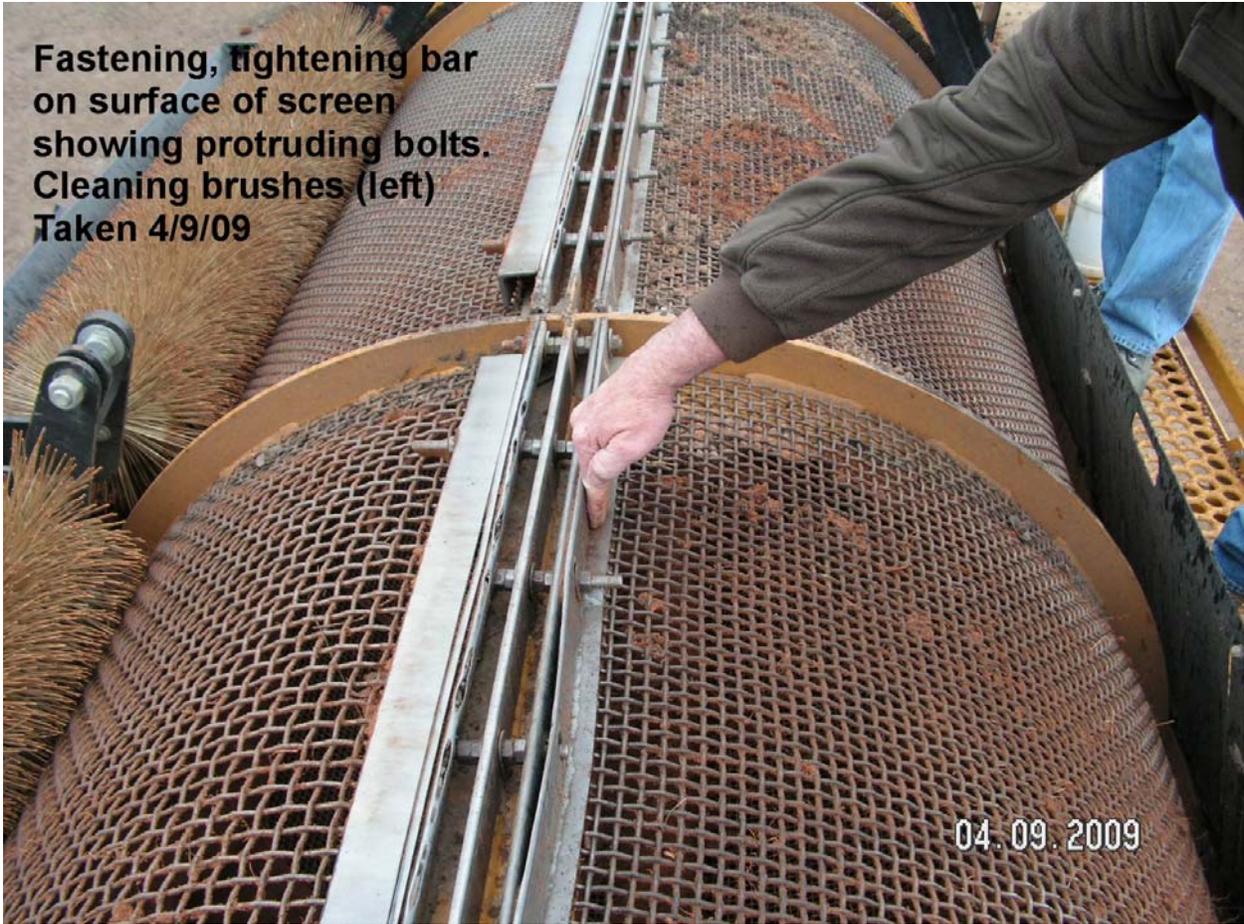
The mesh-covered cylinder has a fastening/tightening bar along the length of it. This bar extends about 2.5 inches above the mesh surface and contains numerous bolts and nuts. The bolts protrude from both sides of the bar 2 inches or more. No definite conclusion is made here, but the image of clothing (gloves, sleeves, etc.) becoming caught on these bolts as the cylinder rotates is formulated.

**Fastening, tightening bar  
on surface of screen  
showing protruding bolts.  
Cleaning brushes (left)  
Taken 4/9/09**

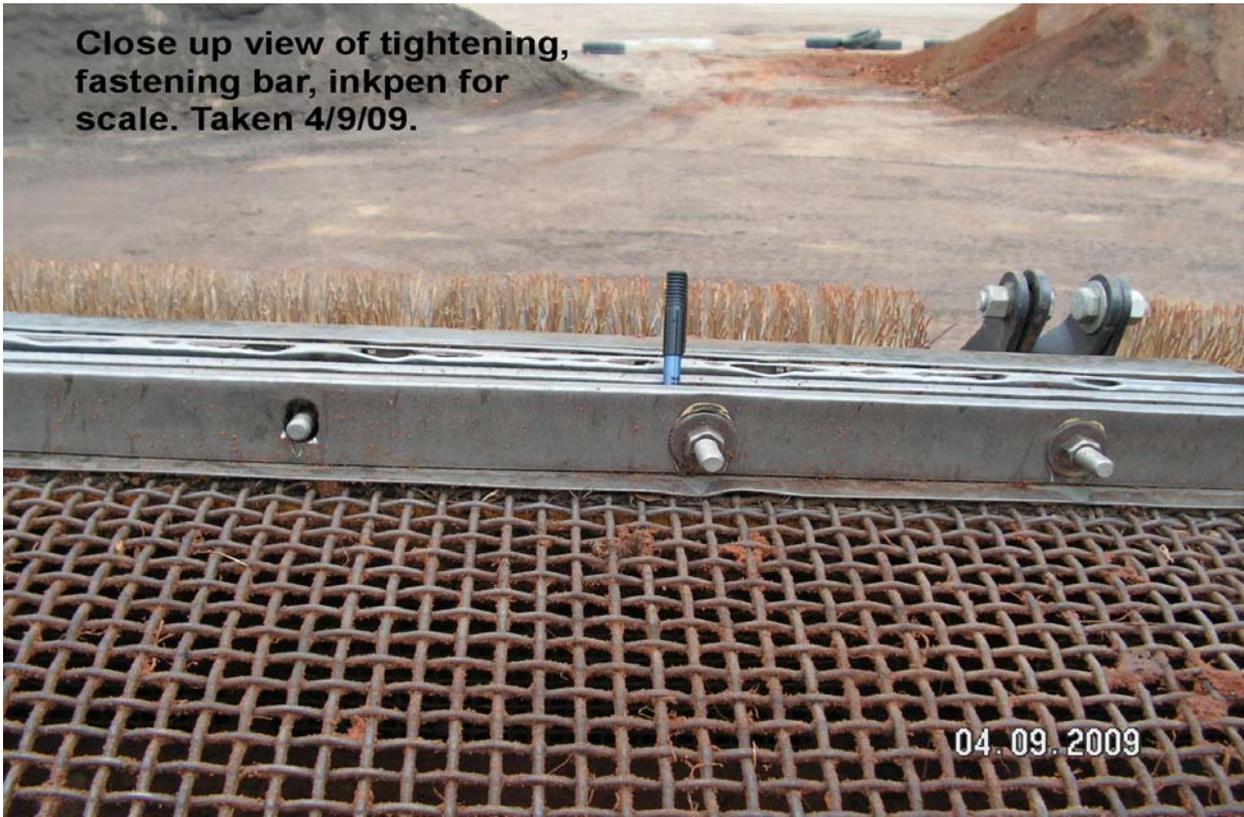
**Close up view of tightening,  
fastening bar, inkpen for  
scale. Taken 4/9/09.**
