**STURAA TEST**

**150,000 MILE BUS**

**GLAVAL CORPORATION**

**MODEL UNIVERSAL**

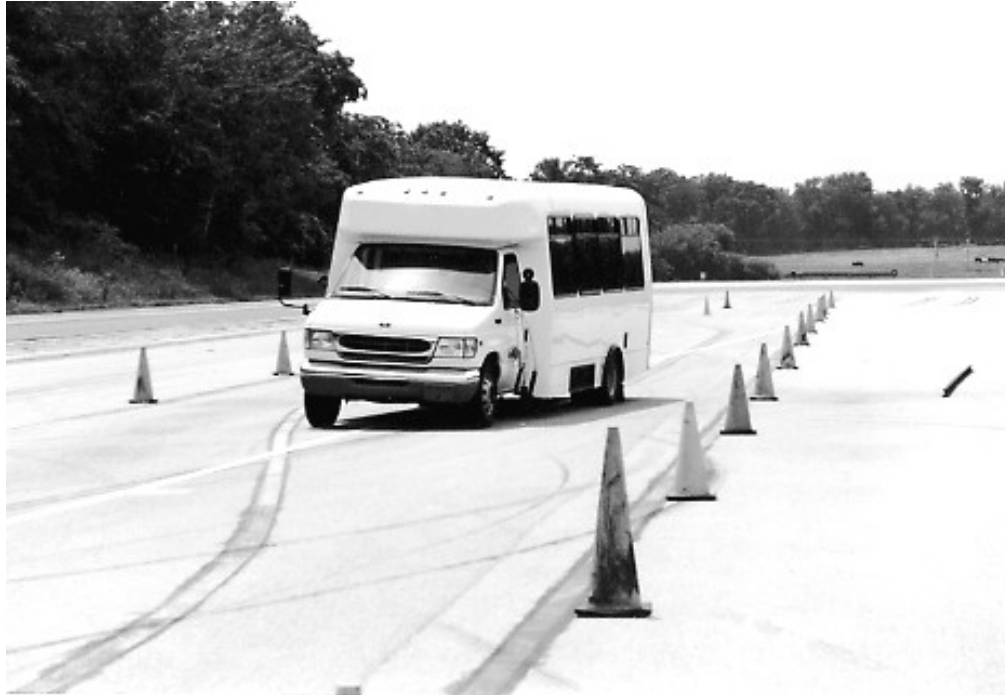
**RIGHT - HAND APPROACH**

| <b>SAFETY TEST: DOUBLE LANE CHANGE</b> | |
|---|---|
| Tire/ground contact was maintained through all portions of testing. | |

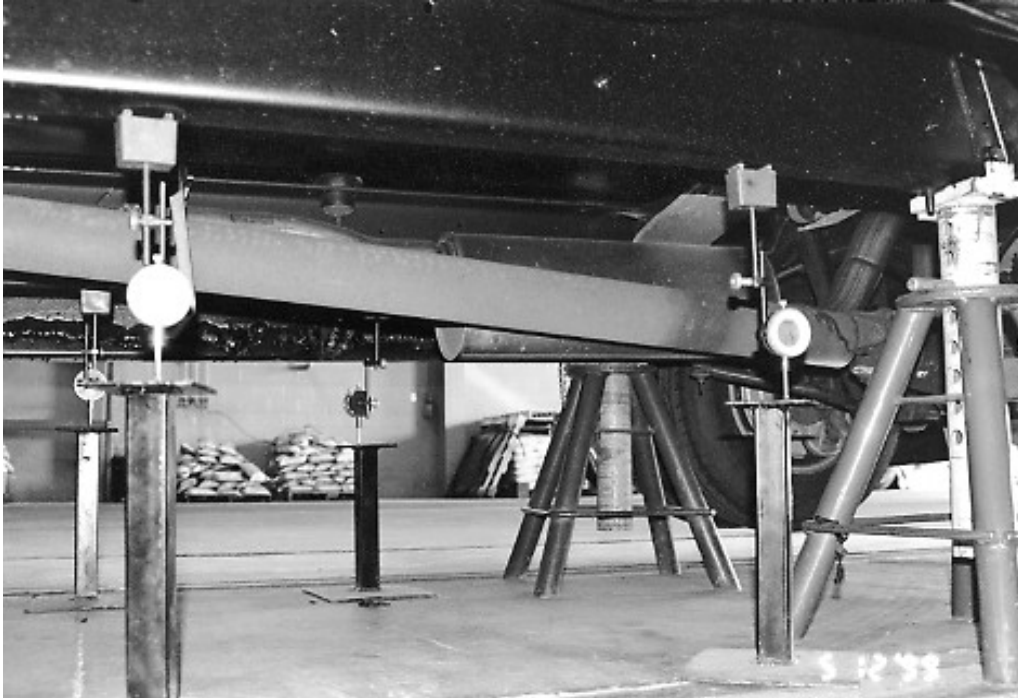
**DIAL INDICATORS IN POSITION**

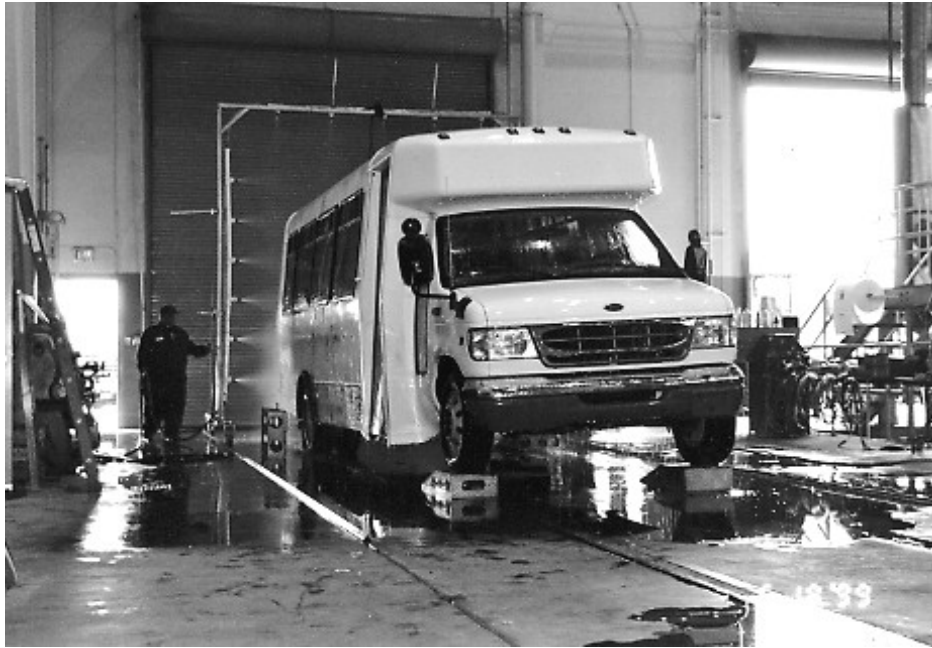
All doors, windows, escape mechanisms, engine, and steering operated normally throughout the test. The undercarriage and body indicated no deficiencies. No water leakage was observed during the test. The results of this test are indicated on the following data forms.

**RIGHT REAR WHEEL 6" LOWER**

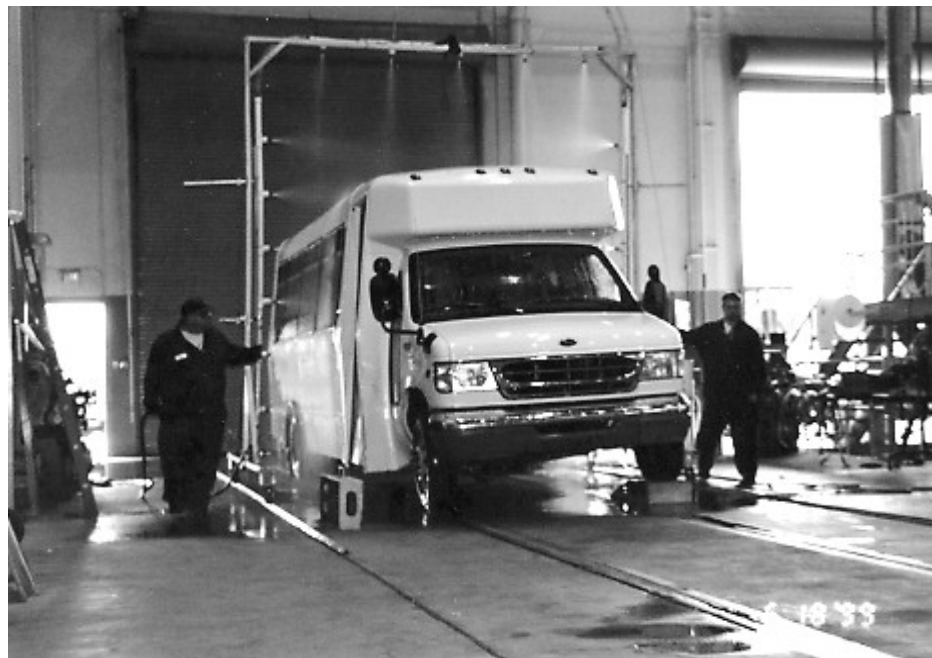
**LEFT FRONT WHEEL 6" HIGHER**

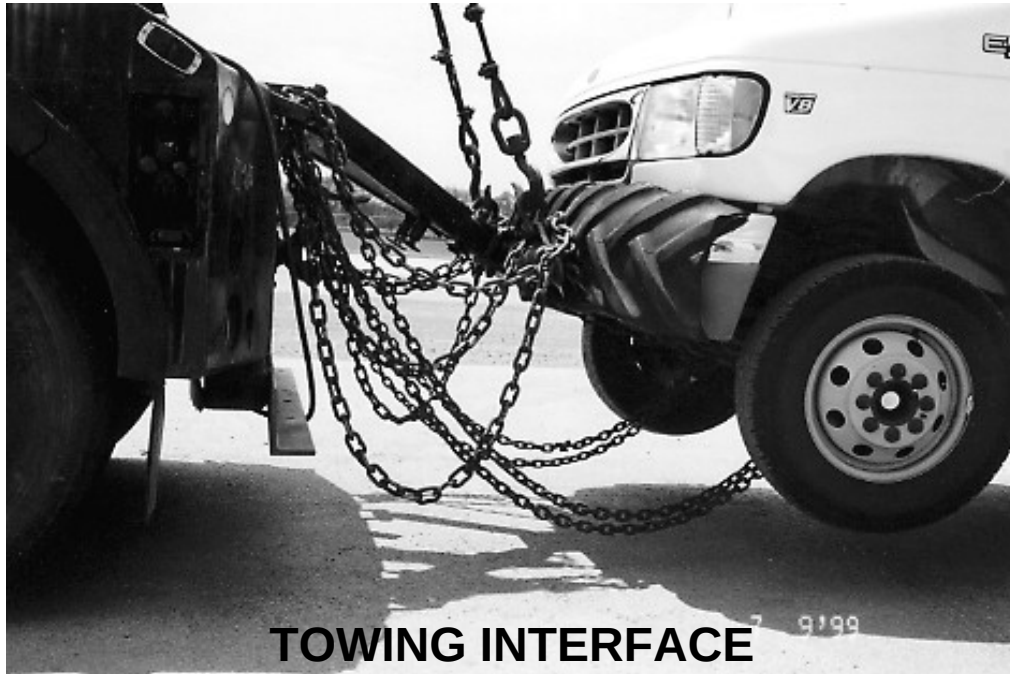
The bus was towed using a heavy-duty wrecker. The towing interface was accomplished by Chaining to the front axle. A front lift tow was performed with no problems encountered with the towing interface. Rear towing is not recommended by the manufacturer. No damage or deformation was observed during the test.

**TOWING INTERFACE**

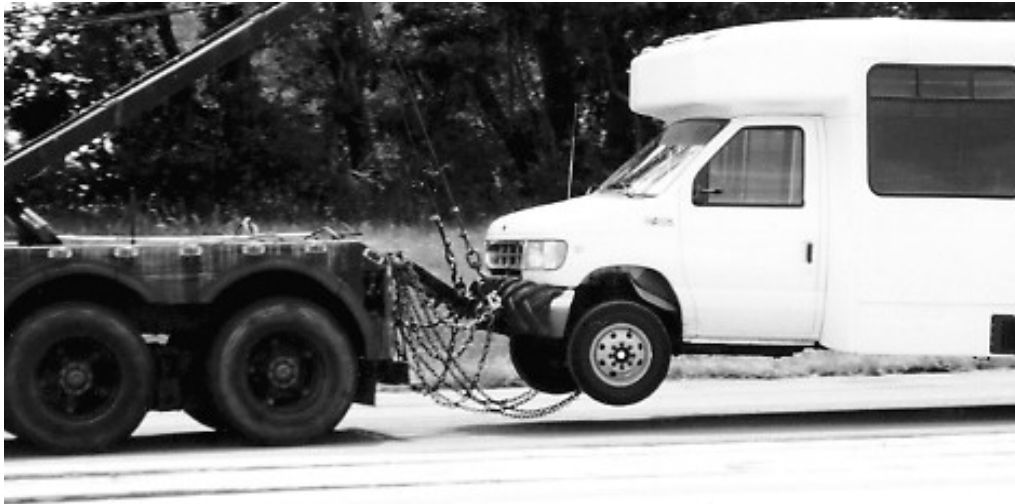
**TEST BUS IN TOW**

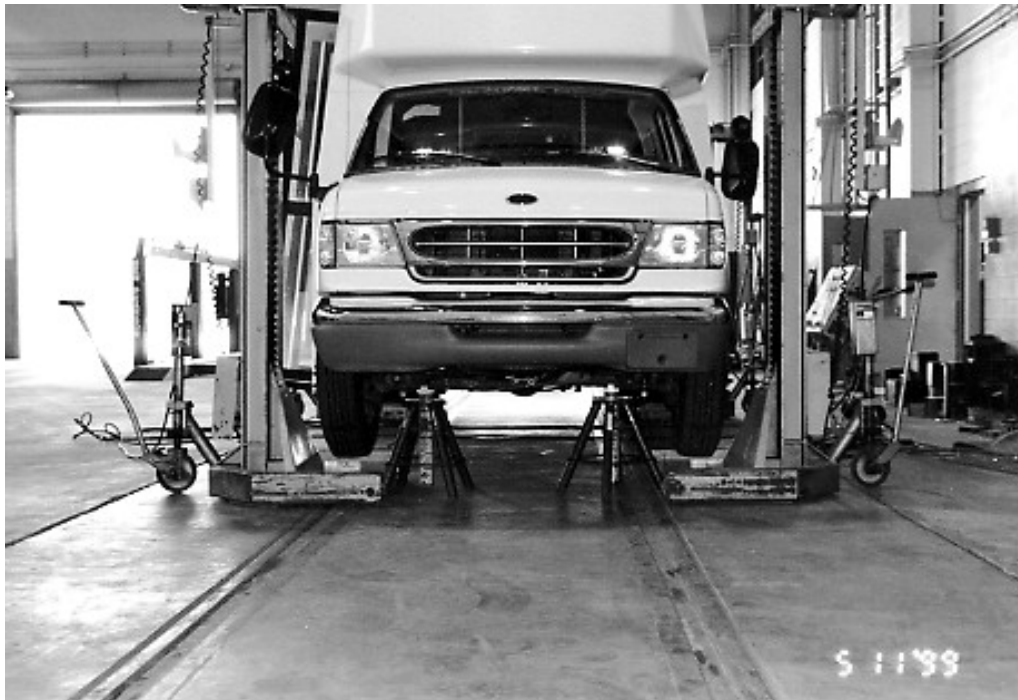
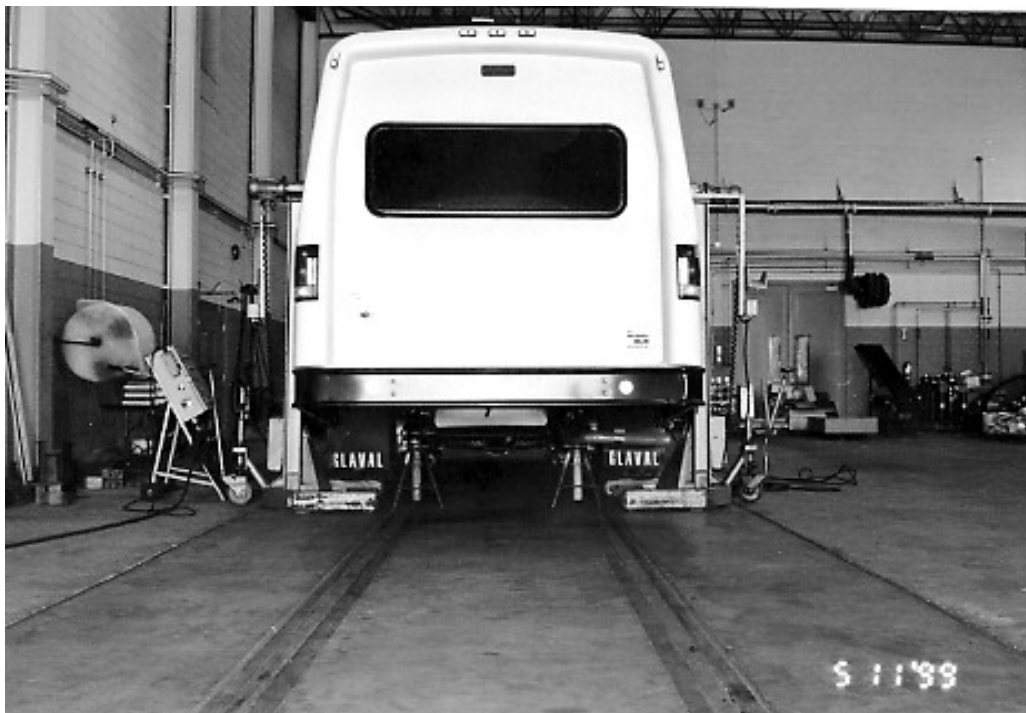
The bus easily accommodated the placement of the vehicle lifts and jack stands and the procedure was performed without any instability noted.

### TEST BUS STABLE ON JACK STANDS

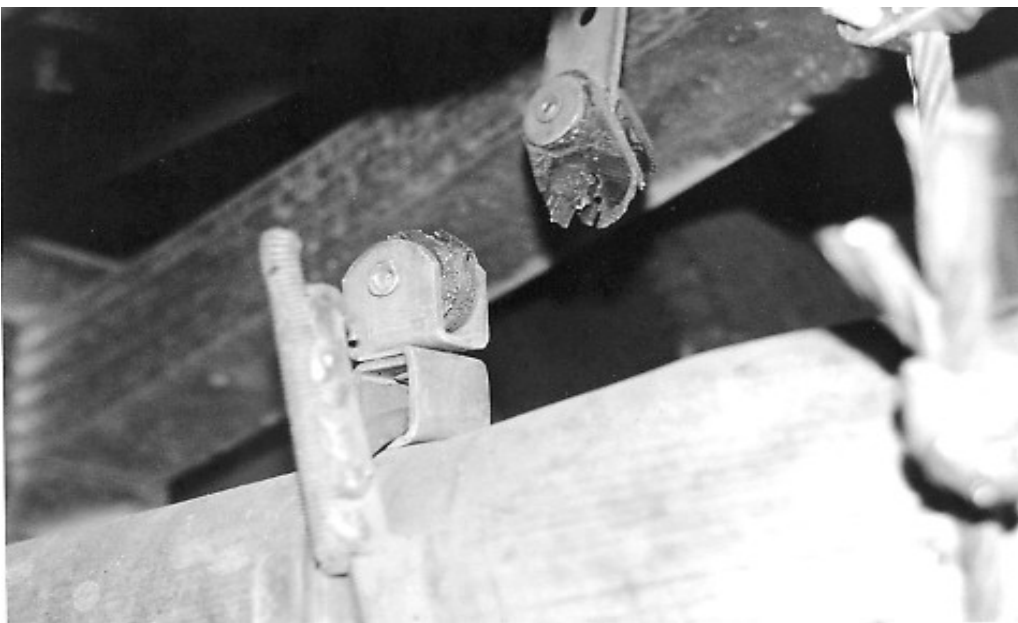
**BROKEN EXHAUST HANGER  
(3,180 TEST MILES)**

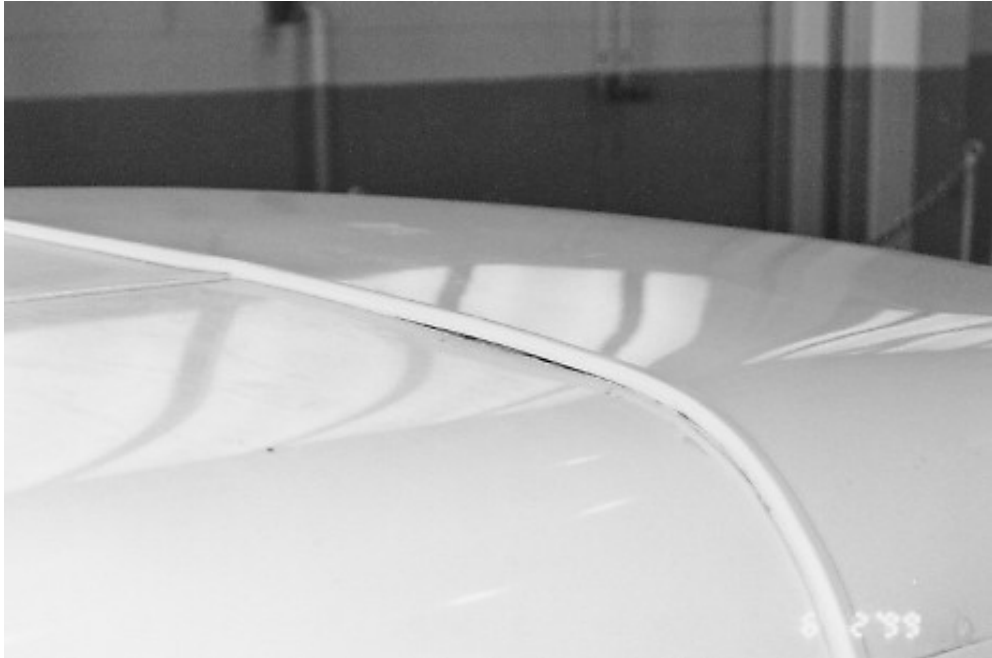
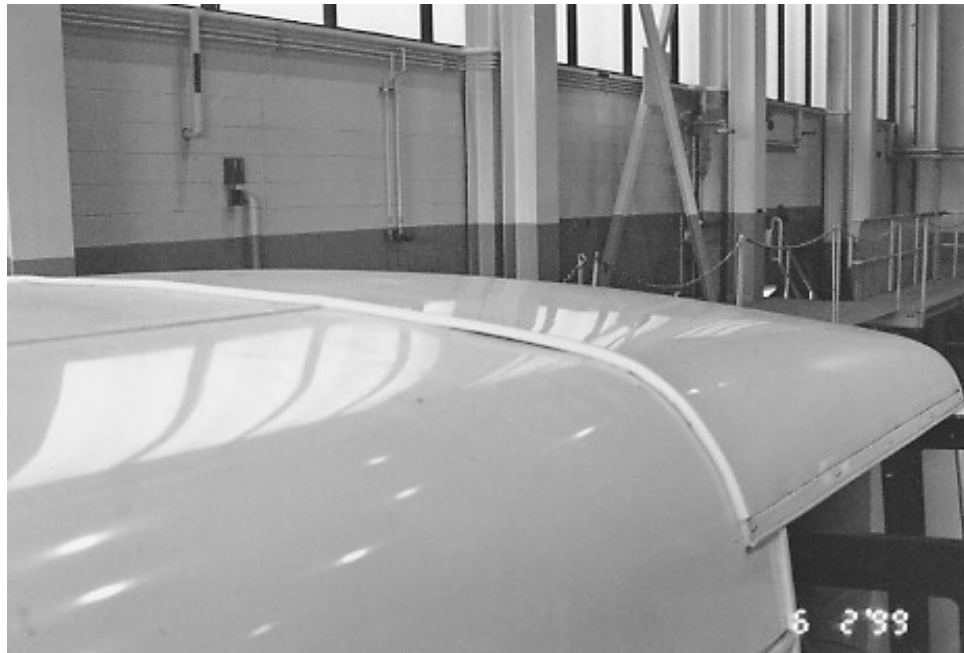
| DATE | TEST MILES | SERVICE | ACTIVITY | DOWN TIME | HOURS |
|---|---|---|---|---|---|
| 07-02-99 | 4,586 | The roof seam is separating above the entrance door. | Removed hold down straps. Re-drilled holes and installed ten new screws. | 3.00 | 3.00 |

## **SEPARATED ROOF SEAM ABOVE ENTRANCE DOOR (4,586 TEST MILES)**

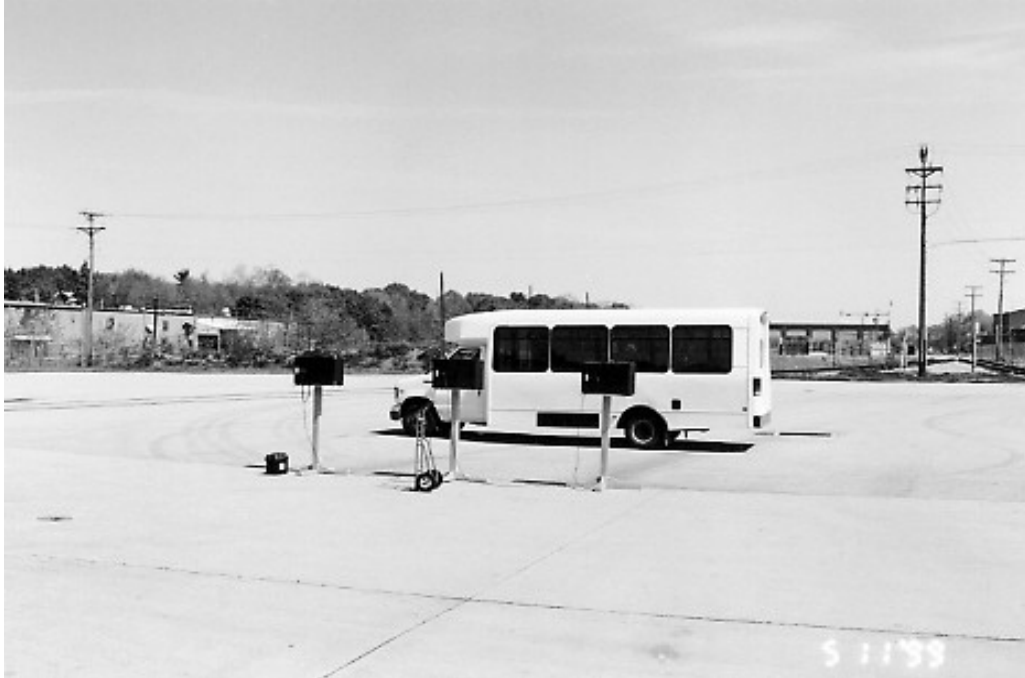
**TEST BUS SET-UP FOR INTERIOR NOISE TEST**
