## OKLAHOMA STATE CAPITOL Exterior Facade Investigation

### **Final Report**

December 18, 2014  
WJE No. 2014.3319

#### **Wiss, Janney, Elstner Associates, Inc.**

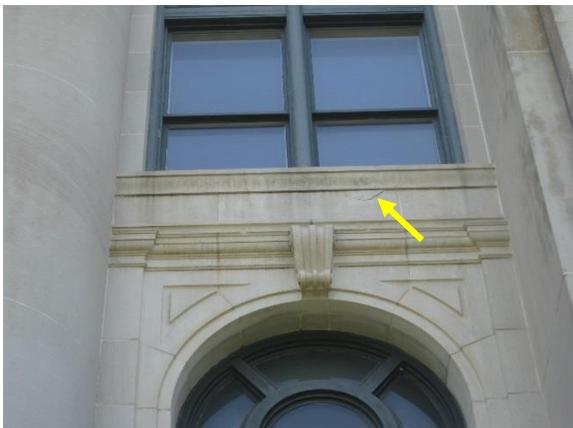
- d. Spandrels: Spalls exist at a total of three panels at the spandrel between the second and third floor windows, or 2 percent of all spandrel wall panels on the building (Figure 17). The spalls are located on the north facade of the building and coincide with concealed mild steel strap anchors (Figure 18). The spandrel consists of three panels (Figure 19). With a metal detector, we randomly surveyed additional spandrel panel locations and determined that strap anchors generally exist at quarter points in the top edge of each panel. An additional seven spalls (6 percent of all panels) exist on the north and south facades that don’t coincide with metal strap anchors.

*Figure 19. Example of limestone spall at spandrel panel*

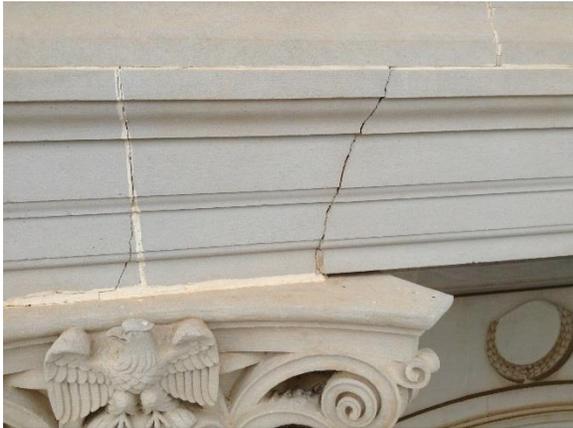
2. Cracks exist at various locations throughout the building including ashlar panels on the main facades (Figure 20), windowsills (Figure 21), frieze panels (Figure 22), and architrave units (Figure 23). There are a few isolated instances where small chips exist that are located near the edge or corner of a panel.

Figure 23. Example of cracked limestone at architrave unit

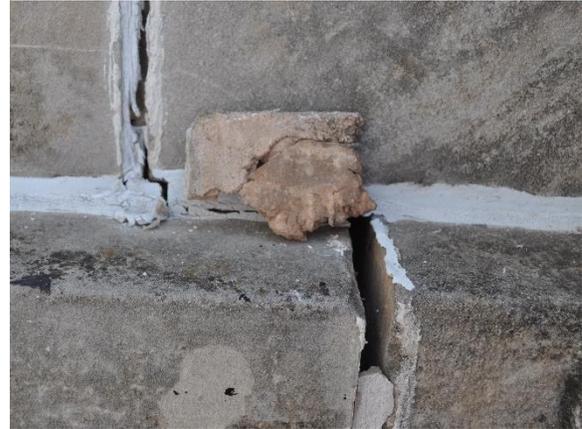
4. There are widespread areas throughout the building where mortar bond failure exists between limestone units (Figure 26).
5. The mortar throughout the building has been coated with a cementitious coating on the outside face of the joints and adjacent limestone units (Figure 27). There are limited areas where mortar is missing or washed out, particularly at upper levels of the dome platform (Figure 28).

Figure 28. Washed-out mortar joint

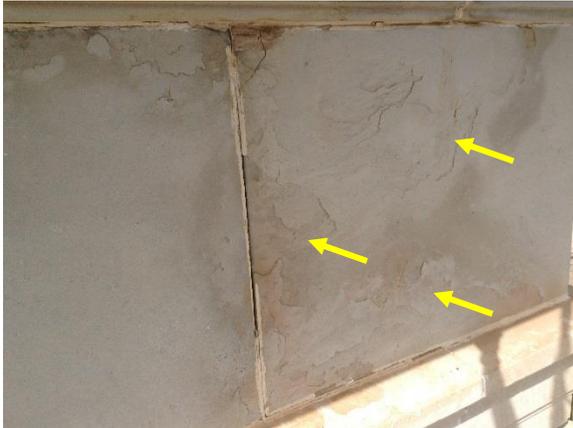
6. Exfoliation exists at a few limestone panels, primarily at the frieze above the south portico (Figure 29 and Figure 30) and also at third floor windowsills.

Figure 29. Exfoliation of limestone units

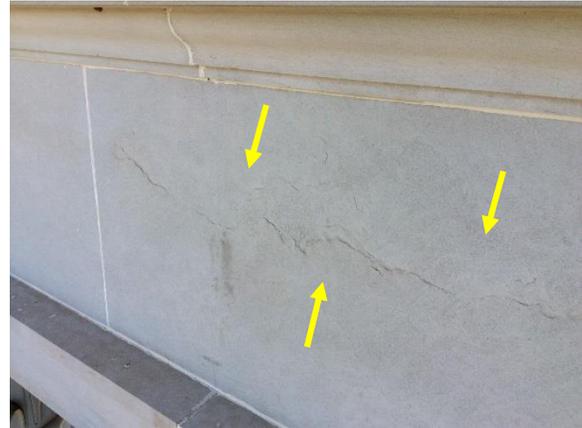
Figure 30. Exfoliation of limestone units

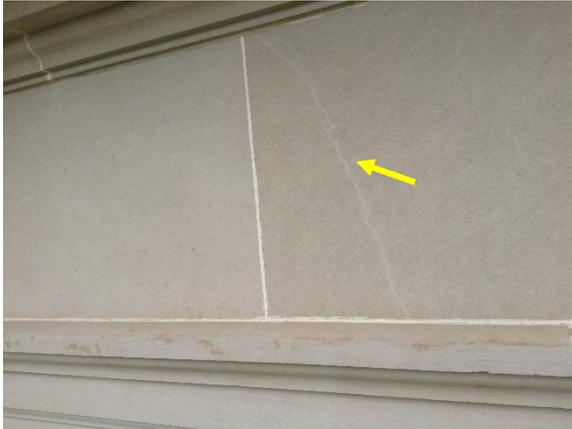
10. Seams exist in limestone panels throughout the building. Seams can be open or naturally filled and in limestone, frequently have contrasting whitish color (Figure 33). In most instances the presence of a seam in limestone is negligible with respect to its strength and long-term performance.

*Figure 33. Seam within limestone unit*

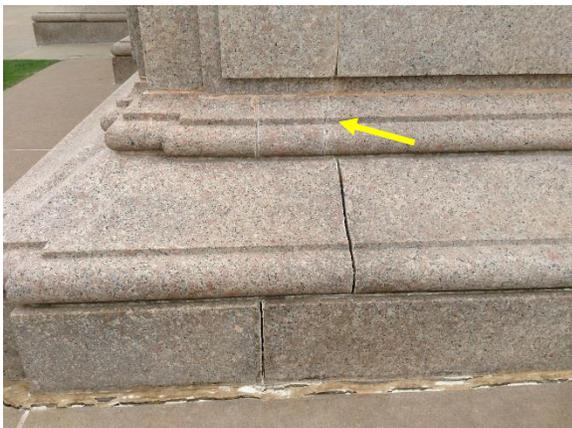
1. Cracks in granite units are generally limited to panels located near the outside building corners (Figure 34 and Figure 35).
2. Corrosion stains exist on granite units located near the top of the light wells. The staining is the result of abandoned anchors that may have previously supported steel grates at the top of the light wells (Figure 36 and Figure 37).
3. Locations with washed-out mortar are significantly higher at granite areas of the facade compared to limestone facade areas. Granite areas where mortar is missing exist primarily at upward-facing joints within the granite watertable above the first floor and at outside building corners on the building (Figure 38 and Figure 39).

*Figure 34. Crack within granite unit*

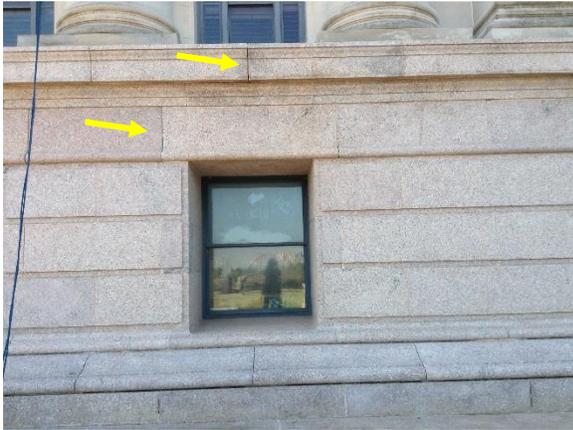
*Figure 38. Washed-out mortar in granite units*

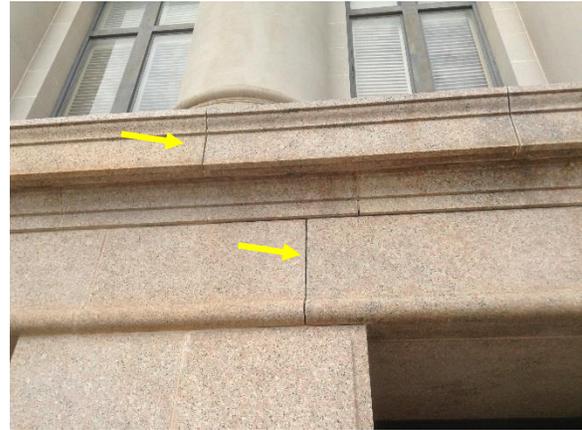
*Figure 39. Washed-out mortar in granite units*

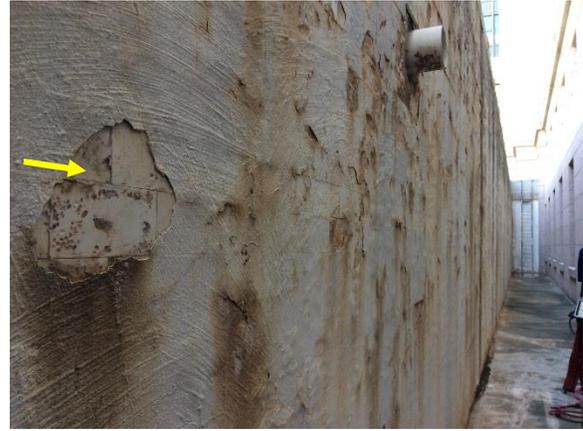
1. A coating has been applied to the exposed surfaces of the below grade reinforced concrete walls (Figure 40).
2. The inside face of the concrete foundation wall (within the light well) was originally clad with mortar-set 1/4 inch thick quarry tile (Figure 41). There are presently a few areas where the original tile is delaminating from the inside face of the concrete wall.
3. Cracks and previously removed spalls were observed extensively throughout the inside face of the concrete foundation walls (Figure 42 through Figure 44).

Figure 41. Delaminating tile at light well

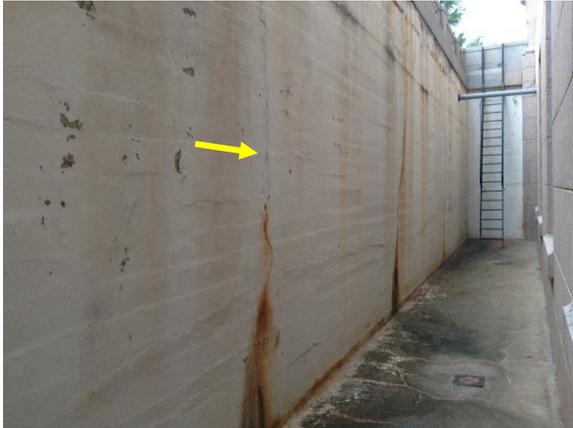
Figure 42. Cracks at foundation walls

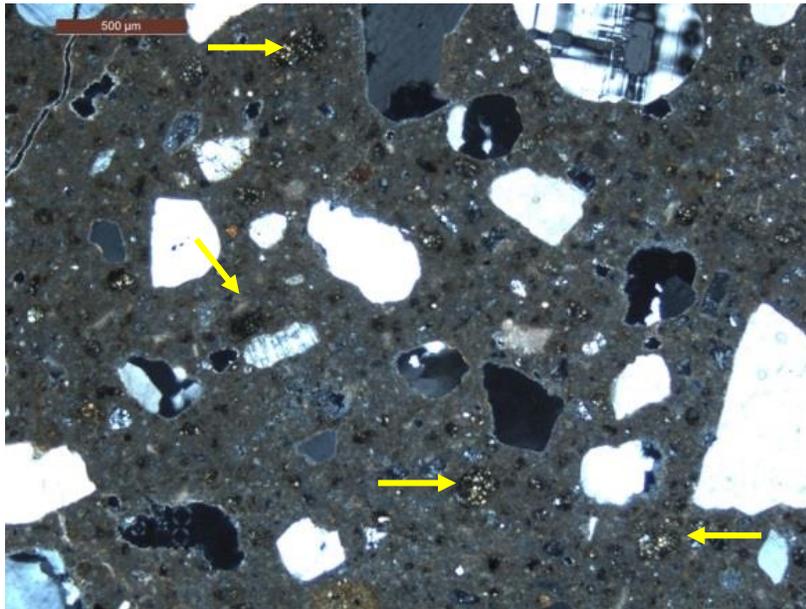
The flat surfaces were typically coated with a thin layer of secondary carbonate and dark-colored debris deposits. The underlying paste was carbonated. The optical characteristics of the paste in the interior region of the mortar are consistent with extensive water leaching and re-crystallization. Micro-crystalline secondary deposits are locally abundant in the air voids and in the paste (Figure 49).

*Figure 49. Original setting mortar. Thin-section micrographs show low sand volume and high binder volume of likely original pointing mortar. Arrows show typical large residual portland cement particles. Cross-polarized light.*

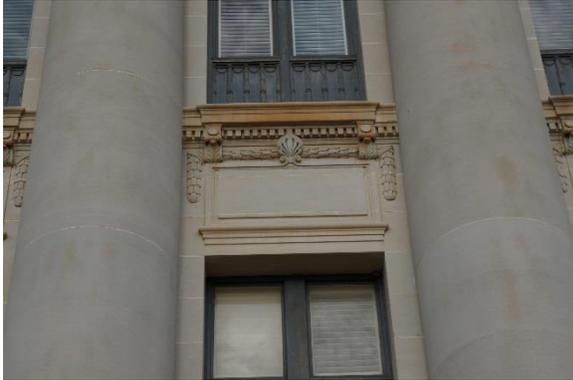
- Dark orange staining of the limestone at the vertical face of the window sill (Figure 53)
- Light orange streaks of the limestone at the columns and pilasters (Figure 54)

*Figure 53. Dark orange staining of limestone at window sill (above)*

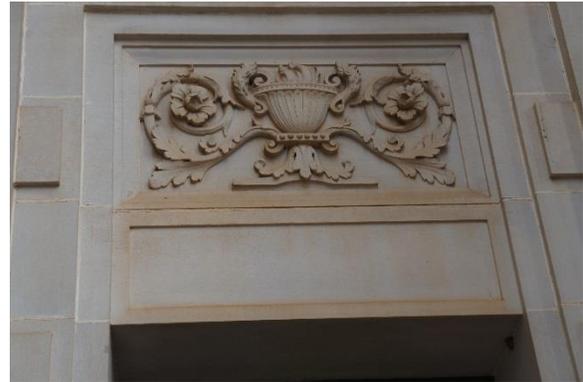
*Figure 55. Orange staining of limestone below punched windows (left)*

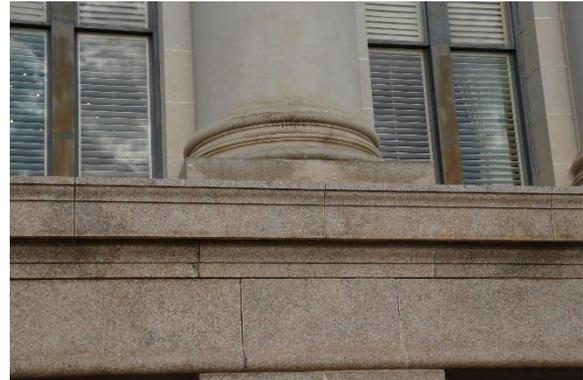
*Figure 57. Dark horizontal streaks on limestone columns (left)*

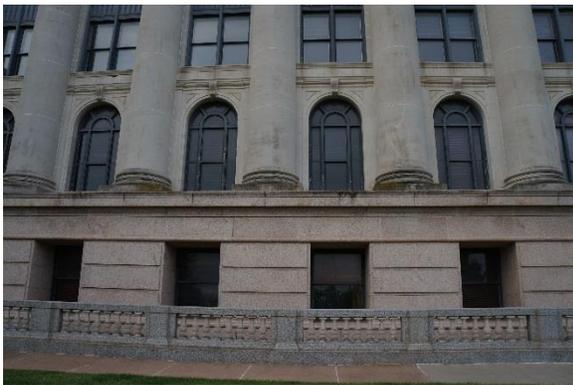
*Figure 59. Soiling at limestone column bases above granite*

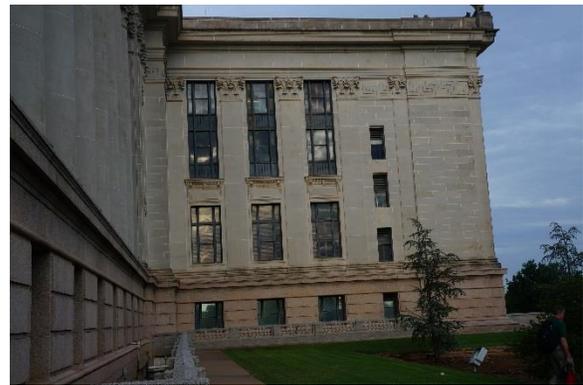
*Figure 60. Dark staining at limestone parapets*

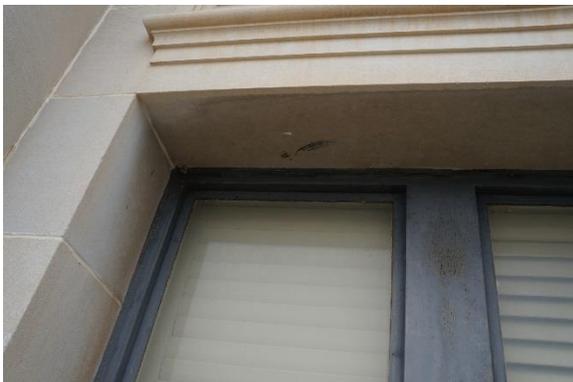
*Figure 61. Dark staining below limestone lintels*

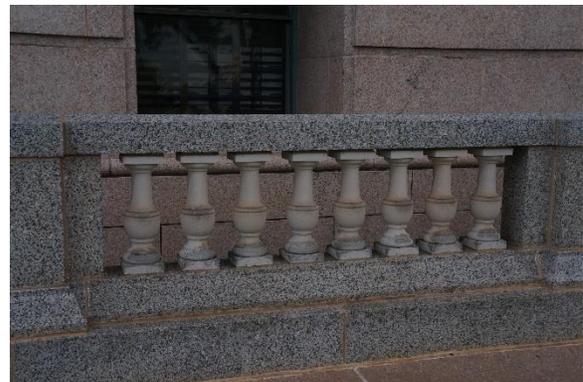
*Figure 62. Stained limestone balusters*

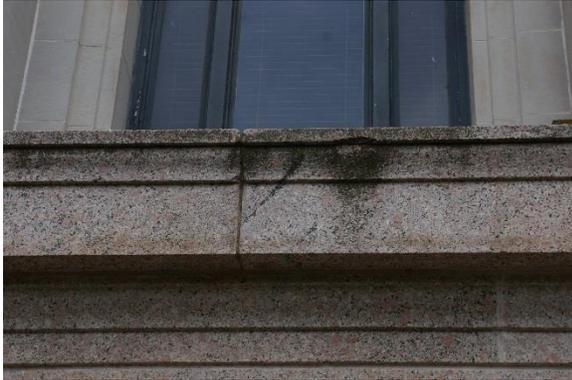
*Figure 63. Biological growth on granite watertable*

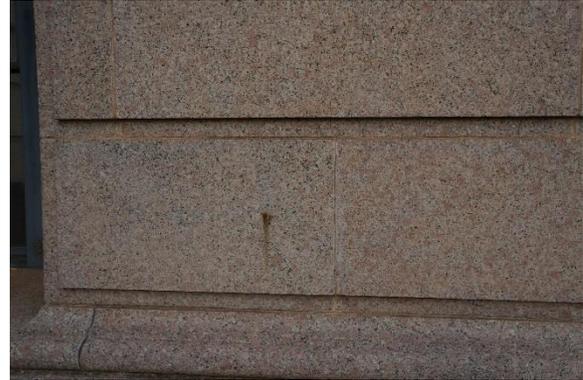
9. Some of the limestone panels have ferrous mineral inclusions at the outside face of the panel (Figure 32). The inclusion has caused iron oxide (brownish) stains to develop on the outside face of the building.

*Figure 64. Staining from ferrous mineral inclusions*

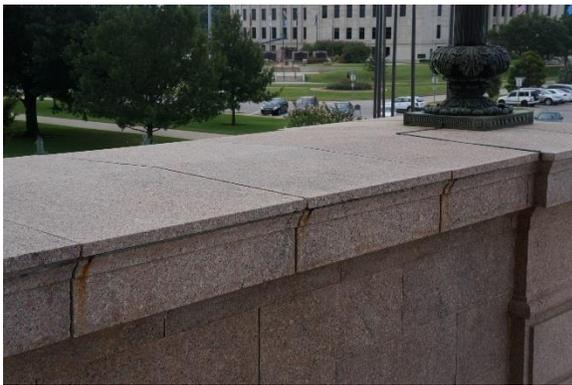
- Iron stains on the granite as a result of surface applied steel anchors and grates (Figure 65 and Figure 66)
- Iron stains on the granite and limestone entrance steps as a result of steel stanchions (Figure 67)

*Figure 65. Staining of granite from surface-applied metal appurtenances*

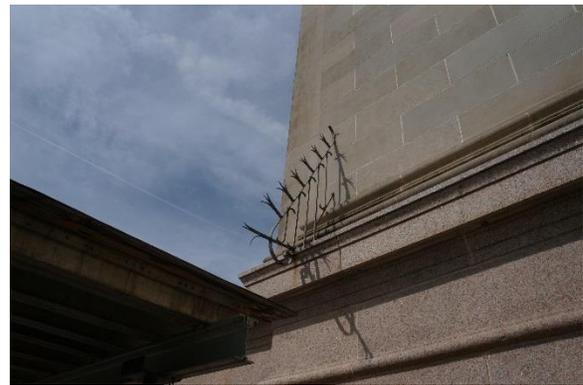
*Figure 66. Staining of granite and limestone from surface-applied metal appurtenances*

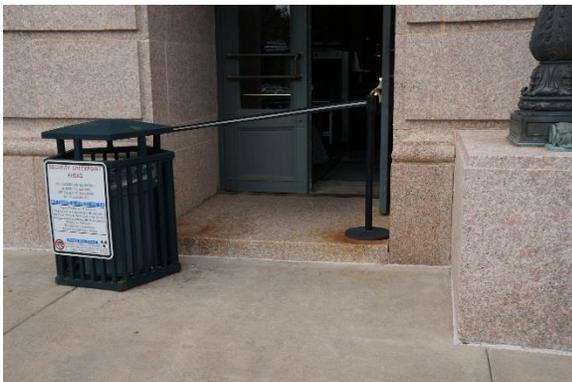
*Figure 67. Staining of granite from steel stanchions at entrances*

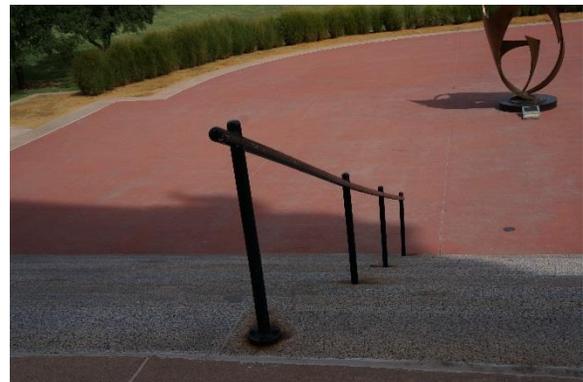
- Iron oxide staining of granite steps from steel railing (Figure 68)

*Figure 68. Staining of granite stairs from steel railing*

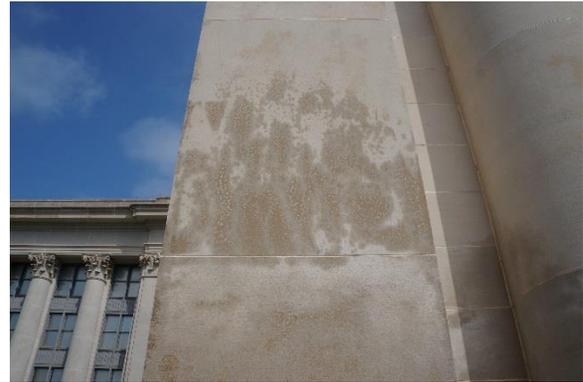
Cleaning trials were conducted of the orange staining on the east wall of the south portico as listed in Table 1 (Figure 69).

None of the trials significantly reduced or removed the orange staining.

*Figure 69. Area of limestone cleaning trial*

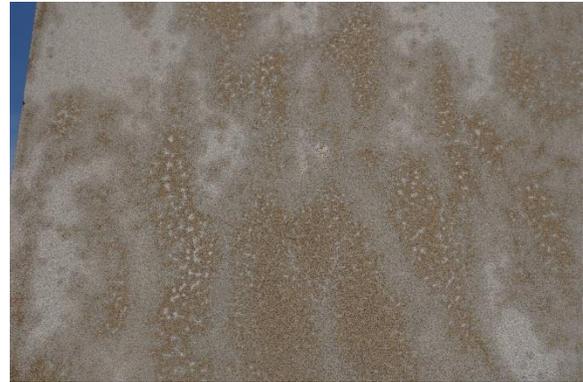
A cleaning trial using very low-pressure water misting was conducted of the orange staining on the south facade to the west of the portico. While the cleaning was unsuccessful at removing the soiling, a drying pattern emerged related to the orange streaks subsequent to the cleaning trials (Figure 70 and Figure 71).

*Figure 71. Close-up view of cleaning trial area*

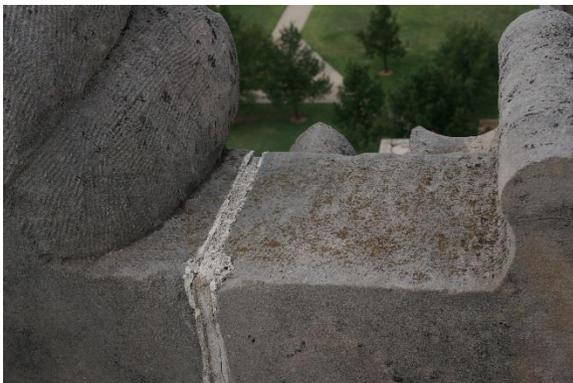
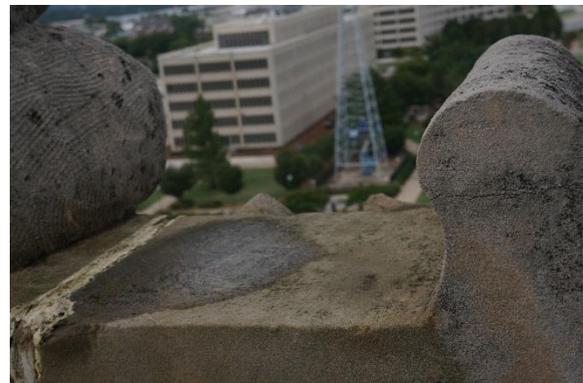
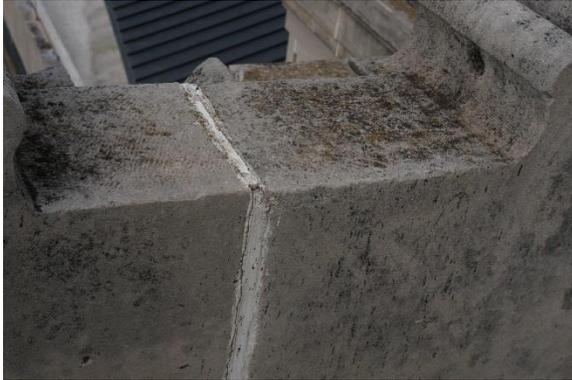
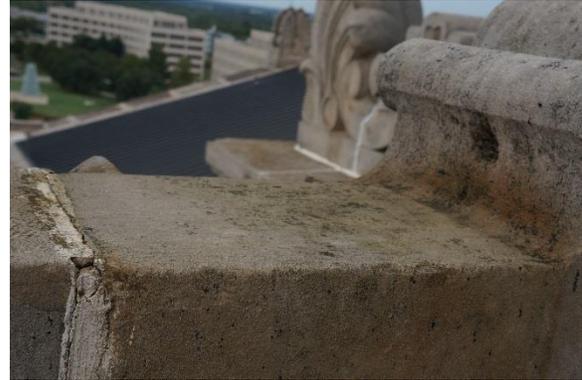
Cleaning trials of the dark biological staining on the limestone were completed on the backside of the platform at the northwest corner of the building as shown in Table 2 (Figure 72 through Figure 75).

Both samples successfully reduced the amount of biological growth.

*Figure 72. Area of trial cleaning at limestone parapet before application of cleaner*

*Figure 73. Area of trial cleaning at limestone parapet after application of cleaner*

*Figure 74. Area of trial cleaning at limestone parapet before application of cleaner*

*Figure 75. Area of trial cleaning at limestone parapet after application of cleaner*

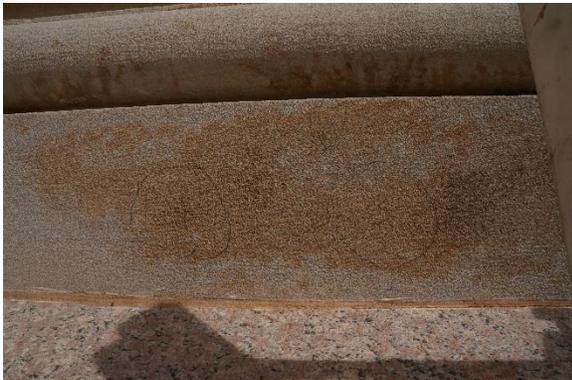
Since the trials of cleaning the orange staining were unsuccessful, three 3 inch diameter cores of orange-stained limestone were removed for laboratory analysis (Figure 76). Two small chips were collected from the surface and analyzed using scanning electron microscopy with energy dispersive x-ray spectroscopy (SEM/EDS) to determine the elemental composition of the discolored surface (Figure 77). One chip encompassed both discolored and non-discolored areas. The elemental analysis of the non-discolored area indicated the presence of calcium, carbon, and oxygen, with very minor to trace signatures from other elements in areas including magnesium, aluminum, silicon, phosphorus, sulfur, chlorine and iron (Figure 78 and Figure 79). In contrast, the discolored surface shows significant signature from silicon, aluminum, and iron, with minor signature due to sodium, phosphorus, sulfur, chlorine, magnesium and titanium, along with potassium and zinc in areas (Figure 80 and Figure 81). The discolored surface is associated with increased levels of silicon, iron, aluminum, titanium, sodium, and other elements. These elements are likely a result of the previous application of a clear penetrating sealer.

*Figure 76. Area of limestone core*

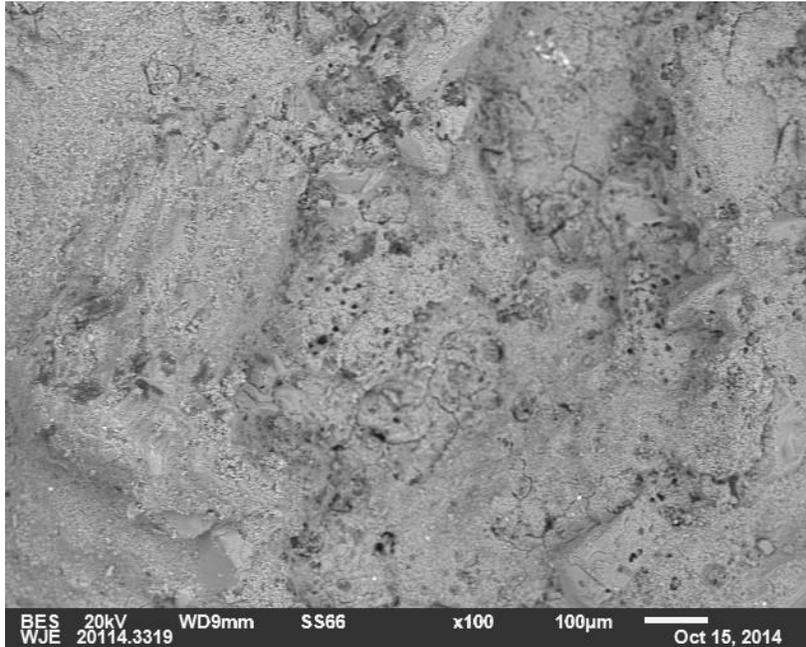
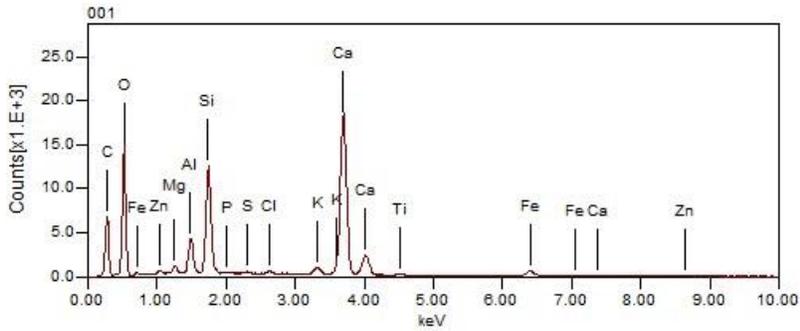
Figure 80. Backscattered electron micrograph and area EDS spectrum of a discolored area of the limestone surface

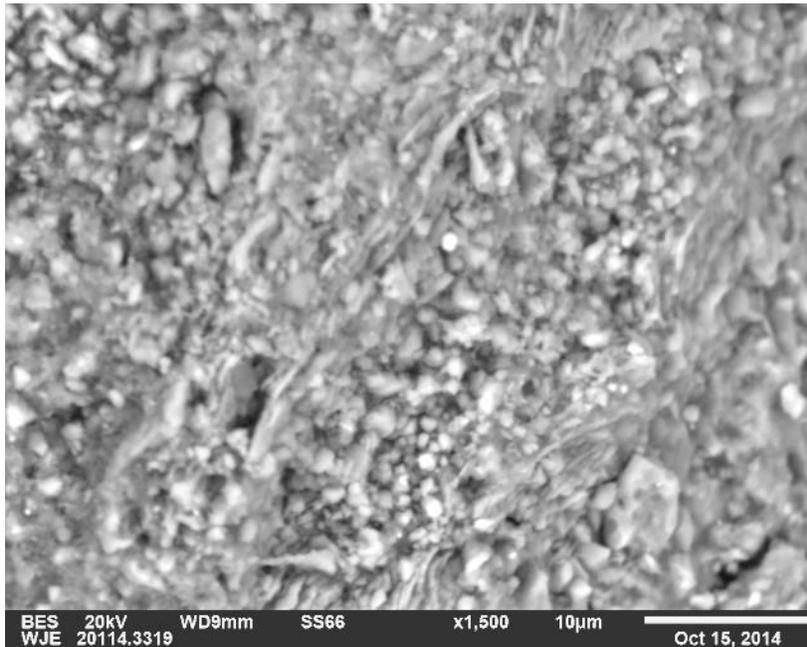
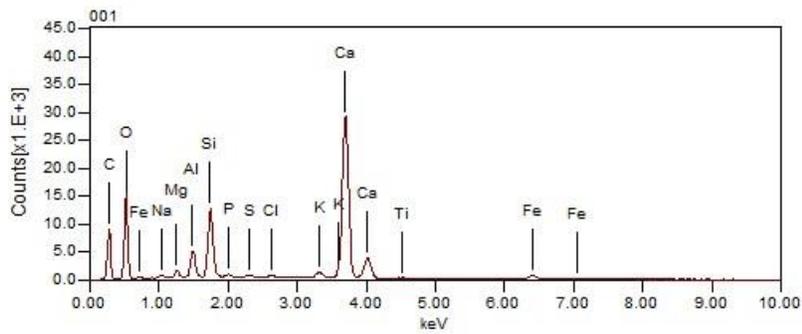
*Figure 81. BE micrograph and area EDS spectrum of a discolored area of the limestone surface*

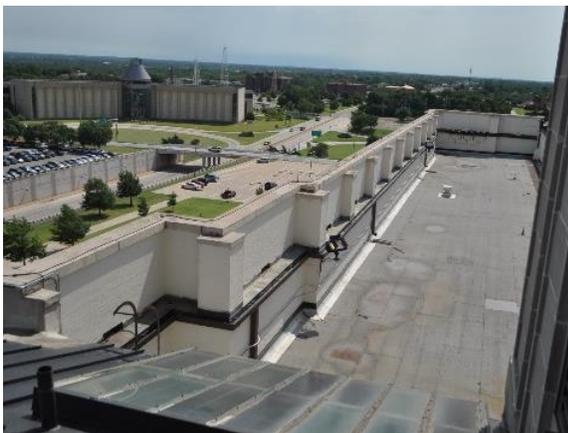
1. The back face of exposed parapet walls are painted (Figure 82). Based on discussions with DCAM, we understand that the back face of the parapet walls was last painted approximately fifteen years ago. Based on conditions observed at inspection openings in the parapet walls, there is at least one additional layer of paint below the exposed coating.

*Figure 82. Overall view of typical parapet wall*

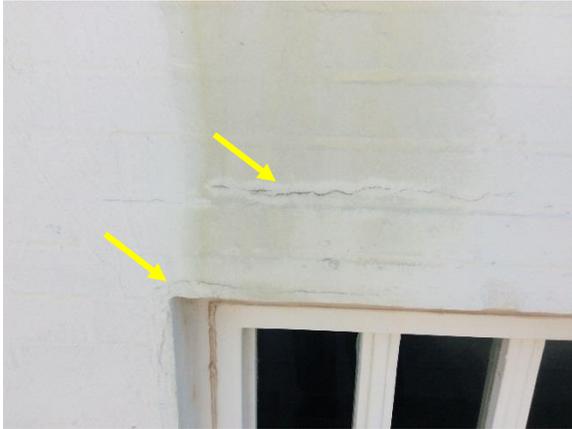
3. Spalled and cracked brick masonry exists above the Senate and House chambers clerestory windows (Figure 84).
4. Diagonal and vertical cracking exists in the back face of brick masonry walls (Figure 85). The cracks generally align closely with scuppers in the upper half of parapet walls, brick masonry piers at the lower half of parapet walls, and lintels above clerestory windows for the legislative chambers.

*Figure 84. Close-up view of spalling and cracking of brick above clerestory windows*

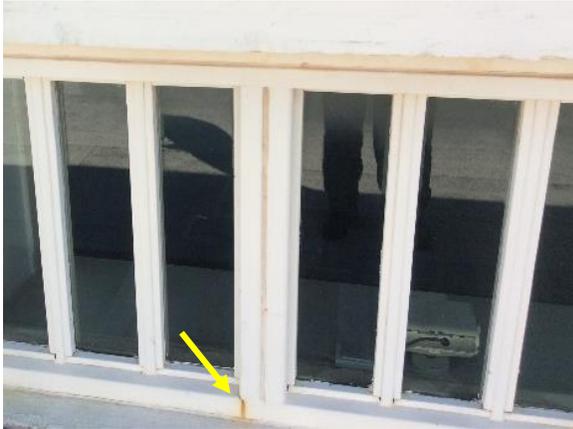
1. The exterior clerestory windows for the House and Senate chambers have painted steel frames and sash with single-pane fixed glass.
2. The House and Senate windows are nearly identical, with the exception that the Senate window openings are approximately 2 feet 3 inches wide, and the House window openings are approximately 6 feet 9 inches wide (Figure 86 and Figure 87).
3. The perimeter sealant is in fair condition. No signs of adhesive or cohesive failure were observed.
4. The roof flashings terminate at the windowsill for both the House and Senate chambers windows. Corrosion stains exist on exposed portions of the sill (Figure 88 and Figure 89).

Figure 88. Corrosion staining at clerestory windowsill

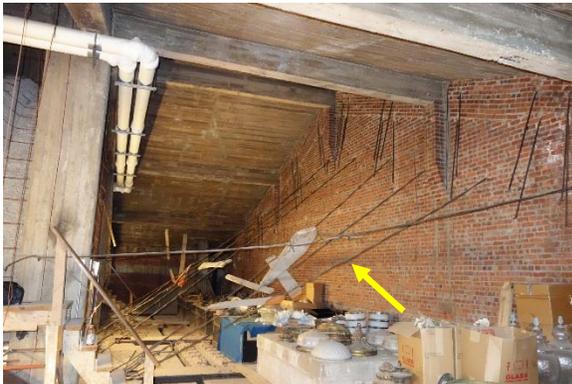
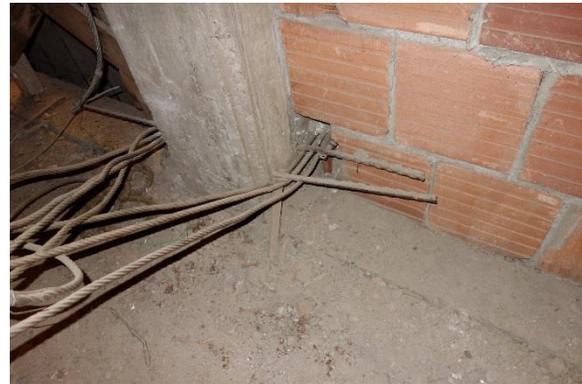
- There are temporary steel cable tiebacks still in place from original construction (Figure 95 and Figure 96). This is evidence that the gable was constructed as a freestanding masonry wall until it reached a point where the top of the wall could be tied back to the reinforced concrete structure.

Figure 95. View of the back side of the south gable showing wire cable ties to concrete structure

Figure 96. Typical tieback of the wire cables to the concrete frame

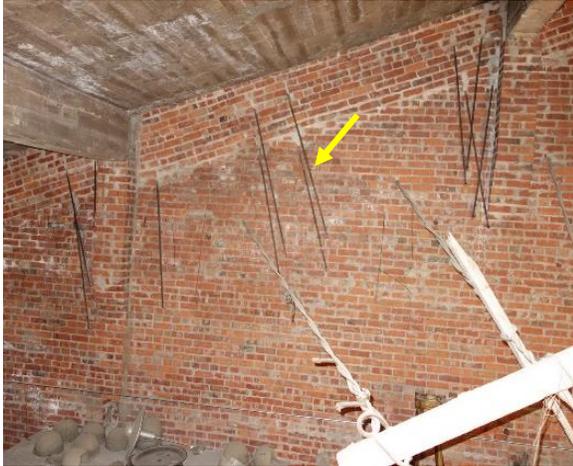
- There are exposed metal anchors that were put in place to laterally support projecting limestone at the top of the pediment (Figure 97). There appear to be two anchors per stone that likely engage the top of each stone unit.

*Figure 97. Metal straps that engage two levels of projecting stone work on the exterior of the south gable*

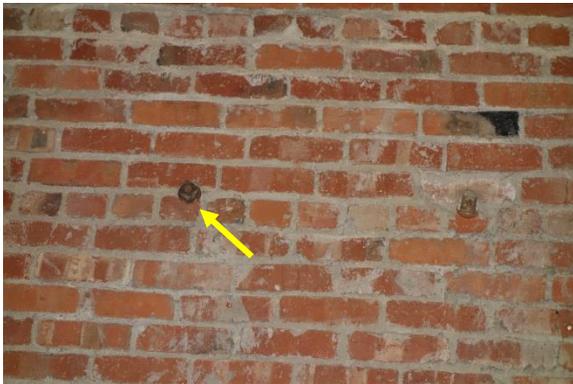
- Brick corbels within the gable wall provide support for the concrete roof beams and the corbel for one of the beams is cracked (Figure 98).
- There are metal through-bolt heads on the interior side of the masonry gable wall (Figure 99). These may be the anchors that tie back the large limestone panels of the pediment that were to be carved *in situ*.

*Figure 99. Through-bolt anchors present on the inside of the south gable wall*

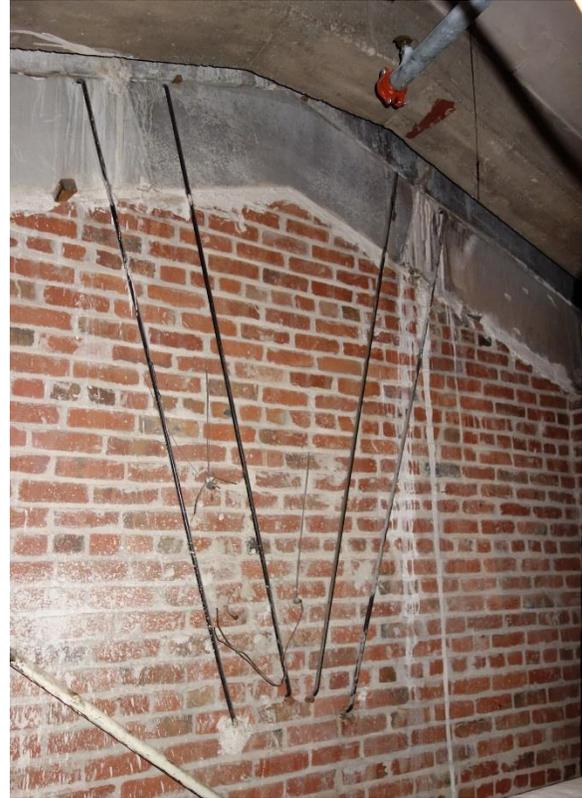
- Exposed metal anchors (similar to the south gable) exist at the back face of the gable wall that provide lateral support for the projecting limestone at the top of the pediment (Figure 102 and Figure 103).
- The brick masonry gable wall is built outboard of the reinforced concrete columns (Figure 104). At these locations, there is cracking that has opened up between the columns and brickwork (Figure 105). Mechanical ties between the brickwork and concrete frame were not observed.
- Gypsum panels exist within the original House chamber skylight openings. Cracks exist in a few of the gypsum panels. (Figure 106).

*Figure 102. The metal straps that engage projecting limestone on the exterior of the west gable (right)*

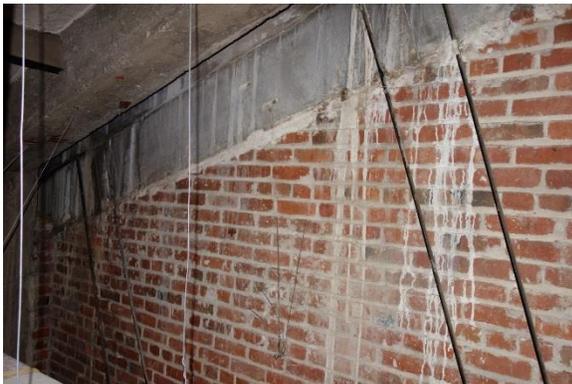
*Figure 104. The masonry wall is constructed outboard of the concrete frame by 4 inches (right).*

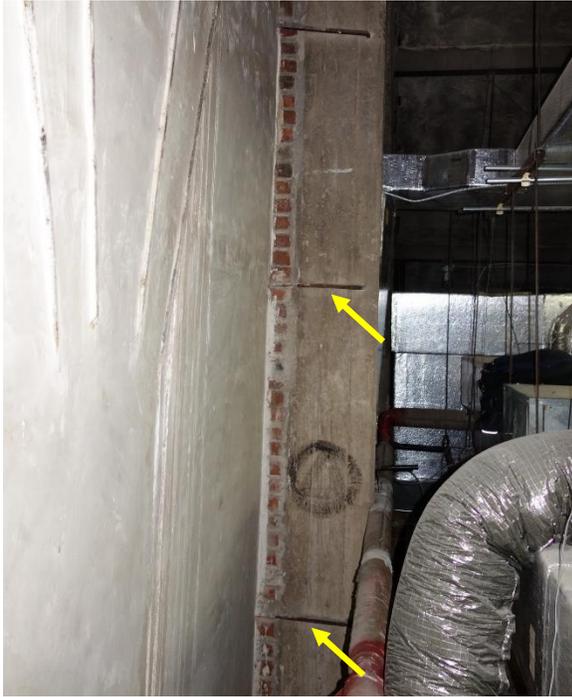
- This gable wall differs from the other gable walls in that the inside face of the wall is finished with rough plaster. Exposed metal anchors (similar to the south gable) are visible at the inside face of the plaster finish (Figure 108).
- The brick masonry gable wall is built outboard of the reinforced concrete columns. Metal anchors laid within the brickwork partially wrap and engage the concrete columns (Figure 109).

*Figure 109. Metal anchors that connect the masonry of the east gable to the concrete frame*

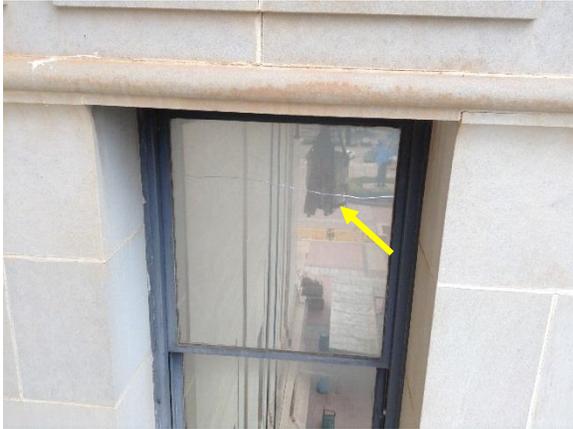
2. Broken glass exists at various windows (Figure 111 and Figure 112).
3. The window frames are painted with multiple layers of paint (described in further detail below).

Figure 111. Broken glass

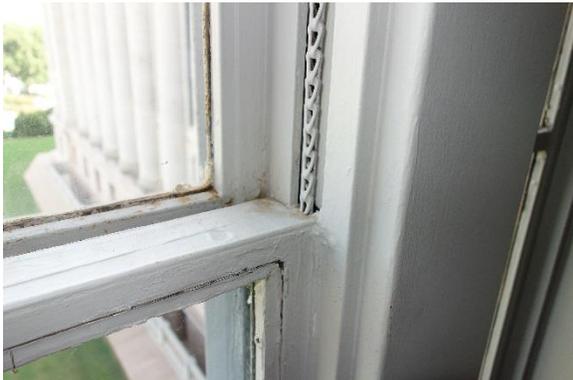
4. The existing coatings have areas of peeling and blistering, and surface corrosion exists on the underlying metal.
5. Interior hardware, such as operating handles and locks, has typically been removed and painted shut (Figure 113).

Figure 113. Typical interior condition of the double-hung windows (above)

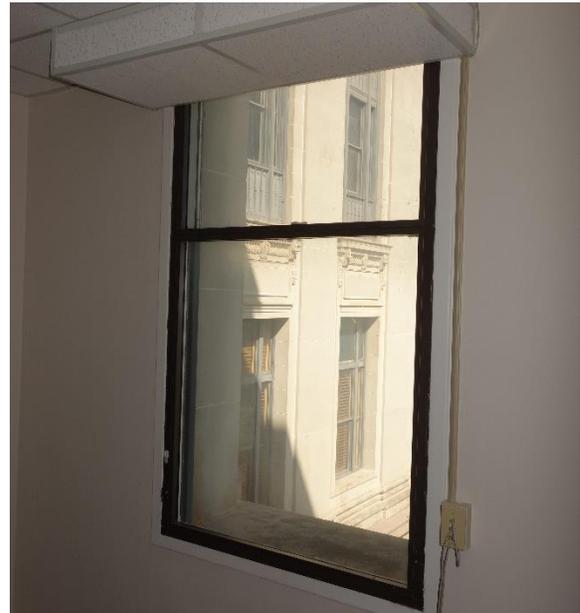
6. Many of the original windows have applied interior aluminum storm windows. The storm window frame profile and center horizontal rail generally match the profile of the original sash and meeting stile (Figure 114).

Figure 114. A window with an interior fixed storm window applied (right) and suspended ceiling blocking access to the upper sash

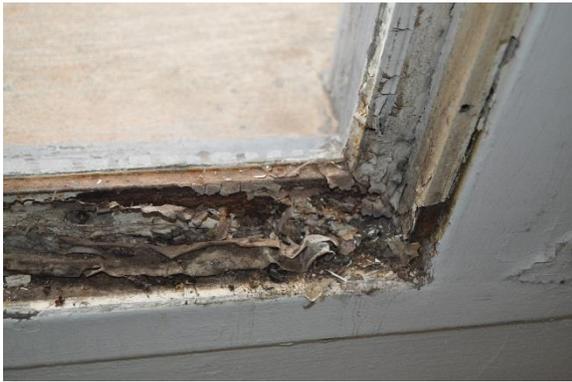
1. The interior storm windows, where they have been installed, have caused damage due to the capture of condensation between the windows and consequent corrosion of the original window frames and sash at the sill (Figure 115).
2. The sash are not easily removed due to corrosion of the parting stops and fasteners (Figure 116).
3. The counterweights do not come out easily (Figure 117).

*Figure 115. Advanced deterioration and corrosion of the original lower sash and the frame sill (above)*

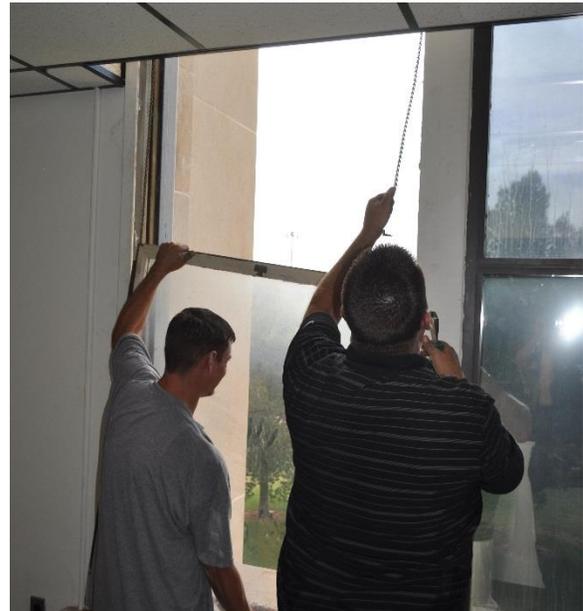
*Figure 116. Removal of the upper sash still connected to the counterweight chain (right)*

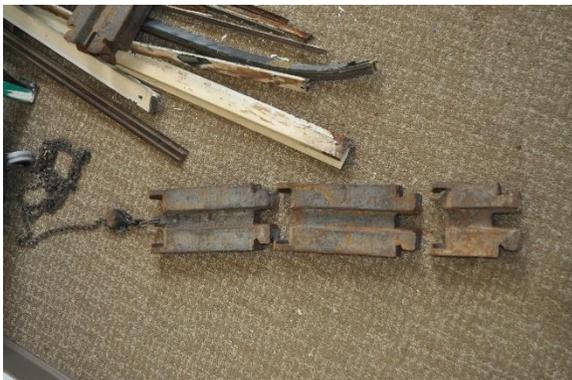
*Figure 117. Sash counterweights made of pig iron*

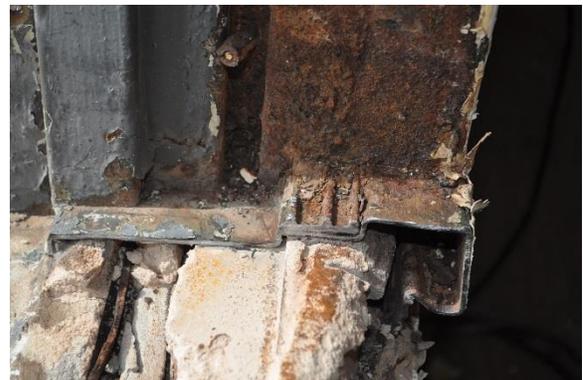
4. Cast iron, rolled steel, break metal steel, and brass components are found in the window systems as specified (Figure 118).
5. The rolled steel sash (Figure 119) and break metal steel sill (Figure 120 through Figure 122) have been repaired with a metal repair putty (filler). The filler was easily removed and not well bonded to the original steel.
6. The steel frames can easily detach from the cast iron but are laid into the surrounding masonry, making the removal of the frames impossible without cutting the frame.
7. The plaster end bead is attached directly to window frame on the interior so some plaster removal is required to remove the window frame (Figure 123).

*Figure 118. Section cut at the steel sill*

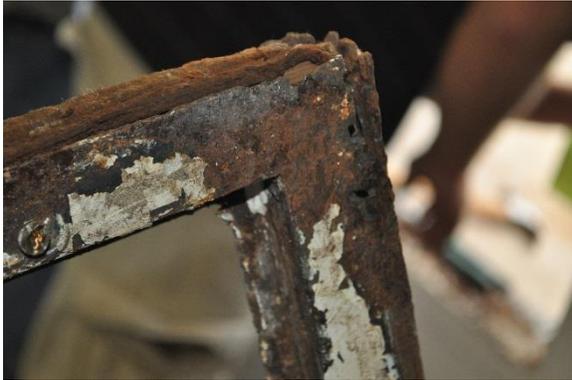
*Figure 119. View of the bottom portion of the lower sash*

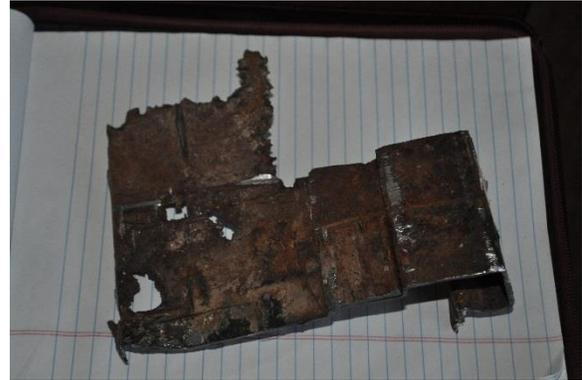
*Figure 120. A portion of the corroded break metal steel sill*

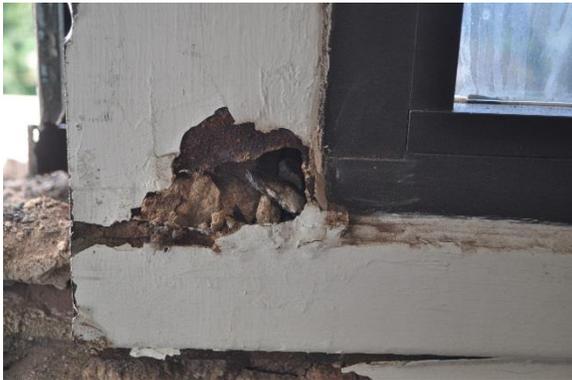
*Figure 121. Corrosion of mullion between window sash*

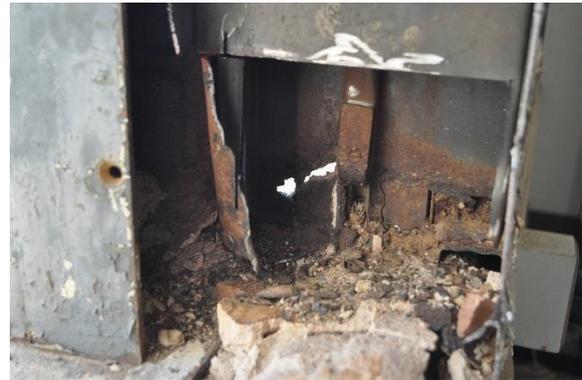
*Figure 122. View within the mullion between the two windows*

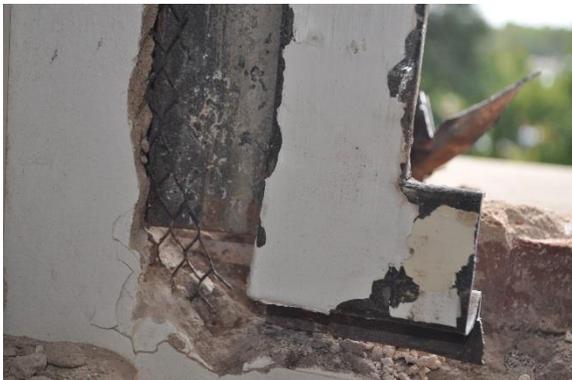
*Figure 123. Close-up view of the left sill*

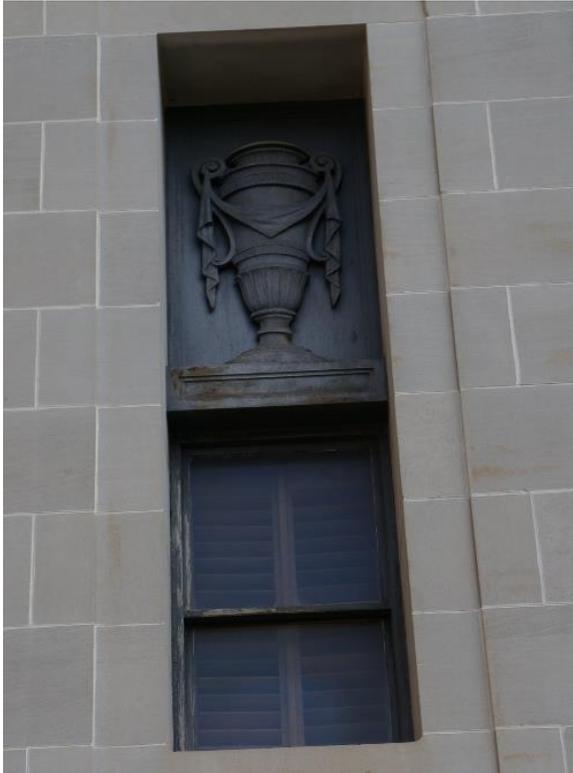
The window sash, frames, doors, and spandrels are ferrous metal, a combination of steel and cast iron, all are coated with a gray-colored coating (Figure 124 through Figure 126). Typically, the coating is moderately chalked with isolated peeling paint. The base metal exhibits some isolated spot surface corrosion (Figure 127). Dry Coating thickness was measured by magnetic gauge per ASTM D7091, *Standard Practice for Nondestructive Measurement of Dry Film Thickness of Nonmagnetic Coatings Applied to Ferrous Metals and Nonmagnetic, Nonconductive Coatings Applied to Non-Ferrous Metals*. The results are summarized in Table 3.

*Figure 124. Typical coating at window framing*

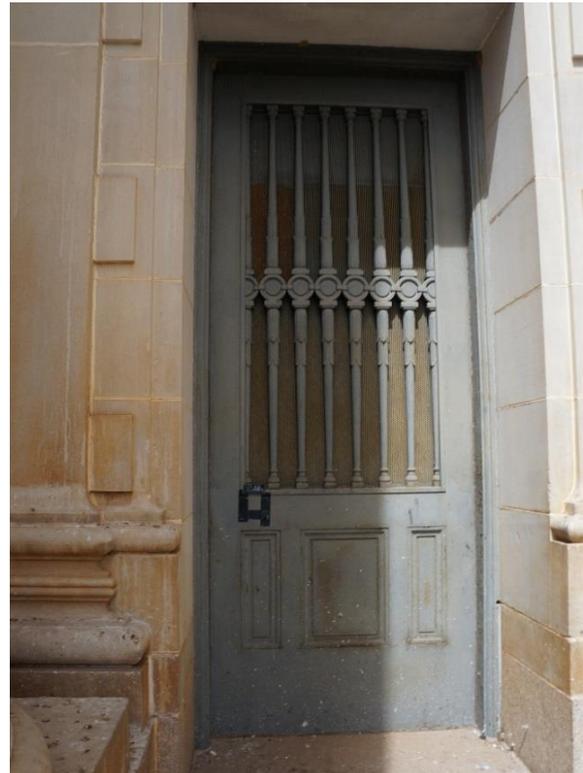
*Figure 125. Typical door coating*

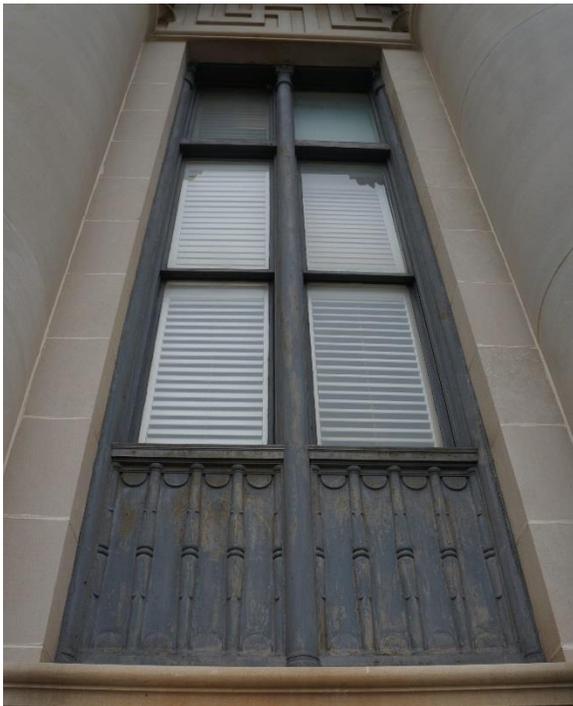
*Figure 126. Typical view of coating at window and spandrel (left)*

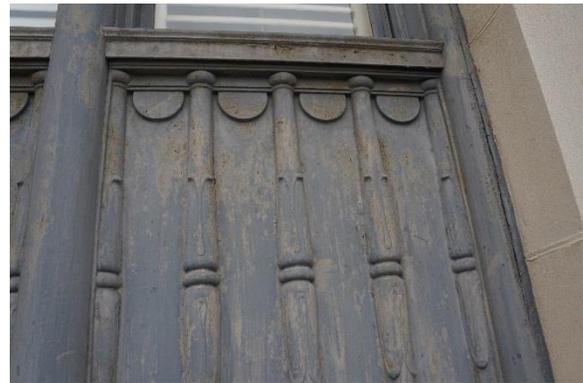
*Figure 127. Close-up view of surface corrosion at coated spandrel (above)*

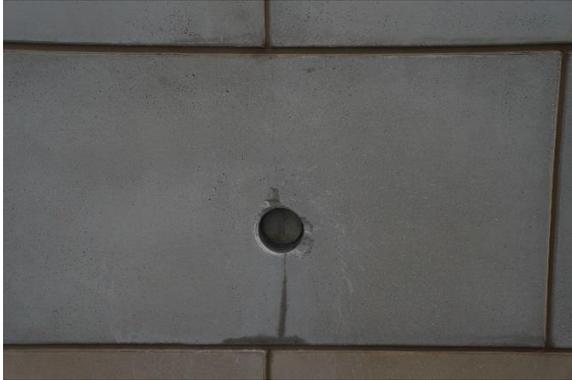
2. With assistance from a masonry contractor, a 3 inch diameter core was made through a vertical crack at one location near the northwest corner of the dome platform, and it was determined that the crack continues through the full thickness of the cast stone unit (Figure 133 and Figure 134).

*Figure 133. Overall view of core removed from cast stone crack location*

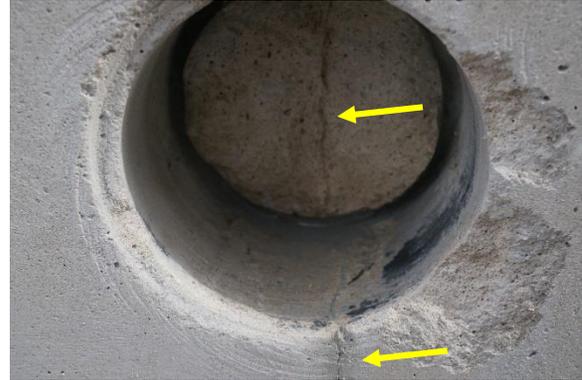
*Figure 134. Close-up view of cast stone core removed from cast stone crack location*

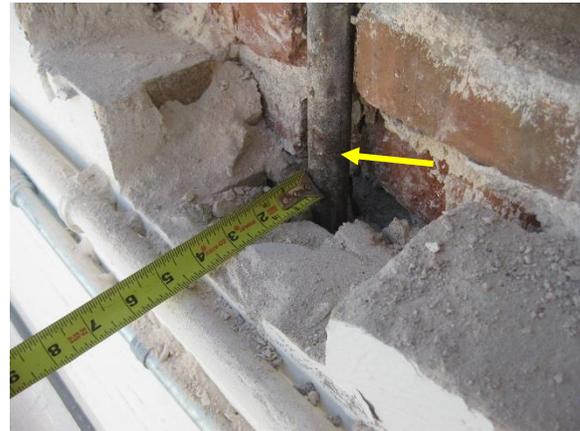
*Figure A2. Cornice anchor rod*

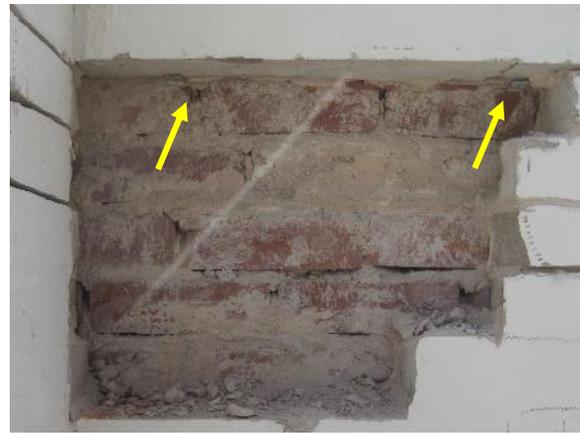
- Located in back face of the parapet adjacent to a brick masonry pilaster (Figure A4).
- Corrugated galvanized steel ties exist between the inner wythes of brick masonry (Figure A5). The ties are spaced 16 inches apart horizontally. Some minor corrosion exists on the surface of exposed ties. The ties engage less than one third of the brick unit.
- The wall is constructed with header units located at approximately 16 inch centers each way (horizontally and vertically).
- Header units do not exist between the pilaster and inner wythes of parapet wall
- Brick masonry within the pilaster is not integrally, reliably tied to back face of parapet wall (Figure A6).

*Figure A5. Galvanized ties within brick masonry*

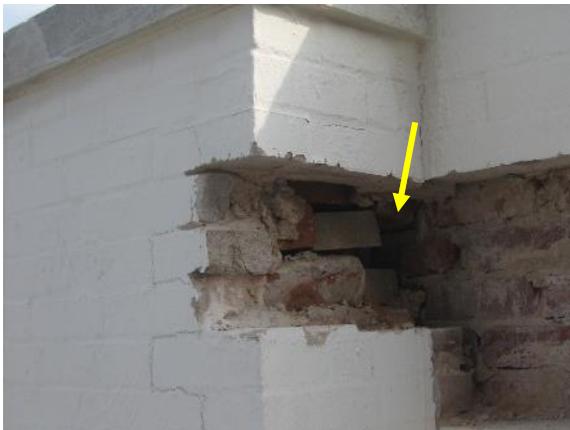
*Figure A6. Lack of tie between pilaster and wall*
