## OKLAHOMA STATE CAPITOL Exterior Facade Investigation

### **Final Report**

December 18, 2014  
WJE No. 2014.3319

#### **Wiss, Janney, Elstner Associates, Inc.**

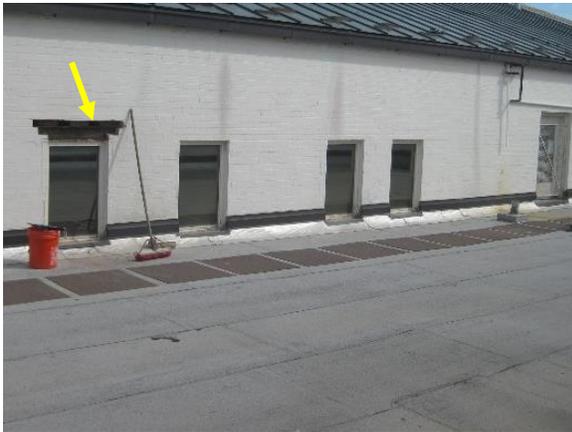
*Figure A7. Overall view of location of Inspection Opening No. 3*

- Located in brick masonry above steel-framed window toward east end of Senate chamber (Figure A7). The brick masonry was hollow-sounding and mortar joints between brick units are cracked.
- Lintel that supports masonry above the window consists of a loose-laid steel beam, 6 inch deep web and 3-1/4 inch wide flanges.
- The outer wythe of brick above the window has approximately 1 inch of brick bearing on the bottom flange of the steel lintel (Figure A8).
- Two square-headed bolts exist in the web of the steel lintel; the bolts do not engage anything on the inside face of the wall (Figure A9).
- Corrosion scale estimated to be 1/8 inch thick observed on the top face of the bottom flange.

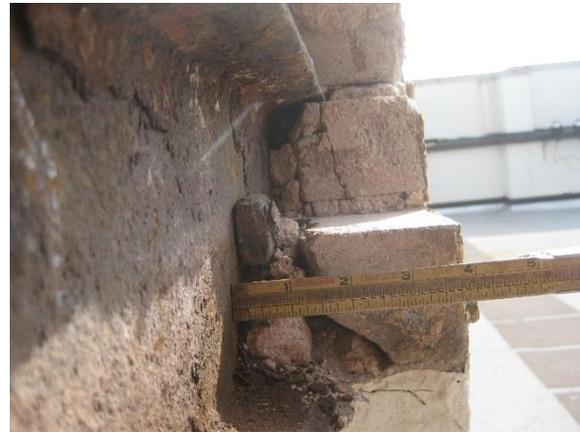
*Figure A8. Bearing of brick on lintel below*

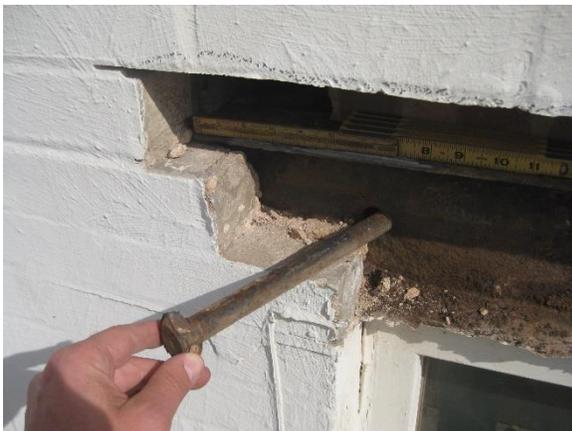
*Figure A9. Unengaged bolt at lintel*

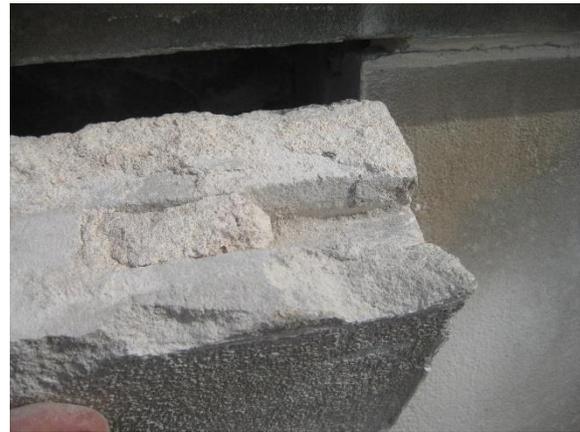
*Figure A11. Lack of strap anchor within opening*

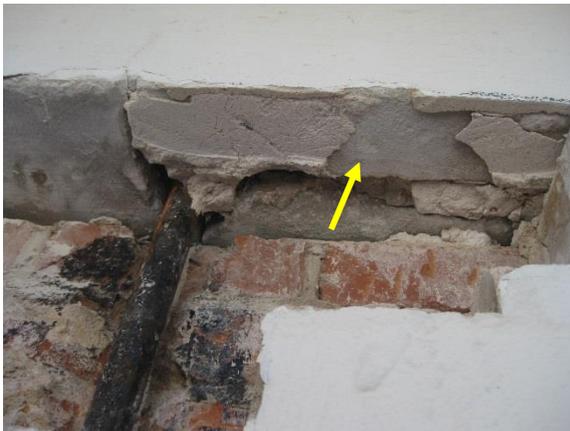
- Located in back face of brick masonry parapet below a dutchman in the back face of limestone cornice.
- The dutchman unit is approximately 3 inches thick, 1 foot 2 inches tall, and 3 feet 3 inches long (Figure A12).
- The cornice anchor consists of 1-1/8 inch diameter mild steel rod; rod aligns with joints between cornice units. The rod is located approximately 4 inches from the back face of the wall and falls within the collar joint between the inner-most wythes of brick masonry.
- Minor surface corrosion exists on the surface of the rod (Figure A13).
- Corrugated galvanized wall ties exist between the inner wythes of brick masonry in the parapet wall below the coping. No corrosion exists on the wall ties, which are spaced 16 inches apart horizontally. The ties engage less than one third of the brick unit at the back face of the wall (Figure A14).

*Figure A12. Dutchman unit above inspection opening*

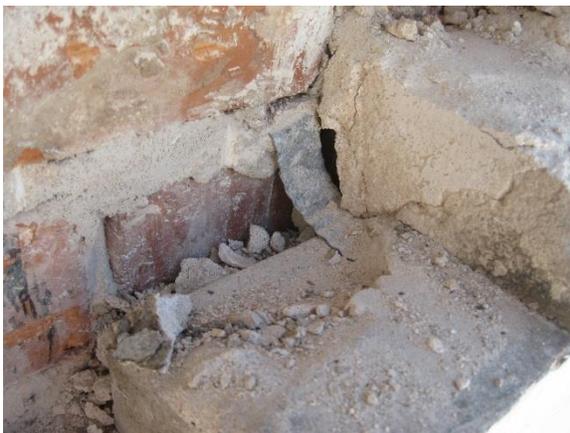
*Figure A14. Typical corrugated masonry tie*

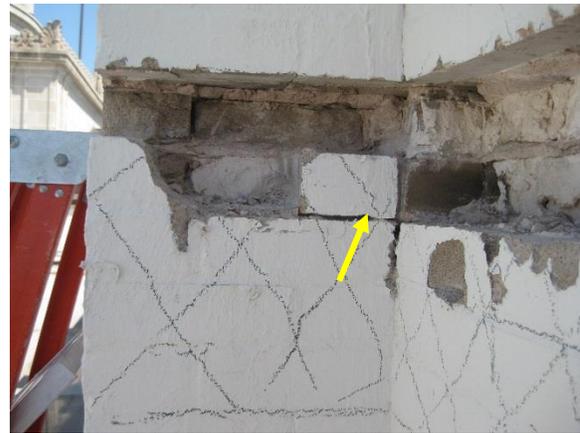
- Located in back face of parapet adjacent to brick masonry pilaster (Figure A15).
- The outer wythes of brick masonry are tied at alternating courses (Figure A16).
- No ties observed between brick header units between the pilaster and inner wythes of parapet wall. Header units are partially obscured by the coating (paint) on the back face of the parapet wall but appear to be spaced at 16 inch centers each way.

*Figure A16. Brick masonry header unit*

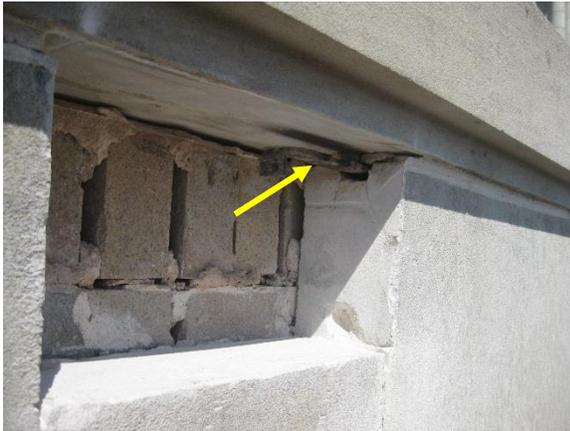
- Surface corrosion exists on the surface of the cramp anchor (Figure A18). The limestone is cracked near the edges of the existing kerf.
- Spalls exist at the outside face of the limestone parapet wall on the south face of the west wing. Spalls only exist where there are cramps between adjacent panels.

*Figure A17. Cramp anchor*

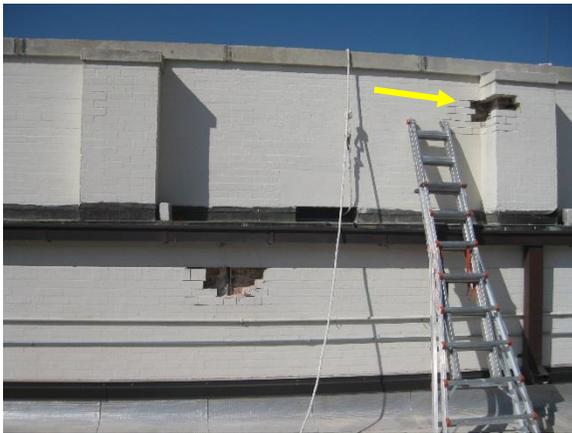
*Figure A22. Overall view of location of Inspection Opening No. 10 (arrow)*

- Located in back face of the parapet adjacent to a brick masonry pilaster near the east end of the roof (Figure A22).
- The outer wythe of the pilaster is tied to the outer wythe of the parapet wall, however, brick masonry within the pilaster was loosely placed at the time of original construction and is not reliably tied to back face of parapet wall (Figure A23).

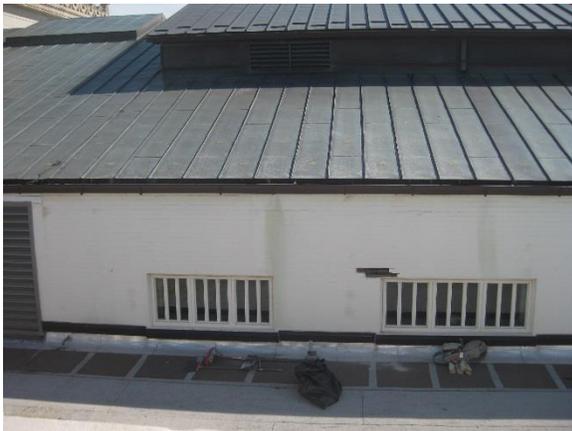
*Figure A24. Overall view of location of Inspection Opening No. 11*

- Located in brick masonry above steel-framed window toward east end of House chamber (Figure A24). The opening was made to assess concealed conditions at a location with no visible distress.
- Lintel that supports masonry above the window consists of a loose-laid steel beam, 6 inch deep web and 3-1/4 inch wide flanges. The bearing length for the lintel on the masonry pier at the east end of the window opening is estimated to be 9 inches.
- The outer wythe of brick above the window has less than 1 inch of brick bearing on the bottom flange of the steel lintel (Figure A25).
- Two square-headed bolts exist in the web of the steel lintel; the bolts do not engage anything on the inside face of the wall (Figure A26).
- Minor surface corrosion exists on the outside surfaces of the steel lintel.

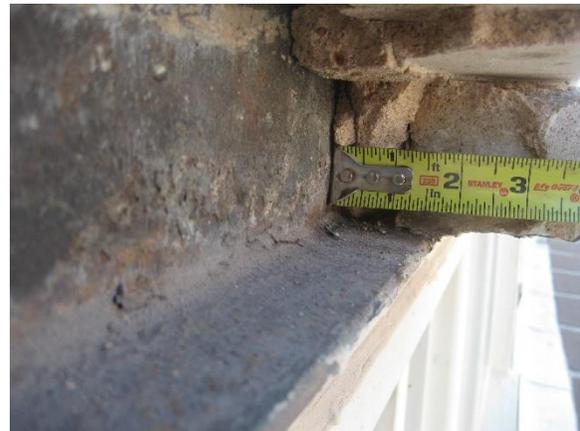
*Figure A25. Bearing of brick on lintel*

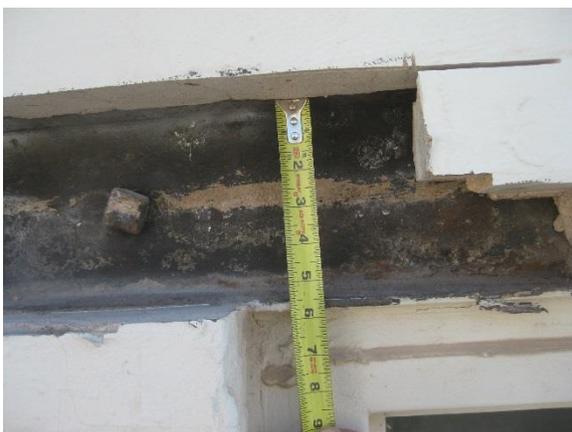
*Figure A26. Unengaged bolt at lintel*

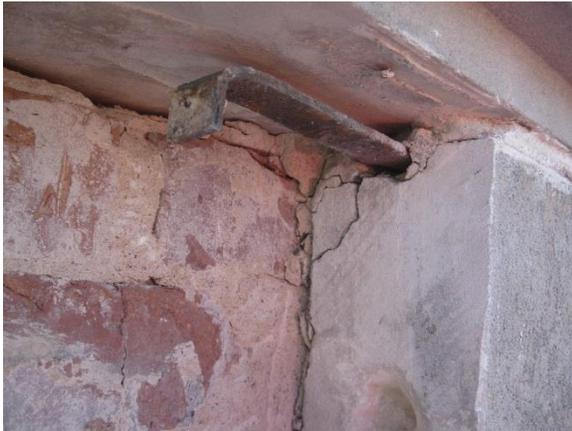
- Located in the top edge of a limestone ashlar near the east end of the west wing on the north facade. The location was selected to document the condition of the concealed mild steel anchor at a limestone panel where a mortar patch was observed during our close-up inspection.
- A mild steel cramp anchor exists between adjacent limestone panels (Figure A27). Surface corrosion exists on the anchor and the limestone is cracked at the back face of the limestone panel.
- No strap exists between the limestone panel and the brick masonry back-up.

*Figure A27. Cramp anchor between limestone panels*

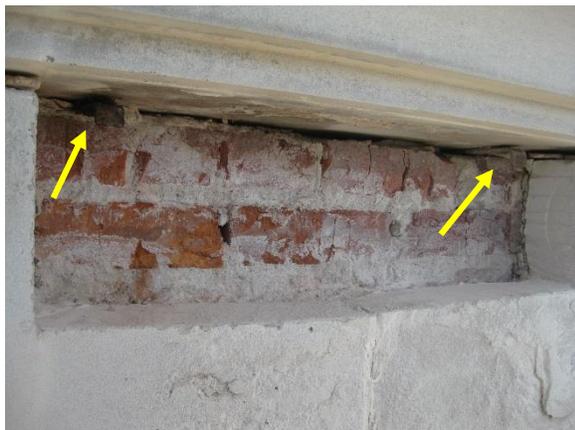
- Strap anchors exist near the edge of each panel near the opening. The strap anchors are set in the brick masonry backup are located approximately 12 inches from the vertical joint between panels (Figure A31). Corrosion scale accumulation on each strap varies between 1/16 inch and 1/8 inch.

*Figure A31. Strap anchors set in brick masonry backup*

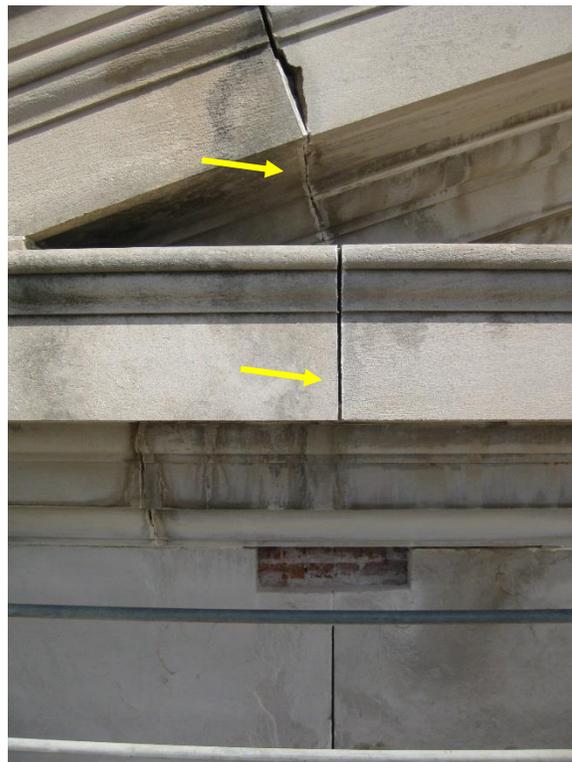
*Figure A32. Open mortar joints above inspection opening*

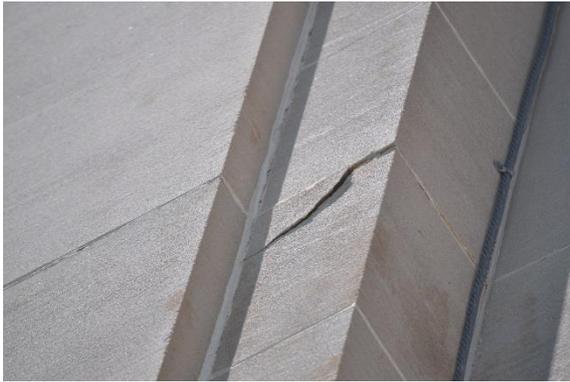
*Figure A33. Location of Inspection Opening No. 15*

- Located on the east face of the pilaster at the southwest corner of the building. The location was selected to document the condition of the concealed mild steel anchor at a limestone panel where a spall was observed during our close-up inspection (Figure A33).
- A mild steel cramp exists between the pilaster and adjacent “jamb” ashlar (Figure A34). The anchor is approximately 1/8 thick and estimated to be 10 inches long. Surface corrosion exists on the surface of the mild steel anchor.

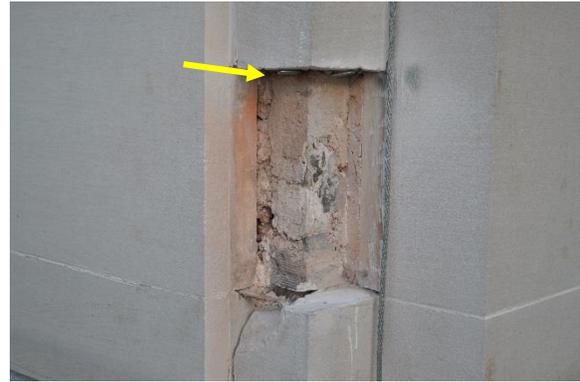
*Figure A34. Anchor within jamb unit*

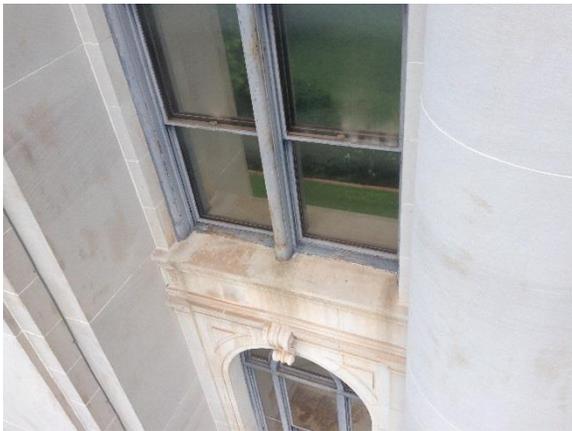
*Figure A35. Overall view of location of Inspection Opening No. 16*

- Located in the limestone spandrel between the second and third floor, at the southwest corner of the building. The location was selected to document the condition of the concealed mild steel strap anchors at a limestone panel with no visible signs of distress (Figure A35).
- The spandrel consists of three limestone ashlars, each 12 inches high and 4 inches thick. The center panel is approximately 4 feet long and the two outer panels are each approximately 2 feet long.
- The center spandrel panel was removed to review concealed conditions. The limestone was installed with one strap anchor at the left (west) side of the panel (Figure A36). Very minor surface corrosion exists on the concealed strap anchor. A strap does not exist at the right (east) side of the panel (Figure A37).
- Remnants of sealant exist at the outside face of the horizontal mortar at the top of the panel.

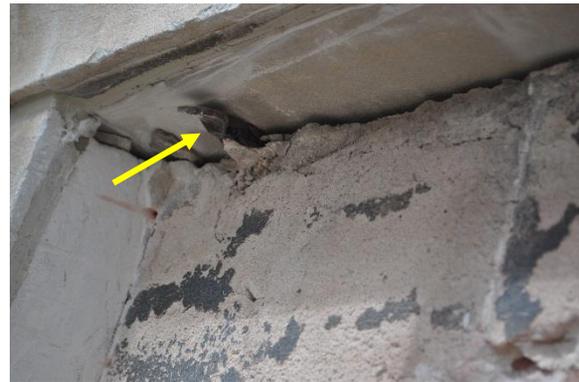
*Figure A36. Strap anchor within opening*

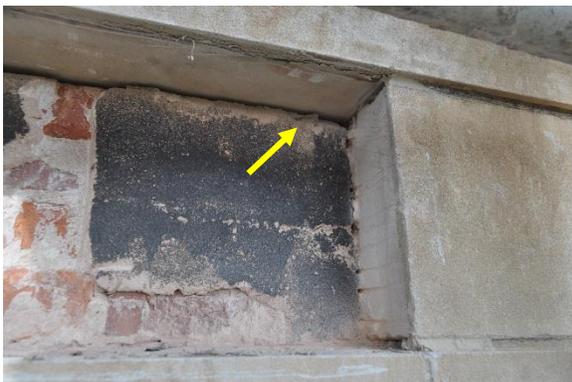
*Figure A37. Lack of strap anchor within opening*

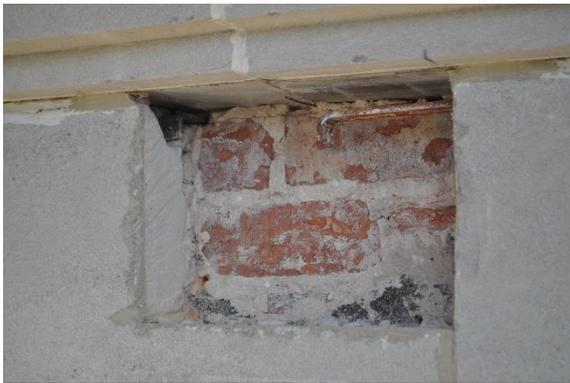
- A mild steel cramp exists between adjacent limestone panels. Very minor surface corrosion exists on the surface of the cramp anchor and the original primer paint is visible on the surface of the mild steel anchor (Figure A38).

*Figure A38. Surface corrosion on cramp anchor*

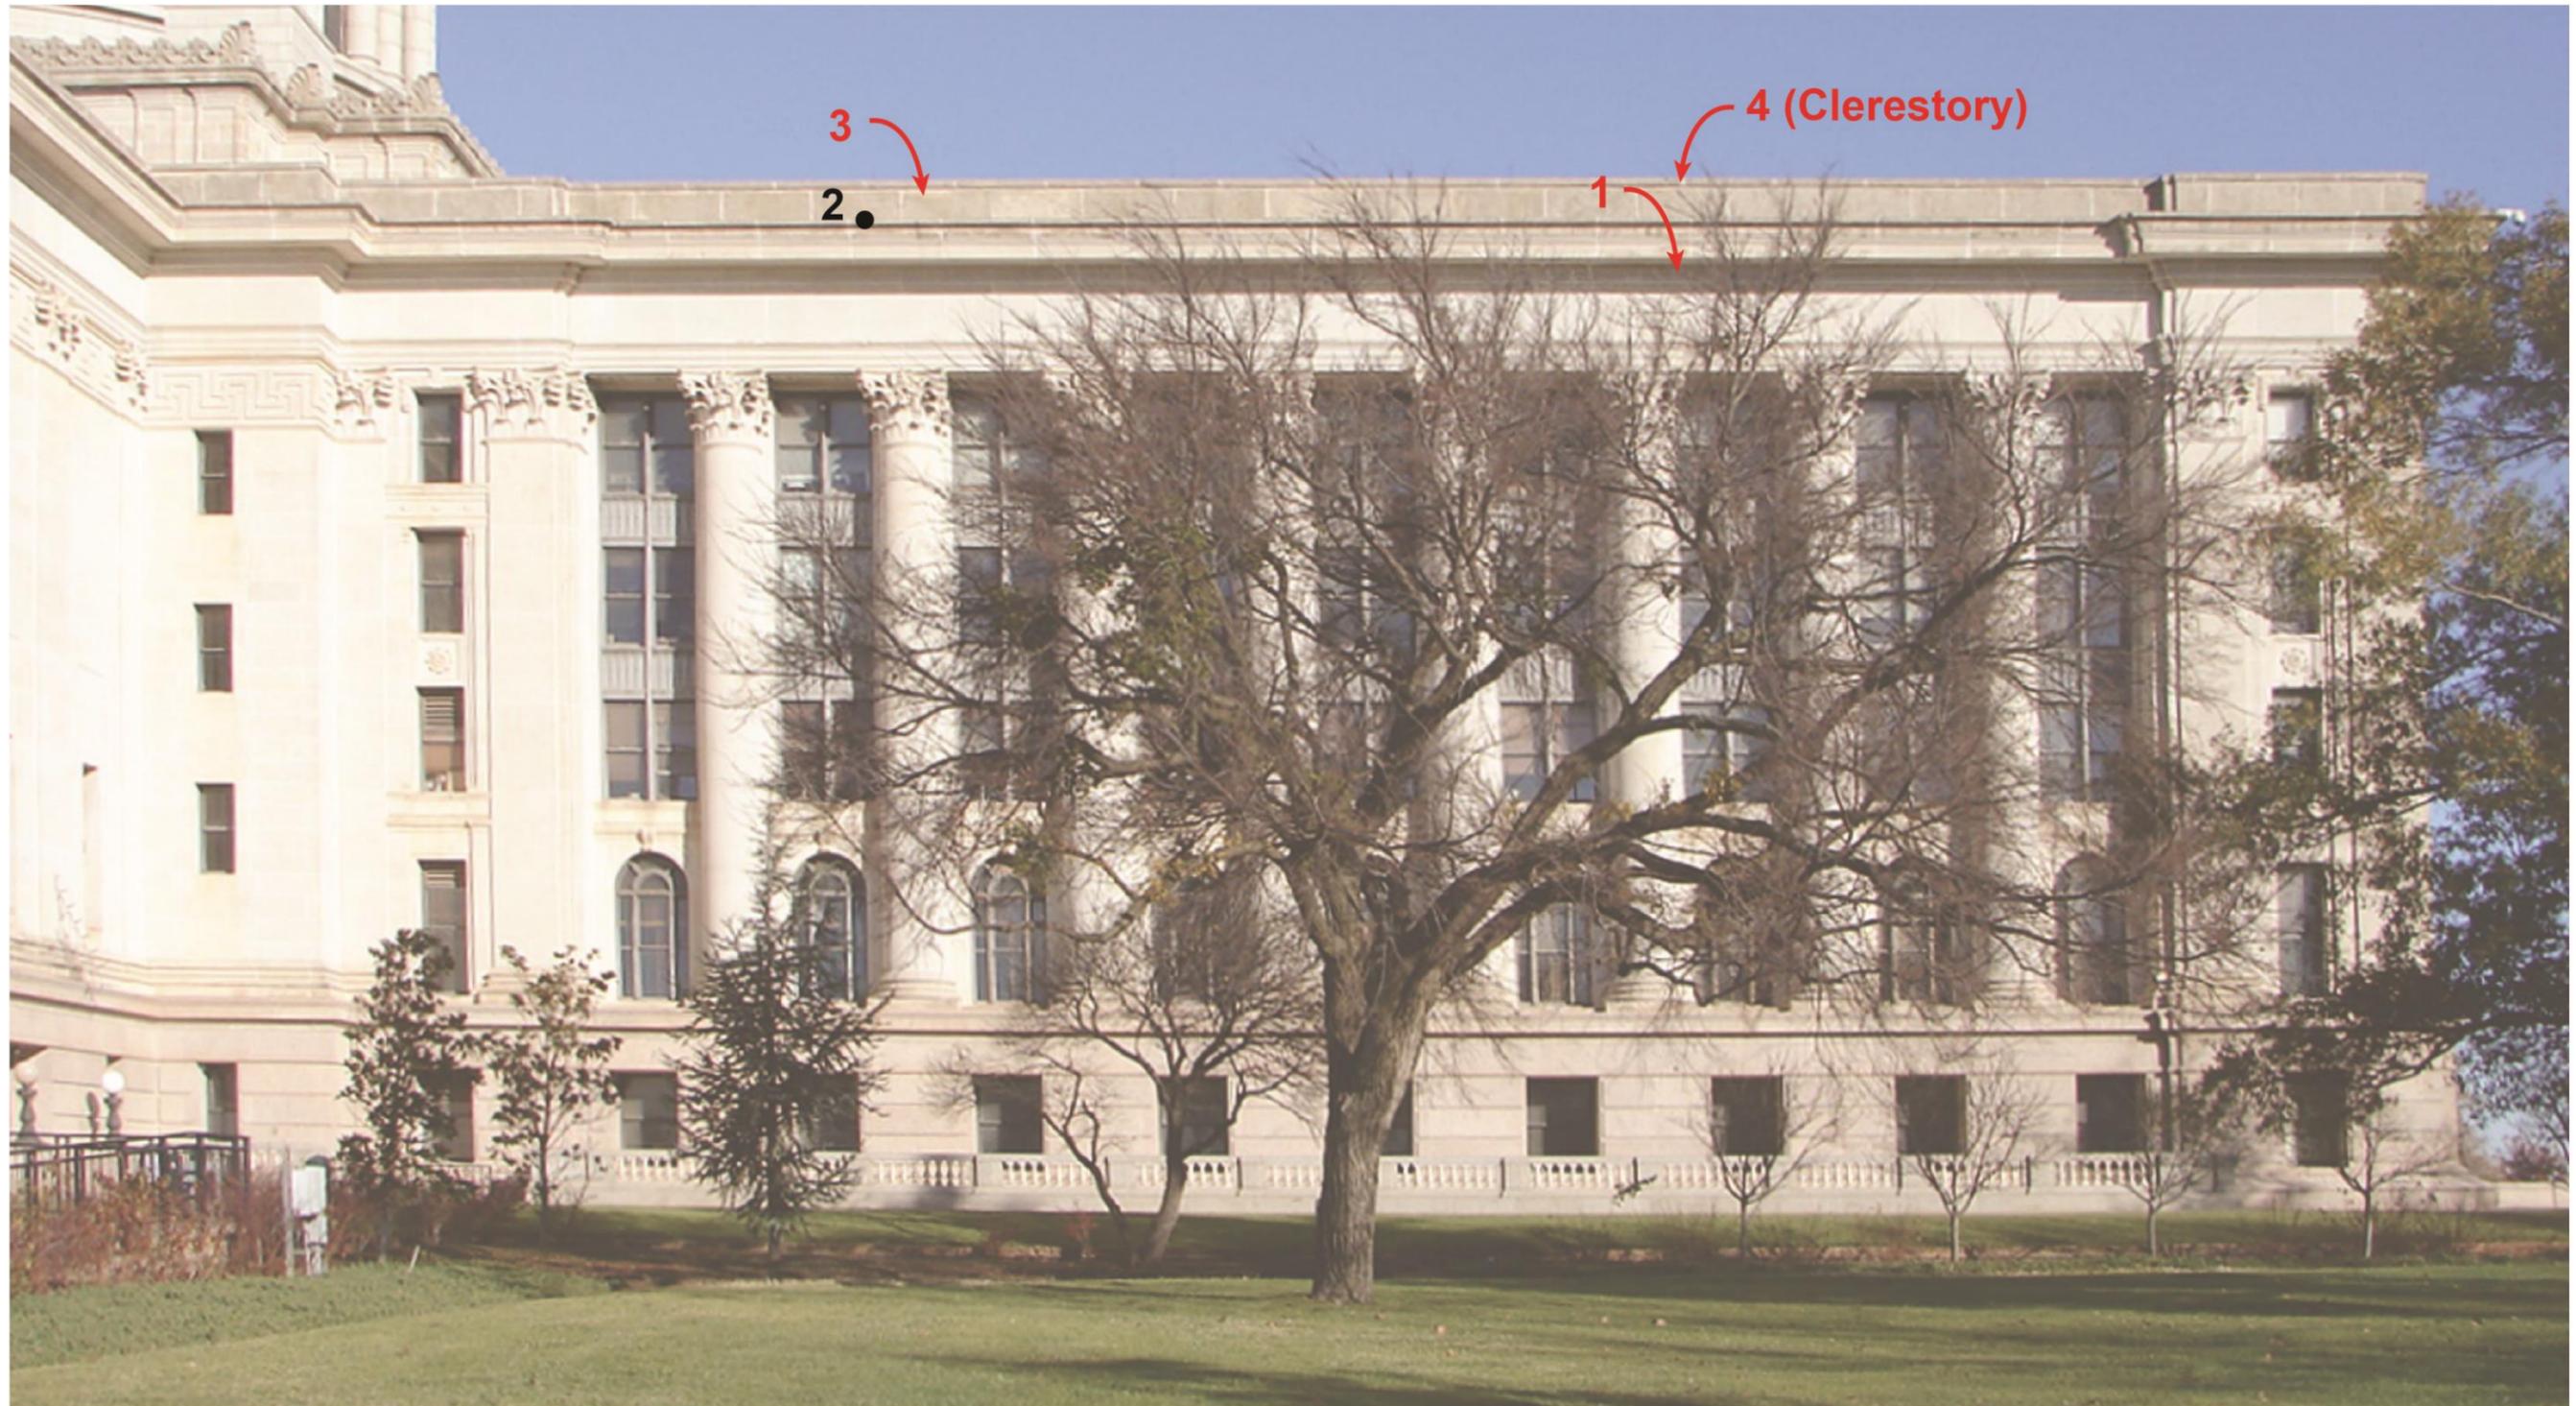
Figure A39. Photograph of south facade, east wing, showing locations of inspection openings. Inspection openings noted in red are on the back face of the facade.

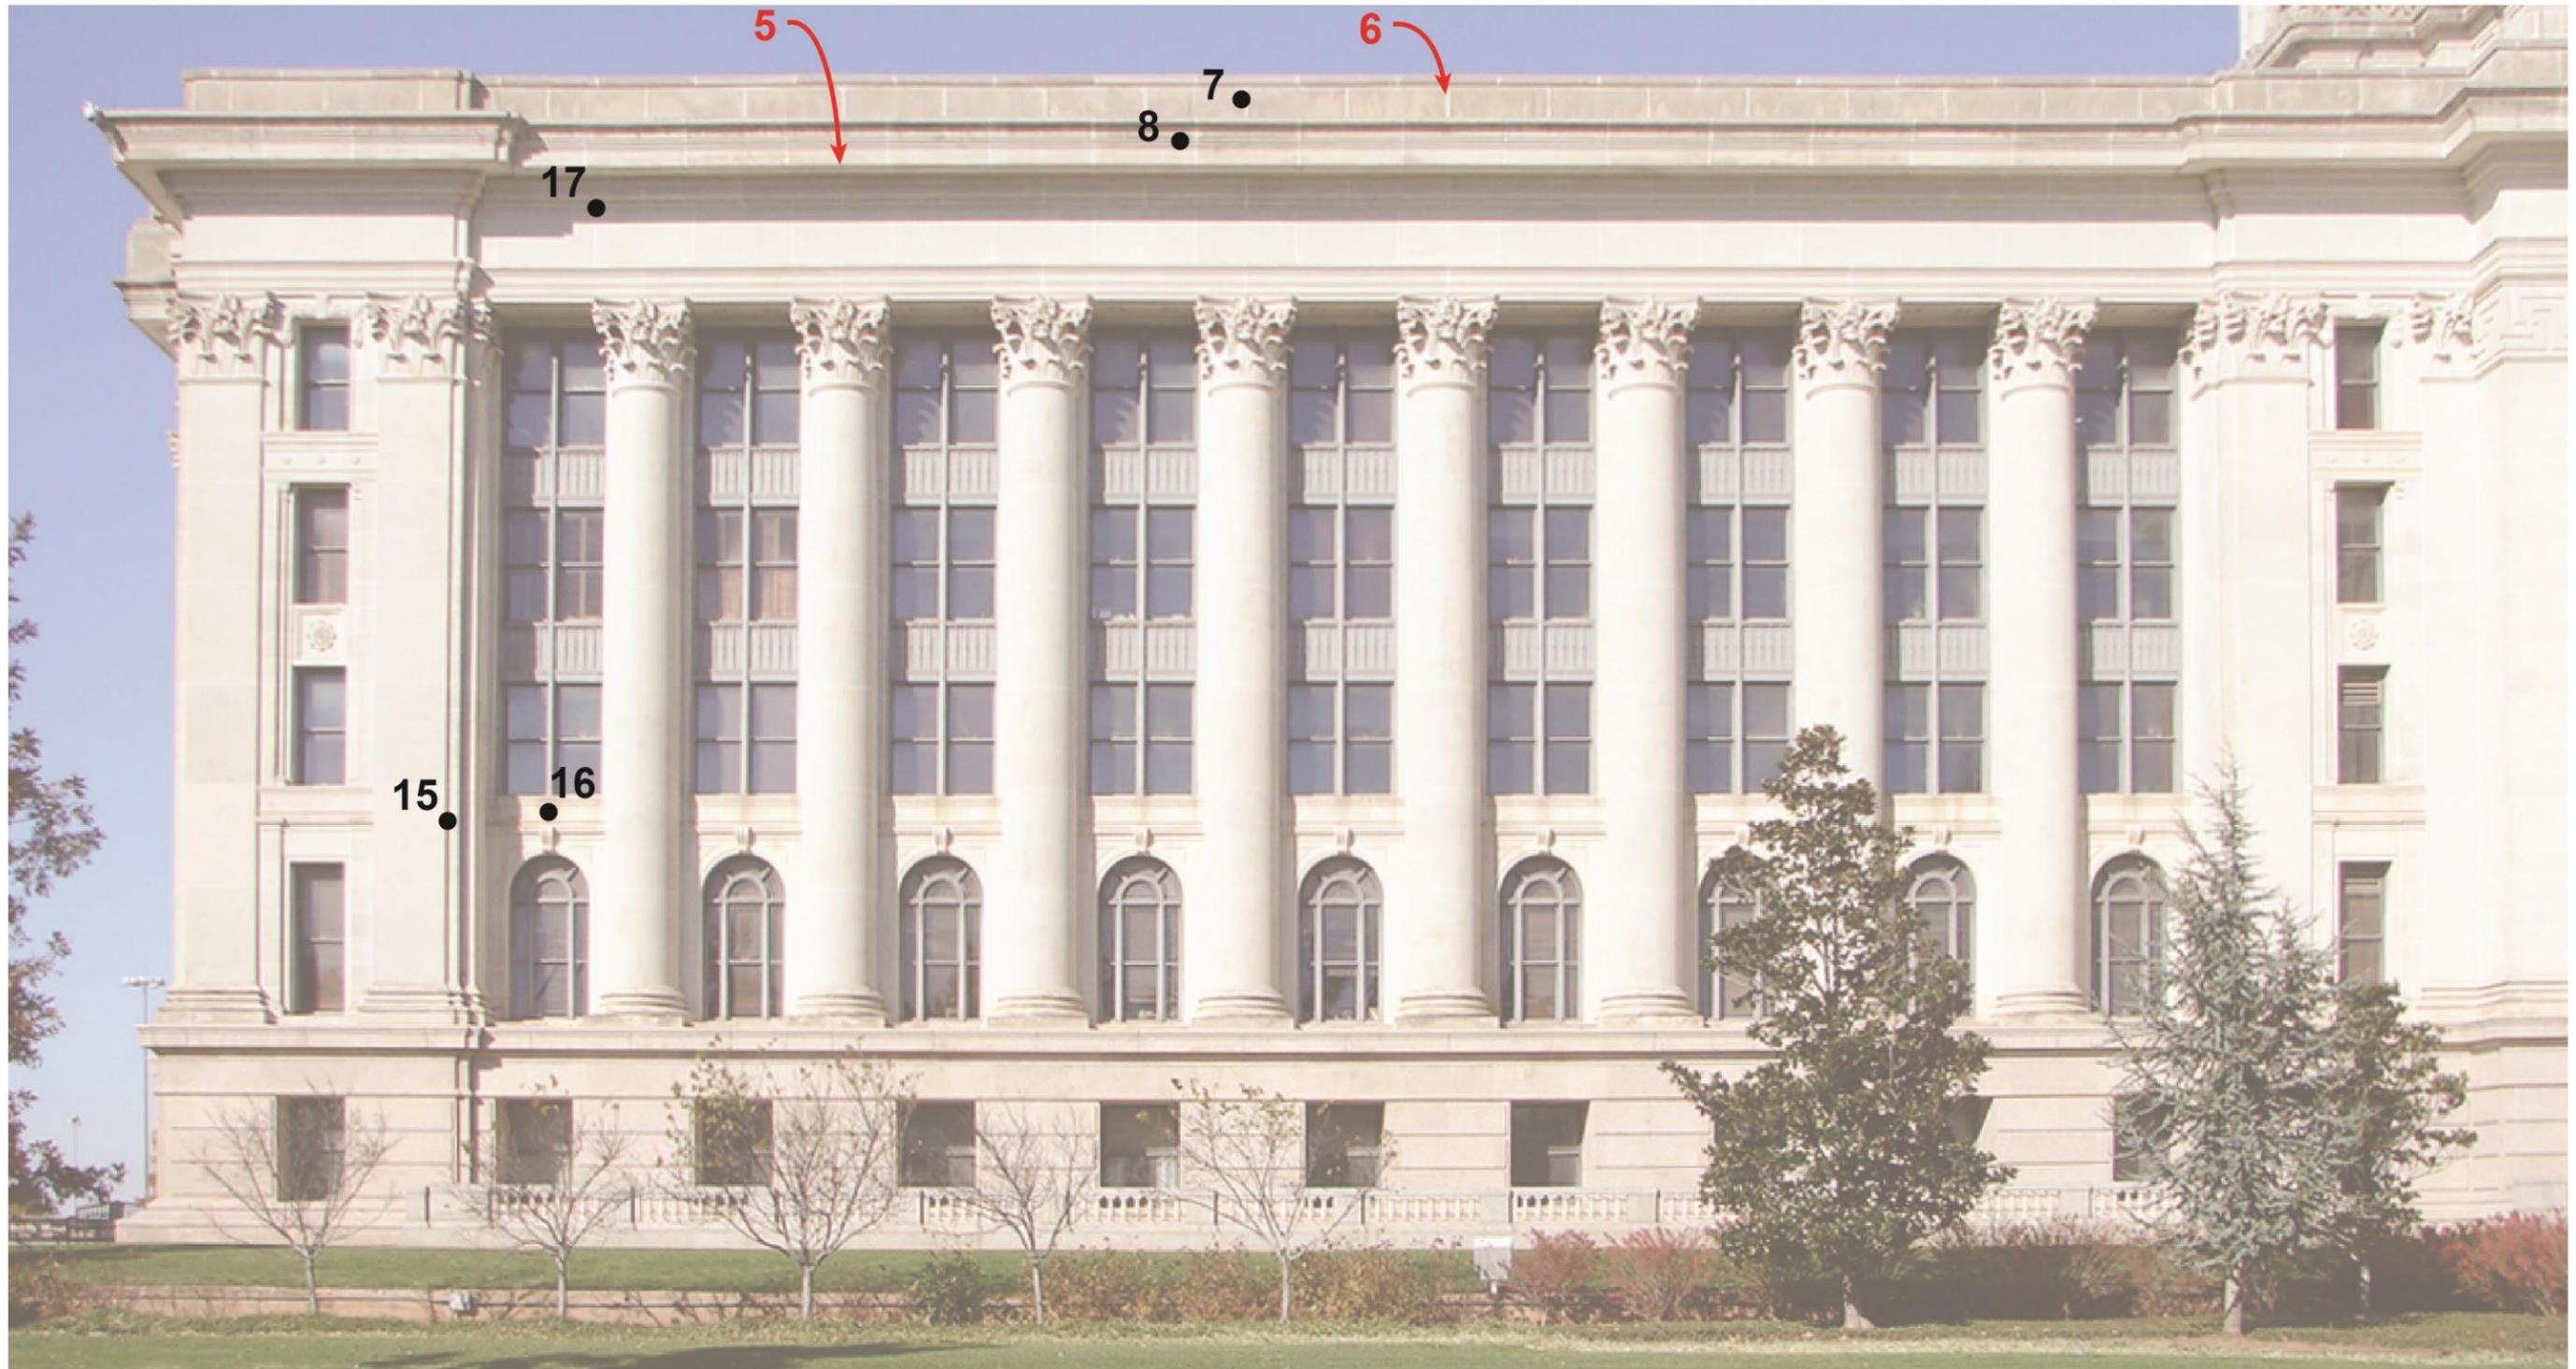
Figure A40. Photograph of south facade, west wing, showing locations of inspection openings. Inspection openings noted in red are on the back face of the facade.

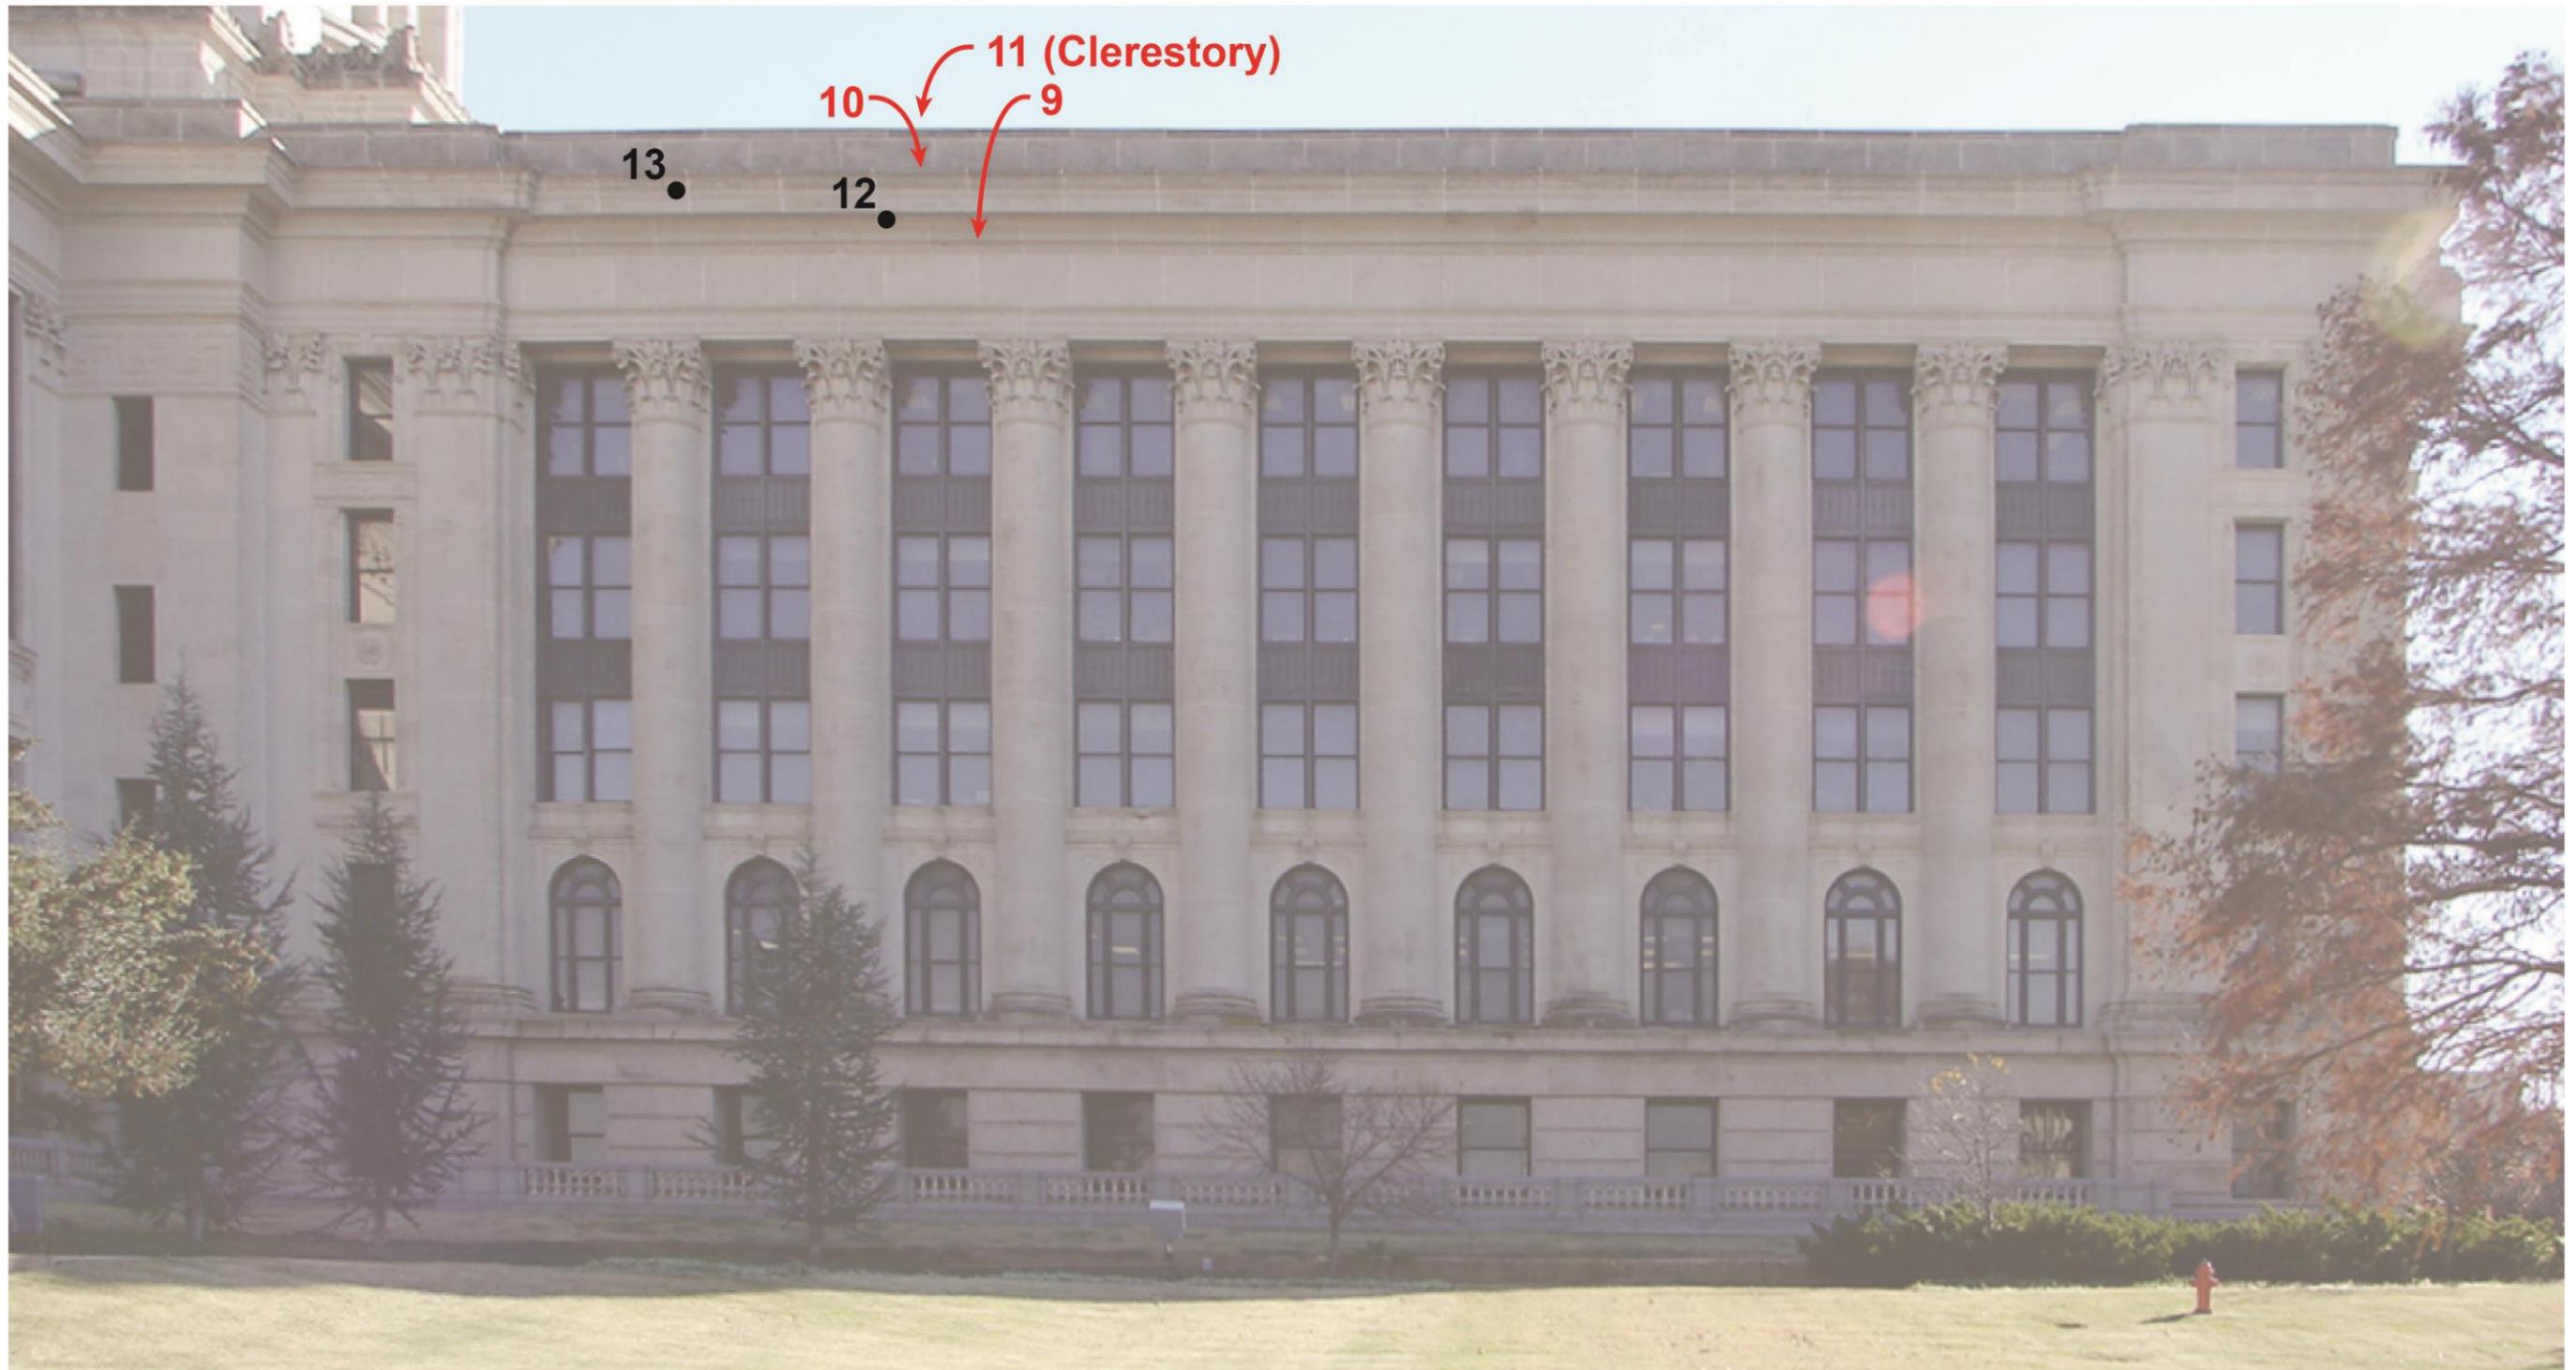
Figure A41. Photograph of north facade, east wing, showing locations of inspection openings. Inspection openings noted in red are on the back face of the facade.

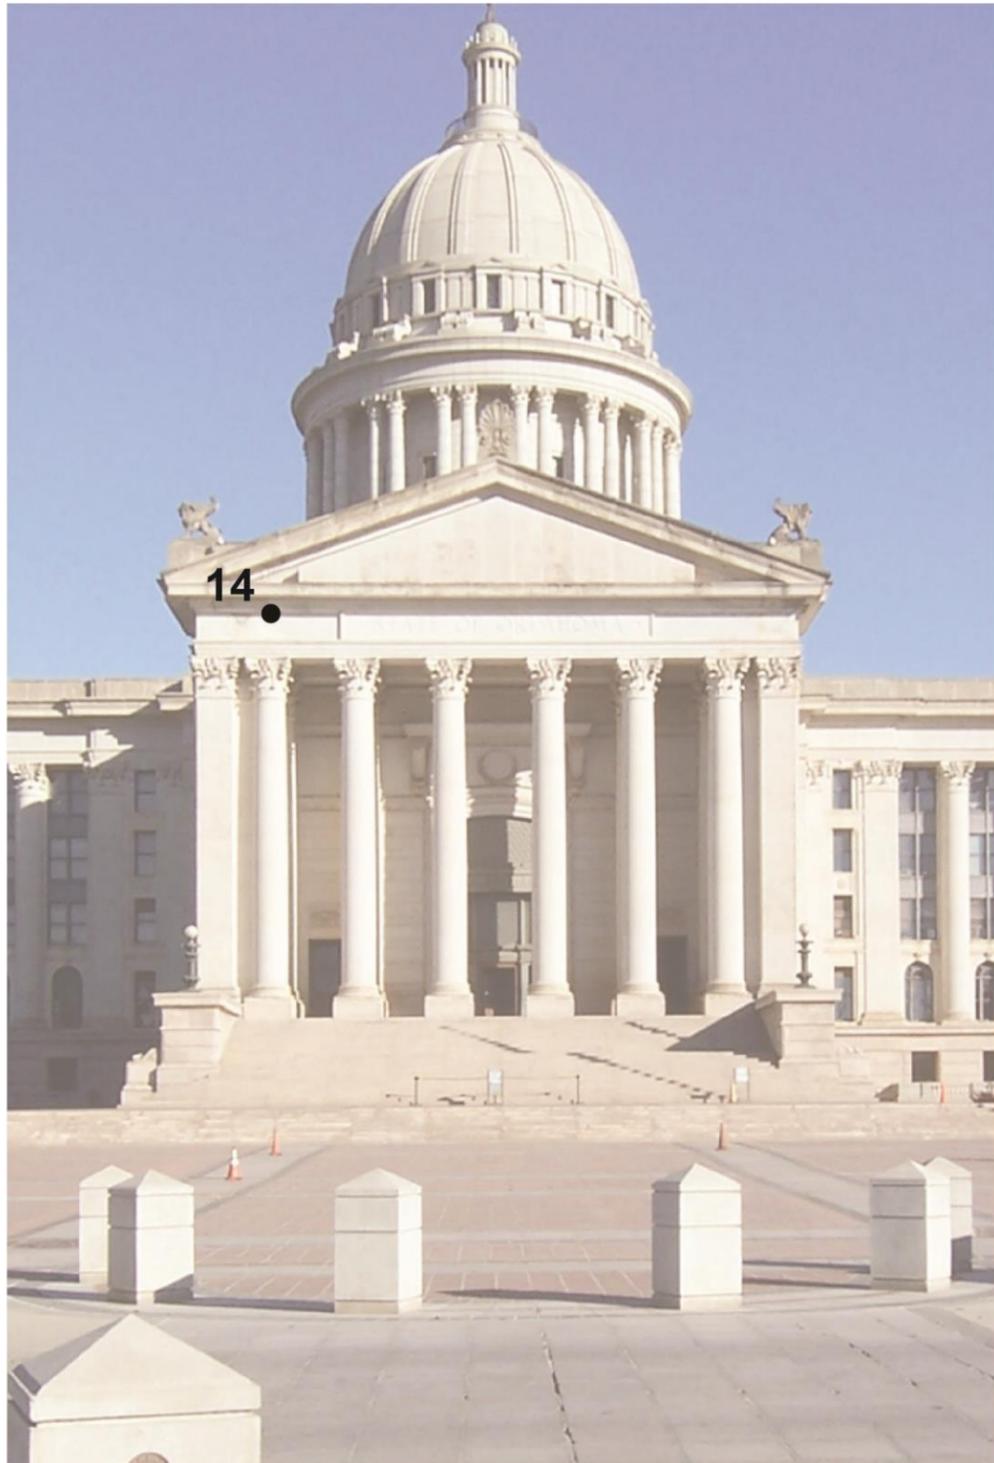
*Figure A42. Photograph of south facade showing locations of inspection openings*
