Assessment of Watershed Dams

Larry Caldwell, PE
Watershed Specialist
Oklahoma Conservation Commission
Stillwater, OK

OACD Annual Meeting
Midwest City, OK
February 28, 2011

Sallisaw Creek Watershed Dam No. 19

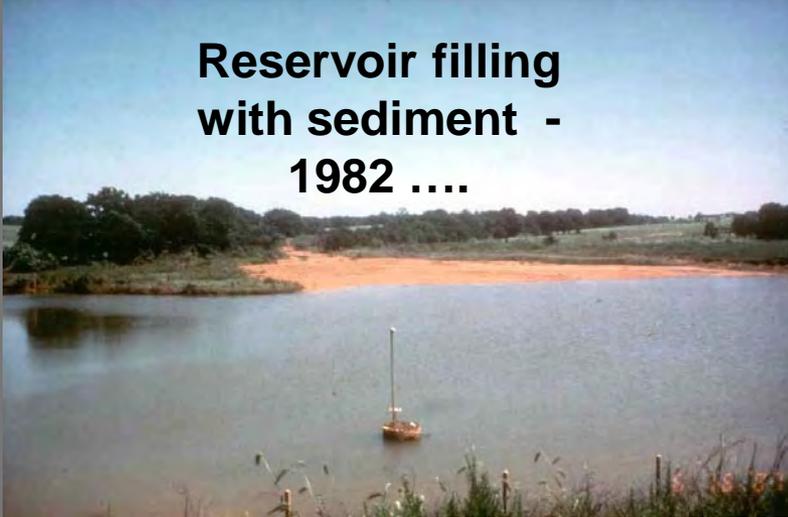
**Reservoir filling
with sediment -
1982**

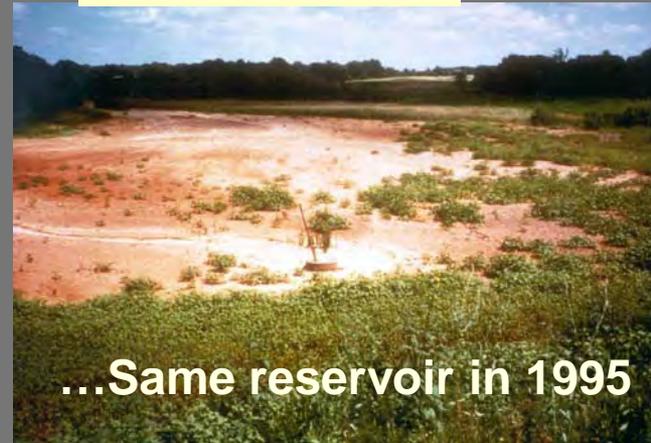
Sedimentation

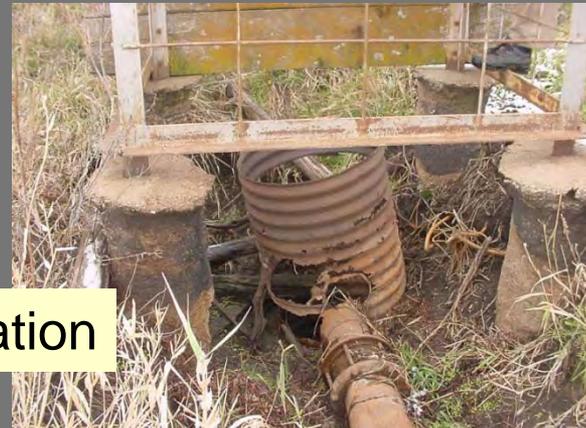
Deterioration

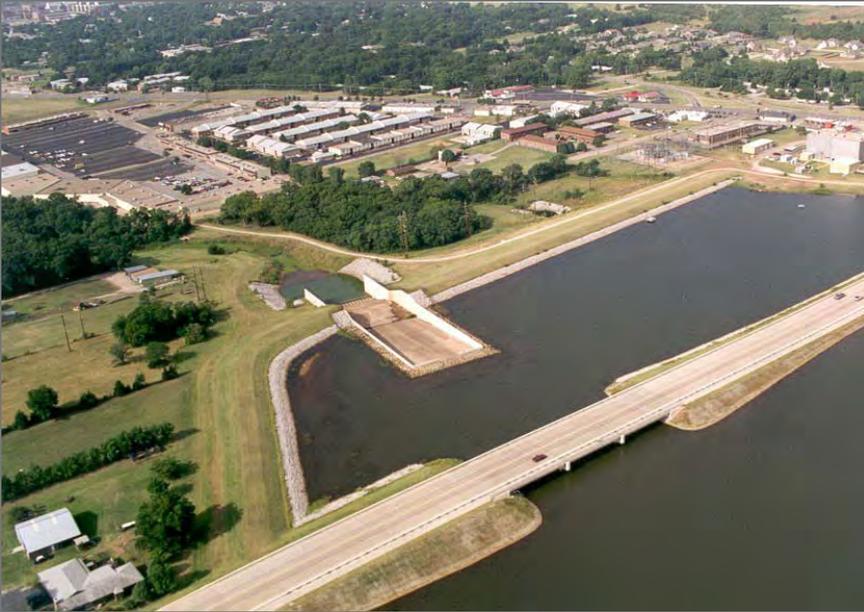
Development downstream

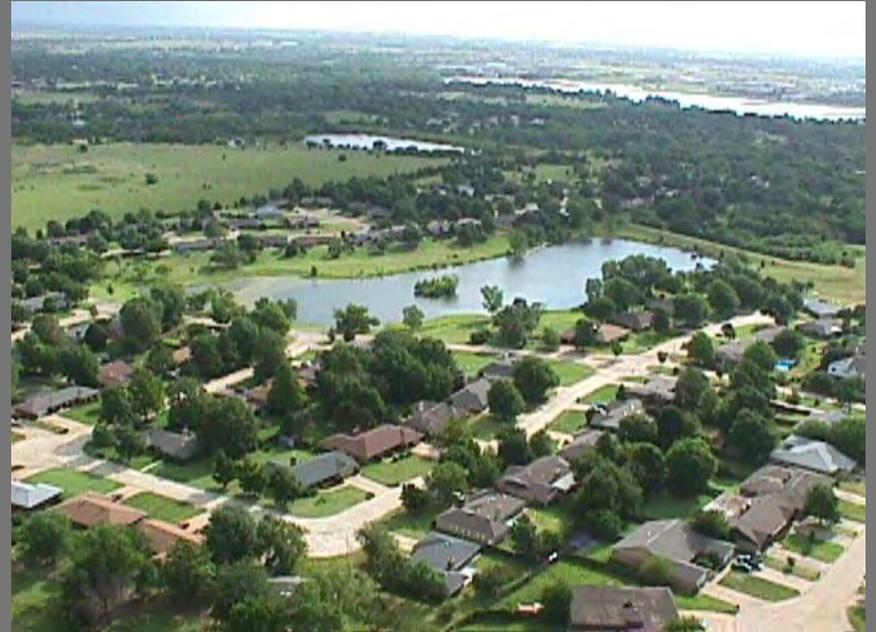
Development around reservoir

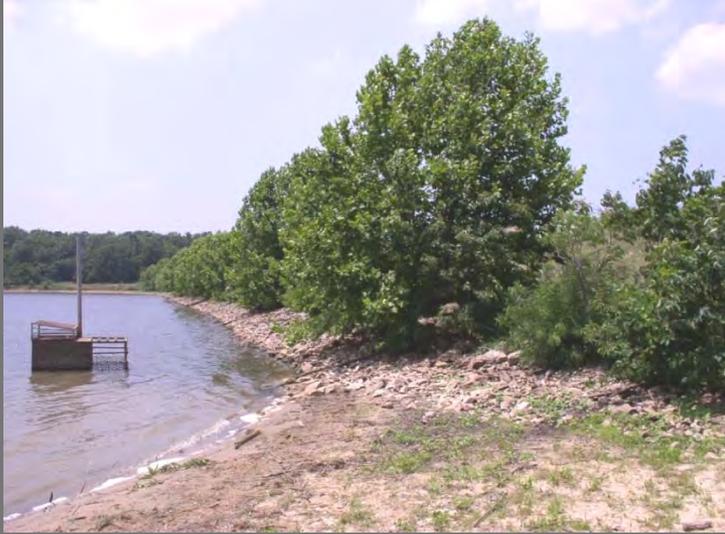
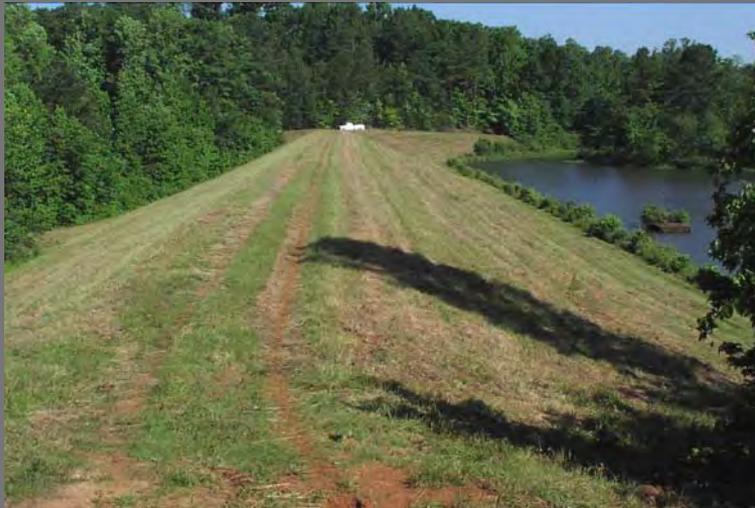
Vegetation

Embankment Condition: There is a good Bermuda grass cover on the dam. There are trees and brush growing on slopes and at the waterline. There are large trees on the right end of the embankment. The top of the dam has some vehicle tracks that should be monitored.

Non-Urgent Actions That Should be Addressed Through Normal Maintenance Activities: The slide gate needs to be replaced, the perimeter fence should be repaired, debris removed from inlet tower, trees and brush removed or chemically controlled. The vehicle and cattle trails in the auxiliary spillway and the trail on the top of the dam should be monitored for erosion problems. The estimated cost of completing this maintenance work is approximately \$6,000.

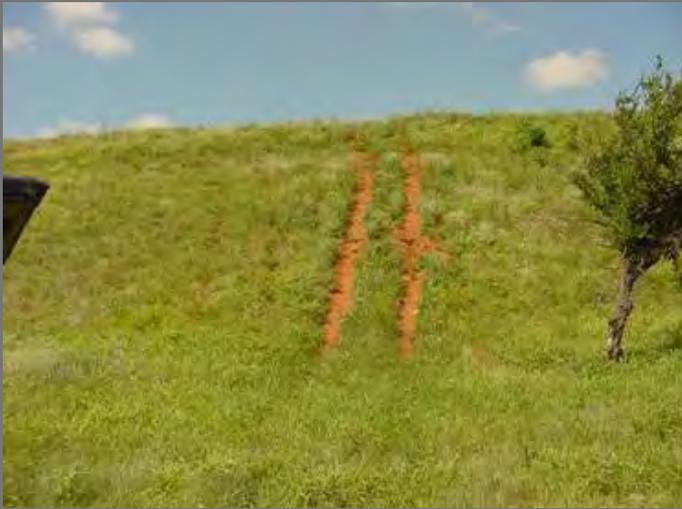
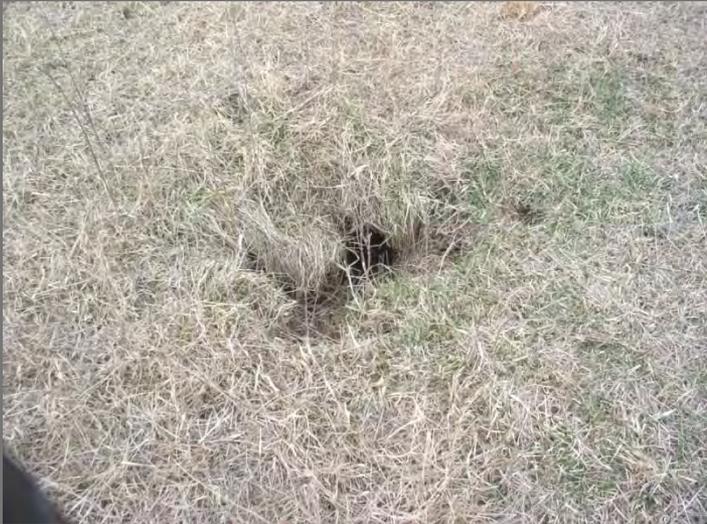
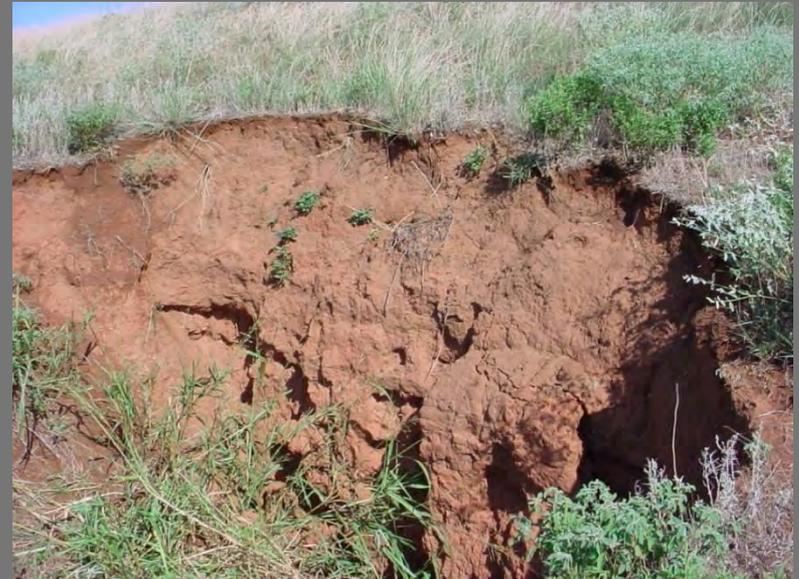
Embankment

Cracks, settlement, sinkholes, burrows & livestock trails

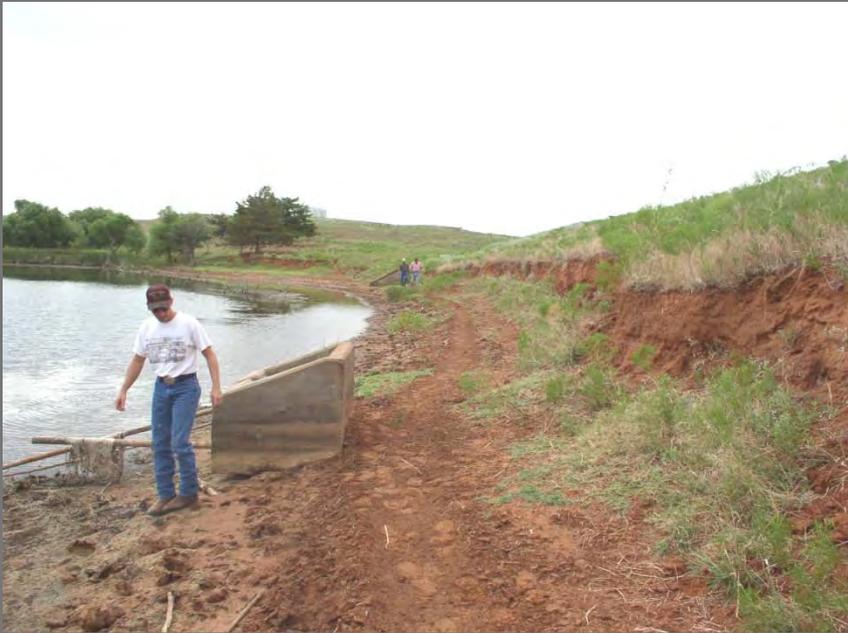
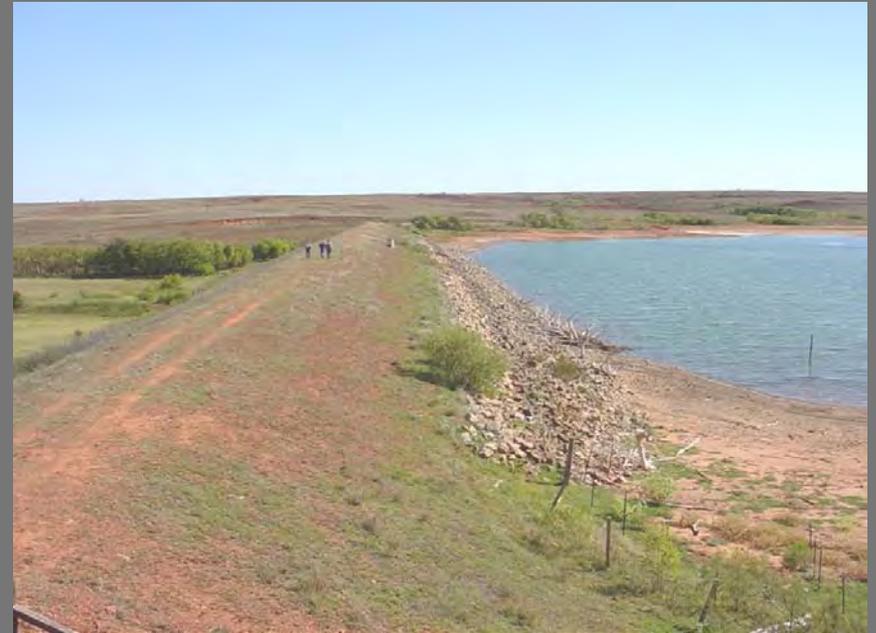
Front Slope

Wave action damage

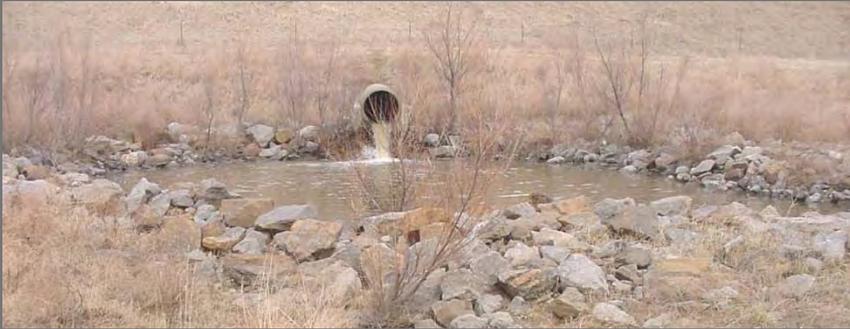
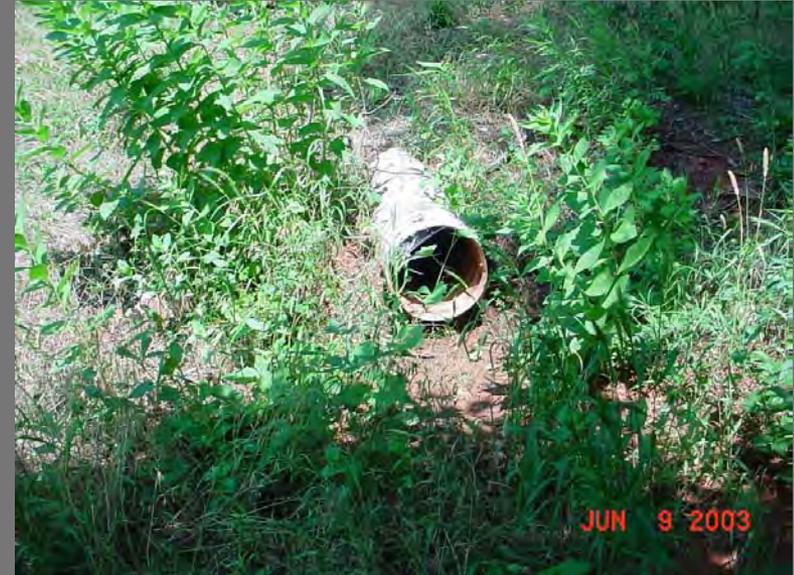
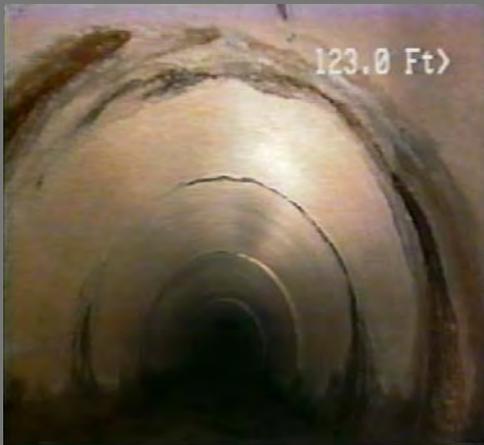
Principal Spillway Conduit

Deterioration,
corrosion or leakage

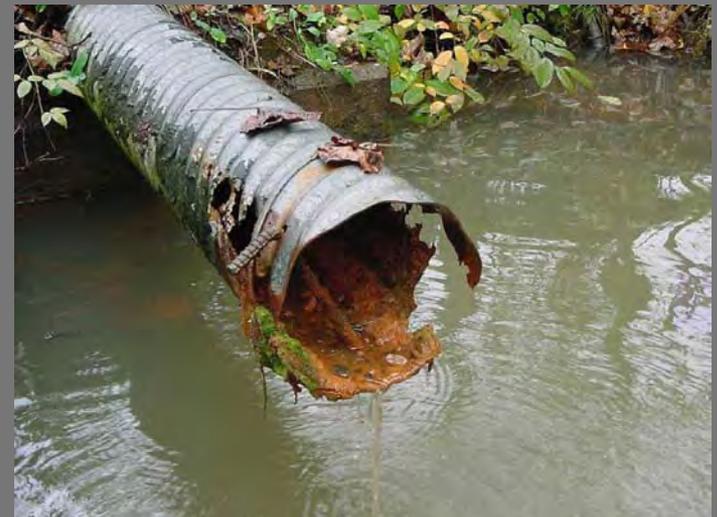
Video inspection of the principal spillway conduit

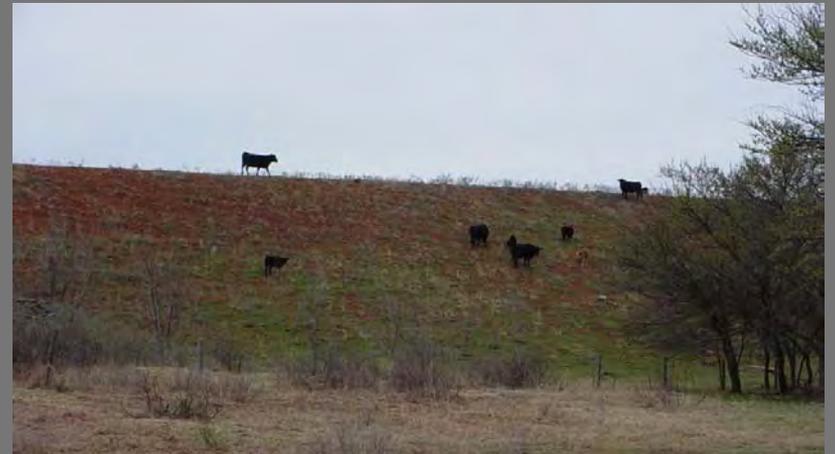
Fence repair needs

Gates open

Over grazing

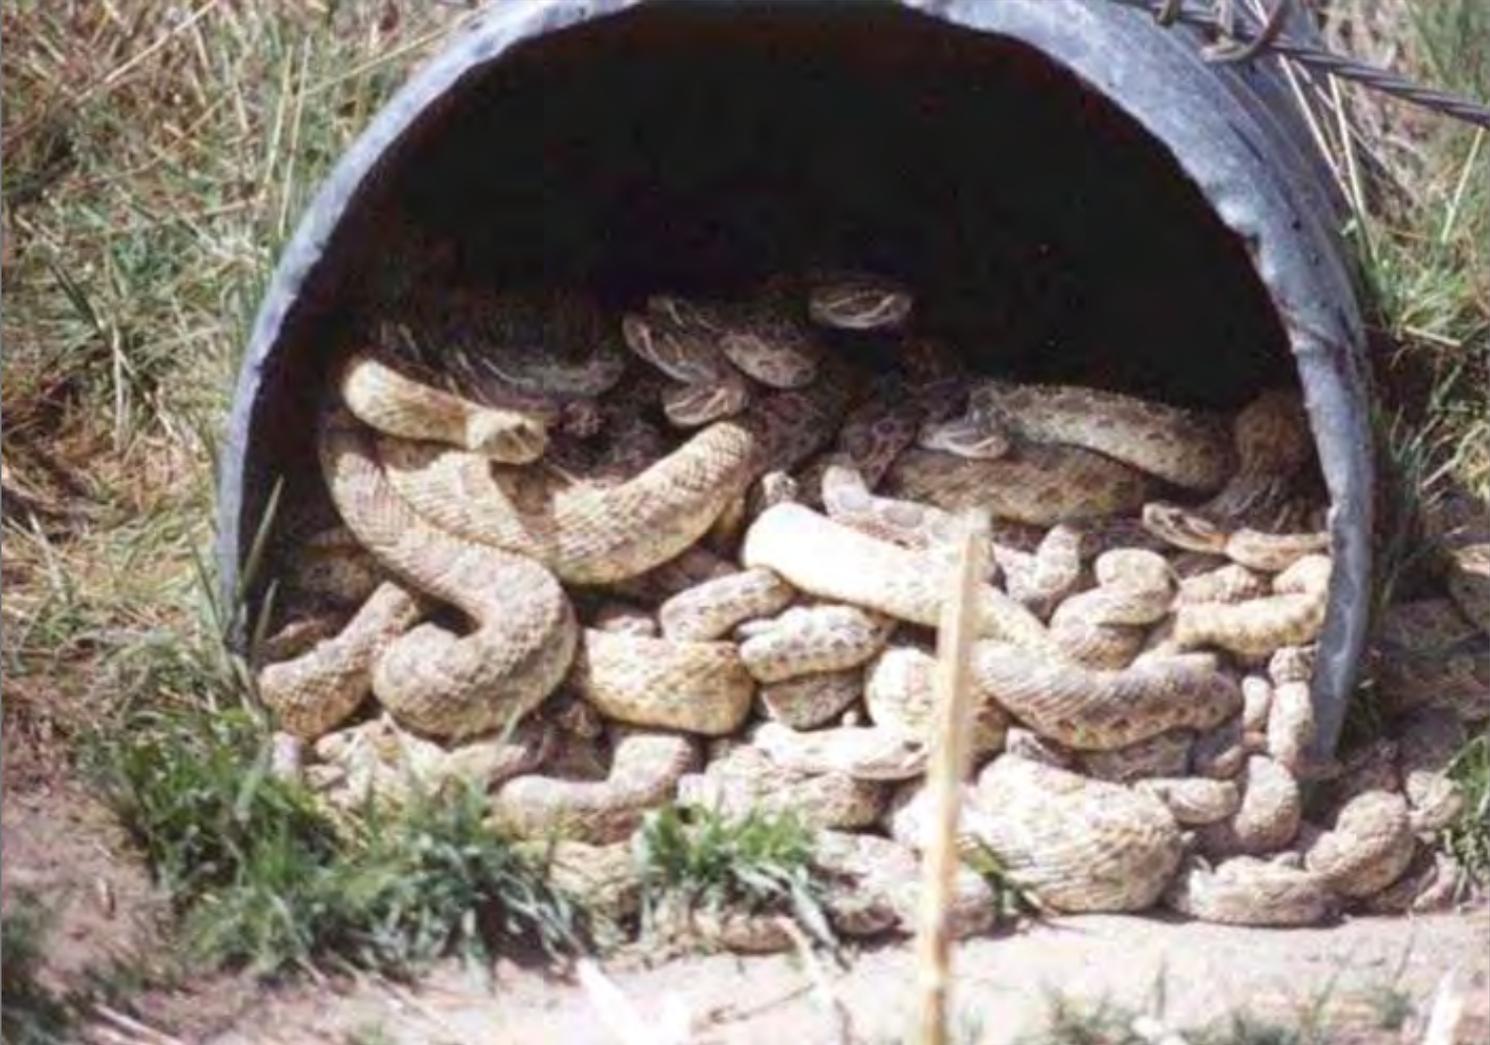
Occasionally, it might just take another trip to complete the inspection!
